CFM International: Docket No. FAA-2007-27229; Directorate Identifier 2007-NE-03-AD.

(c) This AD applies to CFM International CFM56-7B18, -7B20, -7B22, -7B24, -7B26,

"TURBINE REAR FRAME WITH TANGENTIAL STRUTS—MANDATORY INSPECTIONS—LIFE LIMITS

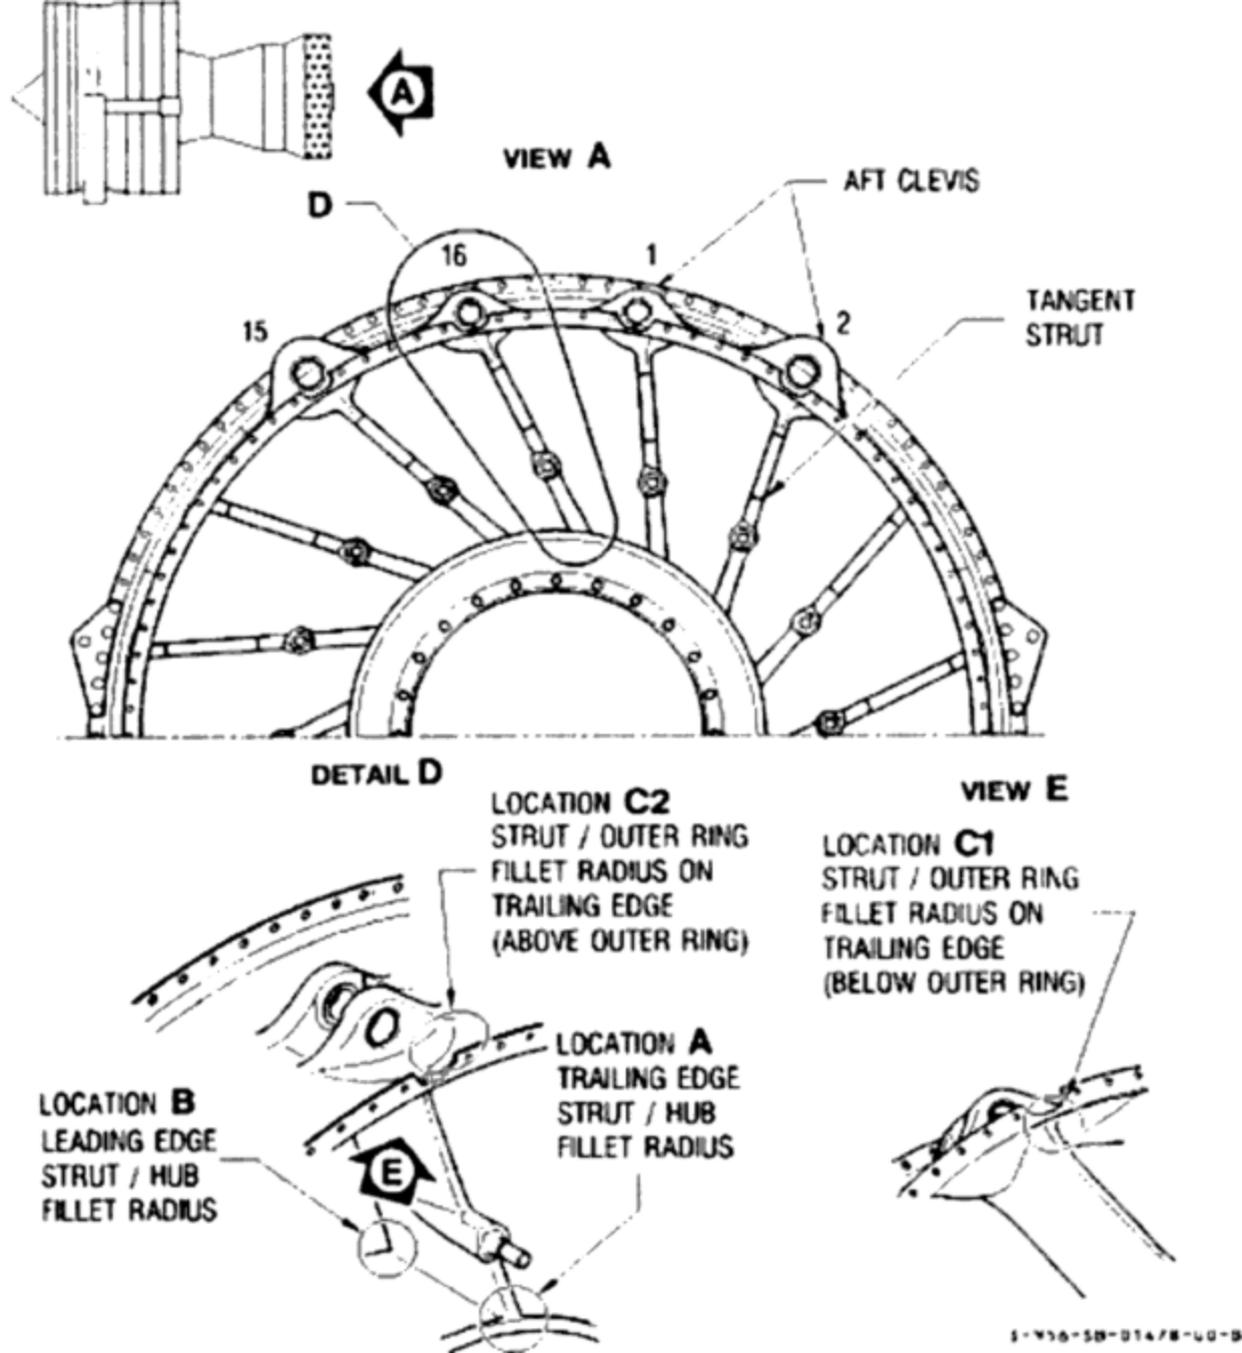
Figure 805,

(d) This proposed AD results from a refined lifing analysis by the engine manufacturer that shows the need to identify an initial threshold for inspecting certain TRFs. We are proposing this AD to prevent failure of the TRF from low-cycle fatigue cracks. Failure of the TRF could result in engine separation from the airplane, which could lead to loss of control of the airplane.

Figure index No.	Inspection location	Inspection threshold (cycles since new)	Inspection intervals (cycles)	Inspection reference
805	Strut/outer ring fillet radius on trailing edge (A)	25,000* for -7B SAC (except business jet) engine models	Refer to Figure 806* for -7B SAC commercial applications	Refer to SB 72-0579*.
	Strut/outer ring fillet radius on leading edge (B)	19,000* for -7B SAC business jet engine models	Refer to Figure 807* for -7B SAC business jet applications	
	Strut/outer ring fillet radius on trailing edge (C1 below outer ring)			
	Strut/outer ring fillet radius on trailing edge (C2 above outer ring)

Turbine Rear Frame with Tangential struts P/N 340-166-205-0, 340-166-206-0, 340-166-207-0, 340-166-208-0, 340-166-209-0, 340-166-210-0-Areas to Be Inspected

2. Mandatory Inspection Intervals for the Critical Areas of the Turbine Rear Frame with Tangential Struts (4 Mount Struts, No. 1, 2, 15, and 16).

C. Turbine Rear Frame Part Numbers 340-166-205-0, 340-166-206-0, 340-166-207-0, 340-166-208-0, 340-166-209-0, 340-166-210-0, for all CFM56-7B SAC engine models (except -7B27A engine models). Refer to figure 805.
