To: [REDACTED]
From: Jeffrey Epstein
Sent: Fri 1/29/2010 12:12:09 PM
Subject: Re: S76 update

Jeffrey and Darren,
The paint is flawless, I compare it to the quality of the Bentley, I am very pleased.
Eric Roth's seat design and appearance of the interior look great.

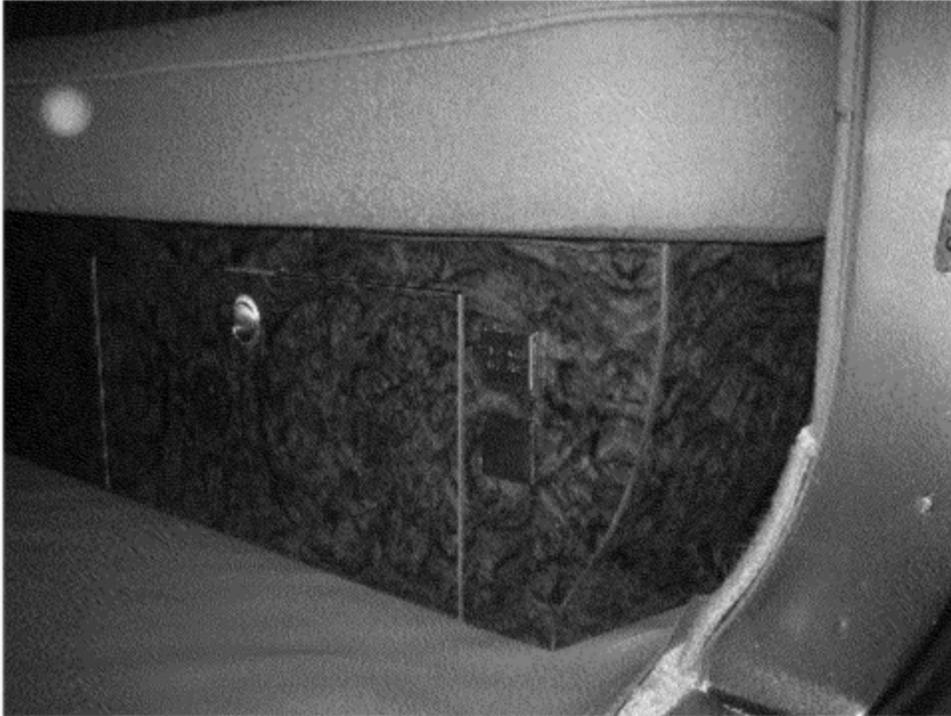
-The S76 will not be fully complete till Feb 10th, Keystone is waiting for two 12 volt outlets to be delivered, they are installed in the passenger compartment. We have four total installed in the passenger compartment, however Keystone realized they where missing two of these outlets, at this time they have installed cover plates: see photo below:
