Façade Inspection & Safety Program
Cycle 7A Report

9 East 71st Street
New York, NY 10021

February 2012

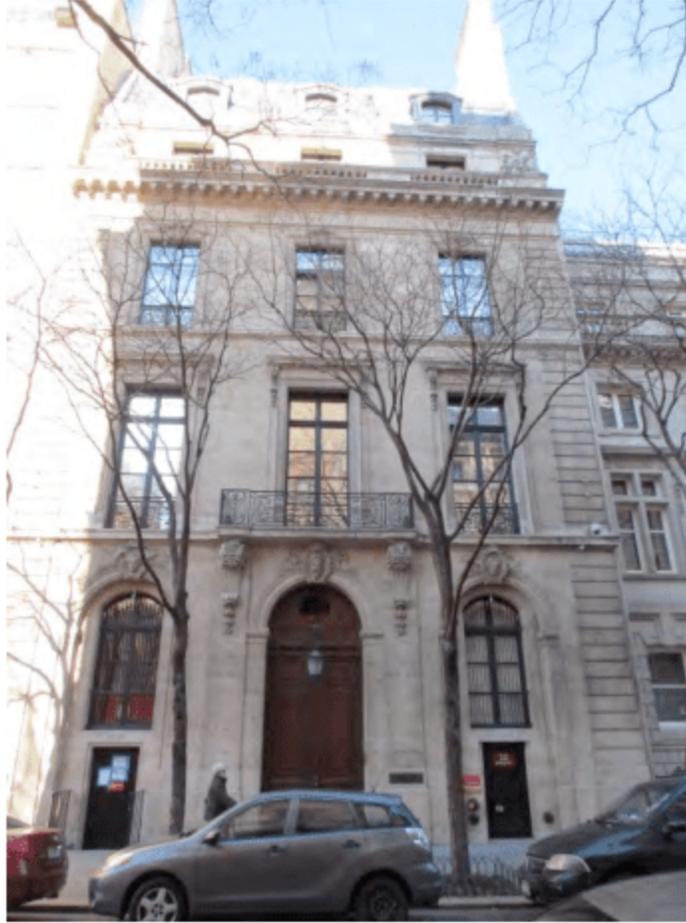
1. View of south (71st Street) façade.

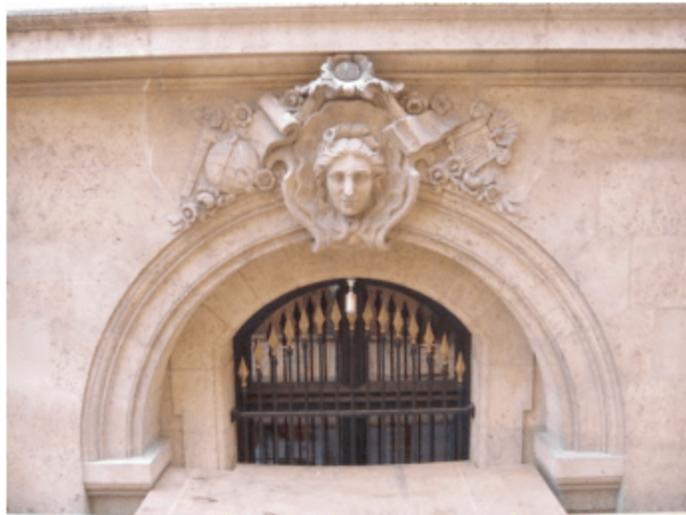
2. Detail of stone ornament at entrance.

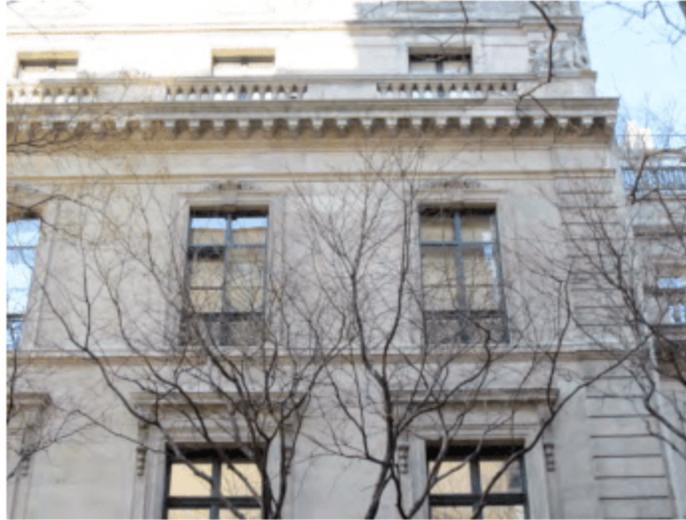
3. Detail view of south façade.

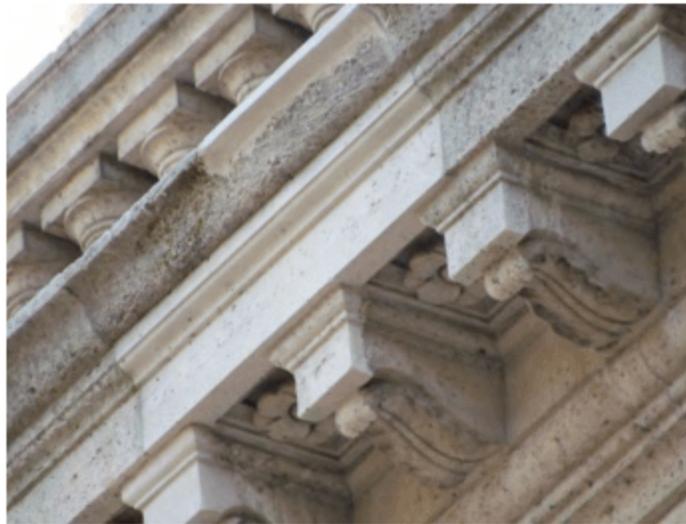
4. Patched sections of stone at south elevation.

- The patching of deteriorated stone has been completed.
 - The painting of deteriorated finishes has been completed.
2. Work permit numbers relating to façade repairs:
- Façade Restoration: Permit#120786970-01-EW-OT
 - Sidewalk Shed: Permit #120850588-01-EQ-SH
3. Job numbers & sign-off dates relating to façade repairs:
- Façade Restoration: Job #120786970 approved 08/24/2011. Sign Off in process.
 - Sidewalk Shed: Permit #120850588 approved 10/05/2011. Sign Off in process.
4. Open ECB façade violations: None.

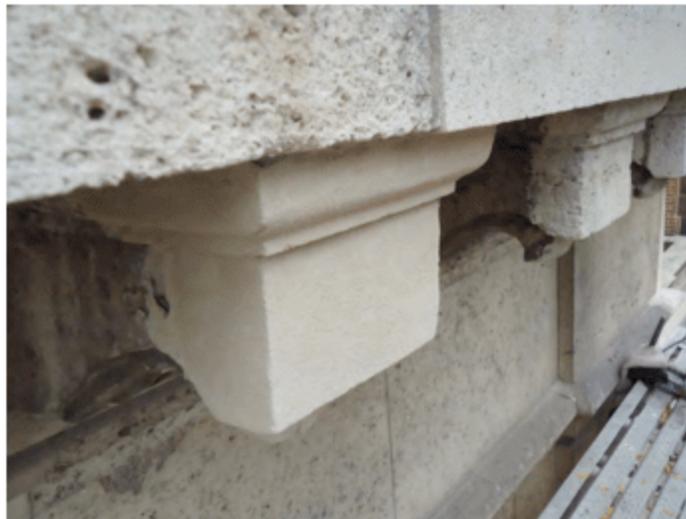
5. Detail view of patched sections of stone at south elevation.

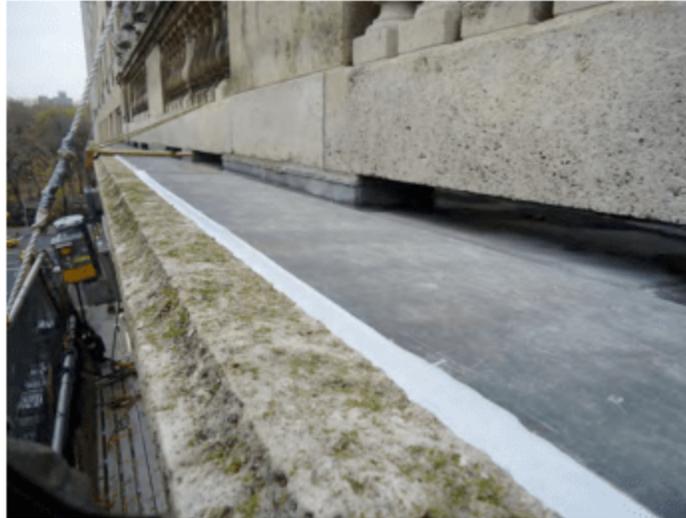
7. New sealant at cornice flashing.

- Deteriorated brick masonry has been reconstructed.
- Masonry repointing has been completed.
- Caulking at control joints has been completed.

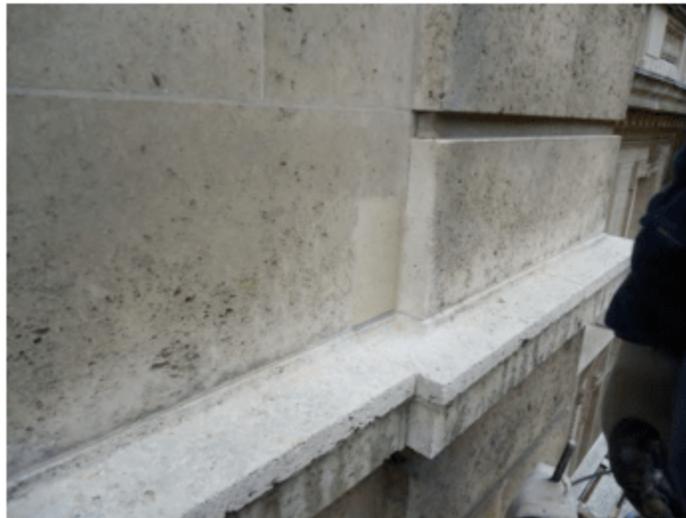
8. Patched sections of stone at south elevation.

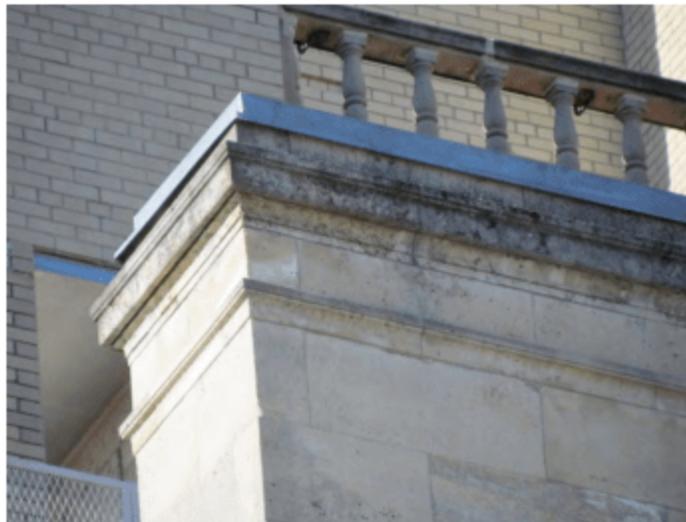
9. Restored chimney cap at west elevation.

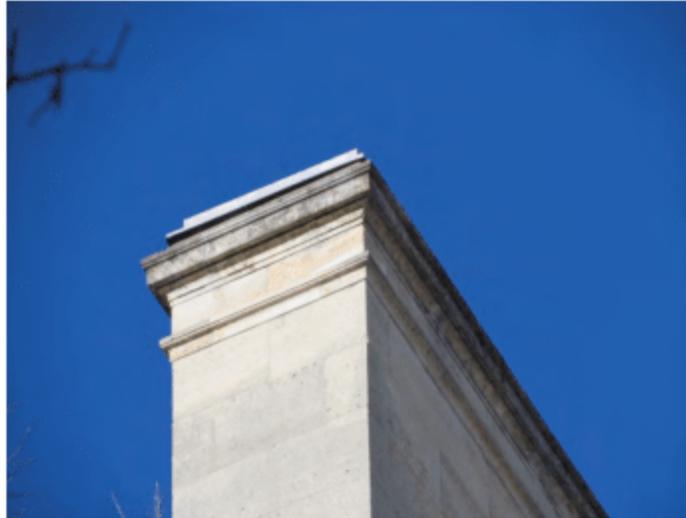
10. Restored chimney cap at east elevation.

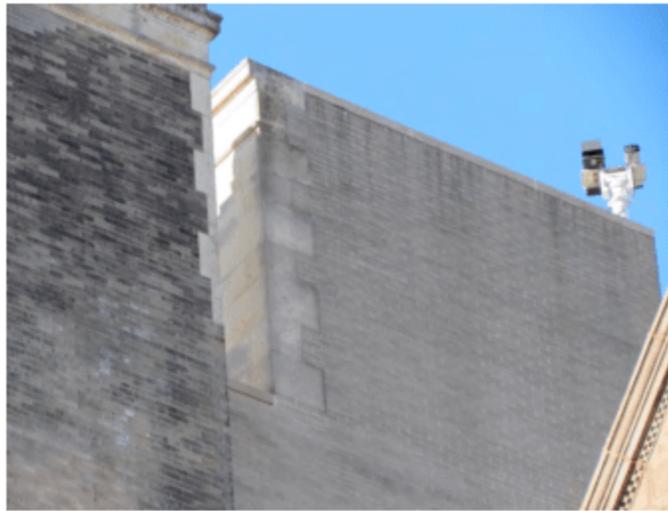
11. Repointed masonry at east wall.

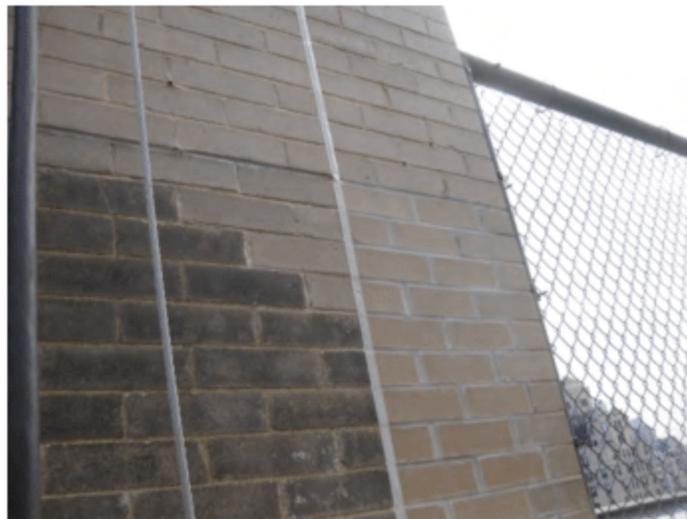
12. Reconstructed masonry at west elevation.
