ASSESSMENT OF IMPACT OF FILL MATERIAL
PLACED OFF THE NORTHWESTERN POINT
OF THE ISLAND OF
LITTLE ST. JAMES

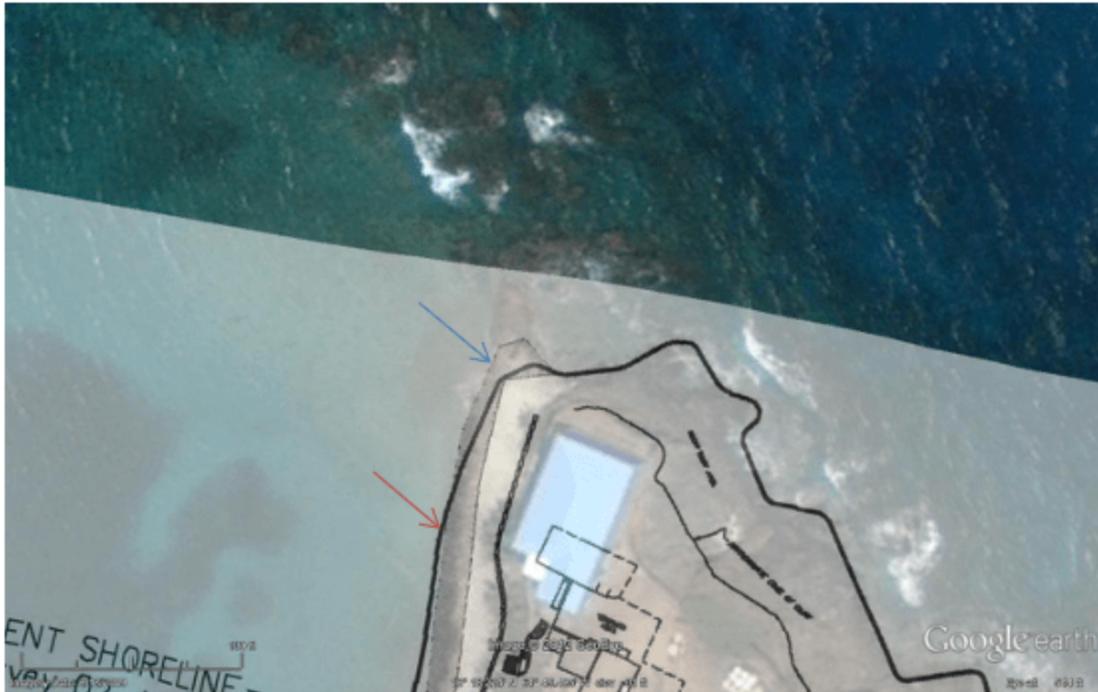
Figure 1: The February 17, 2009 survey conducted by Brian Moseley and Associates overlain the August 18, 2009 Google aerial. The blue arrow represents the 2009 shoreline the red arrow the 2003 shoreline as drawn from aerial and survey data.

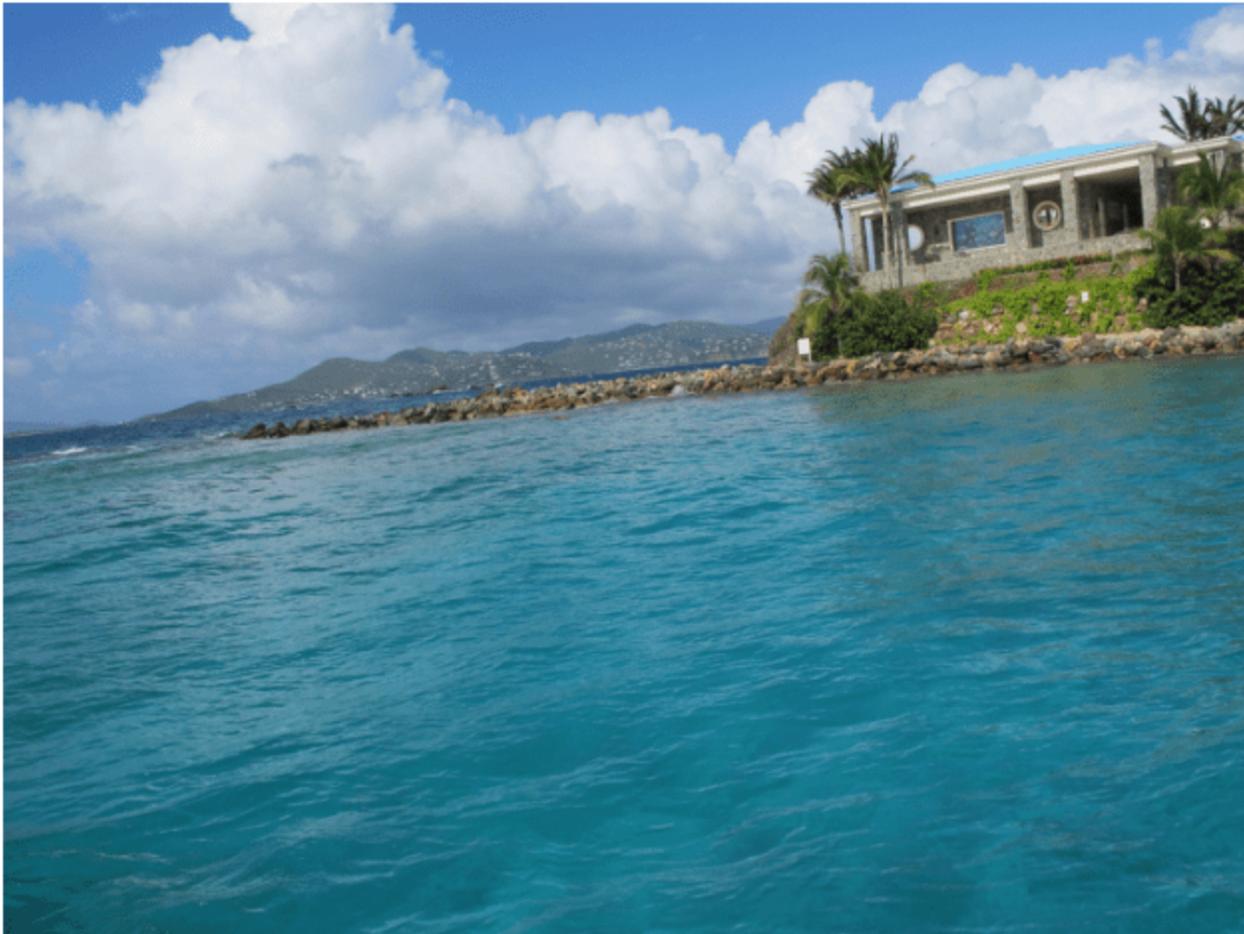
The fill material extends offshore from the point on shallow pavement and rock outcroppings.

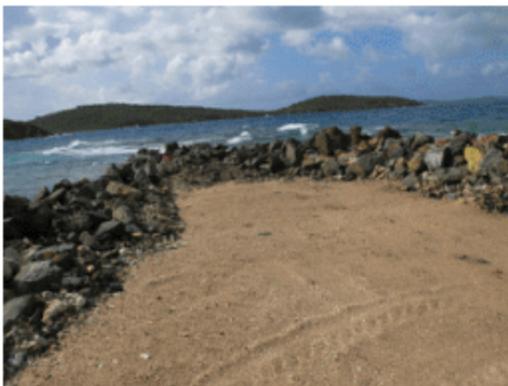
Sandy material extends part way out the created groin which then narrows to all riprap. The northern slope of the riprap is much steeper than the southern and western slopes.

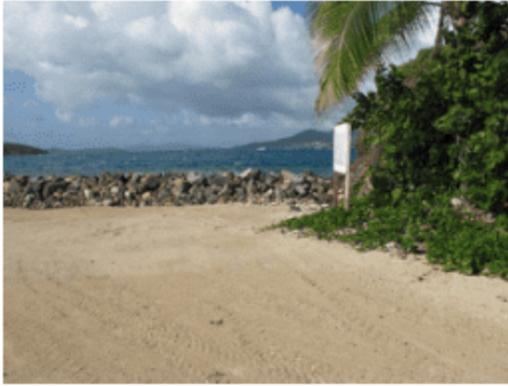
This sign is at the base of the slope and is approximately 10ft. from the base of the building. As shown in the large photograph above, the riprap now extends out 140ft. from the sign. GPS readings were taken with a Garmin Hand Held GPS at the sign and at the outer edge of the emergent riprap.

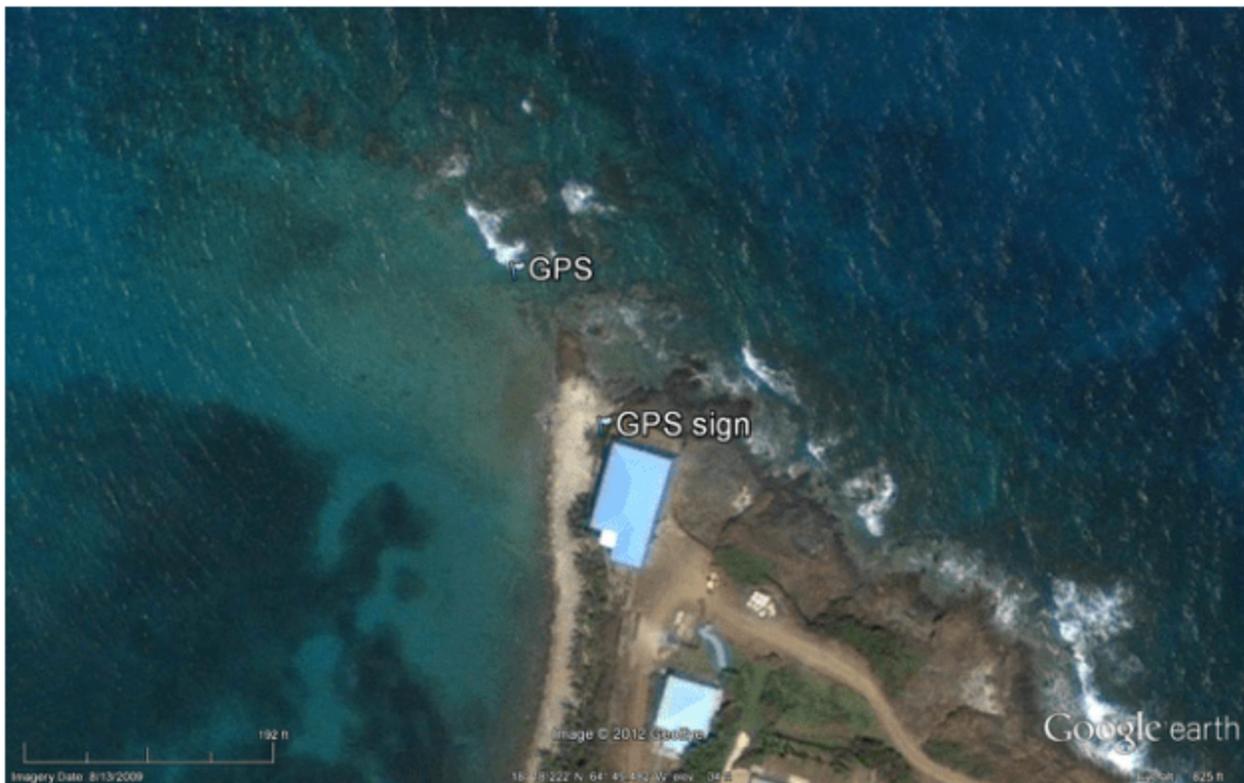
Figure 2: Shown above are GPS readings taken at the site in May 2012, the GPS places the outer edge of the riprap 80ft. from the 2009 shoreline. Because of the sea conditions and steepness of the northern riprap face the width of the groin could not be accurately measured with the GPS.

From the aerial showing the GPS points above it is apparent that additional material has been placed in the sea. It would appear that somewhere between 1000 and 1250 sq. ft. of benthic habitat was directly impacted by the placement of fill. It appears that the fill material impacted very shallow tidally areas

out to a depth between 1' and 18" to the south and to the north the impacts go deeper to as much as a depth of 5ft. because of stones falling into the grotto which runs along the point.

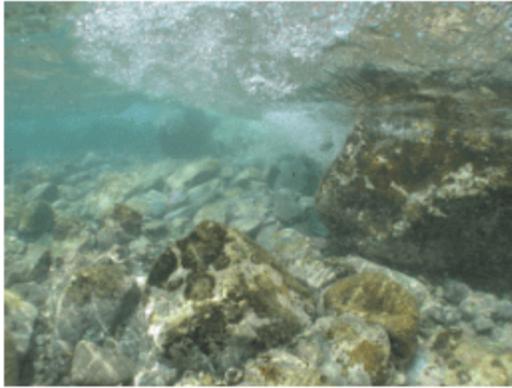
Dive surveys were conducted in May and June of 2012 to assess the impact of fill. It was fairly rough on all days surveyed but seas did calm sufficiently to allow for a thorough survey. The new fill material is visibly different than the older natural and older fill material found farther to the south along the riprap.

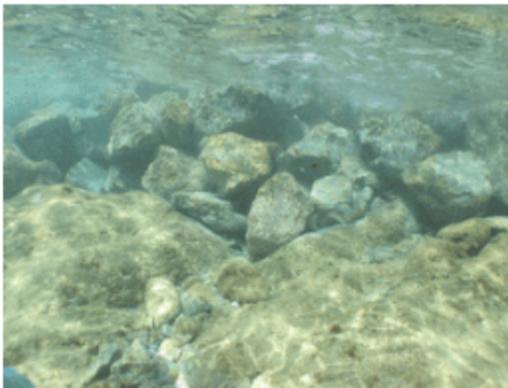
The older material along the areas where the new material was not deposited has encrusting algae and crustose coralline algae covering between 10-80% of its surface. Most of the smaller rocks are worn smooth due to being tumbled by the waves.

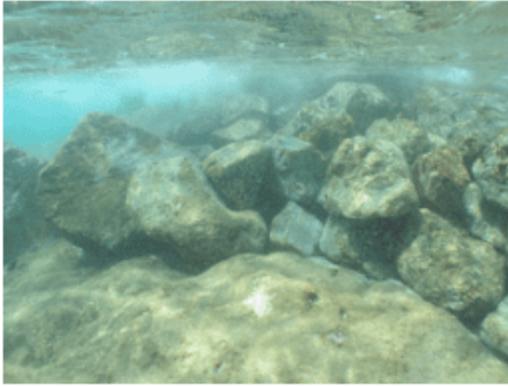
The new material looks very different, has rougher edges and has not yet become as colonized to the same degree the older material has. The new material has no more than 10% coverage by algal species.

The fill material appears to have been carefully placed rather than dump, which limited the extent of the damages caused directly by its placement.

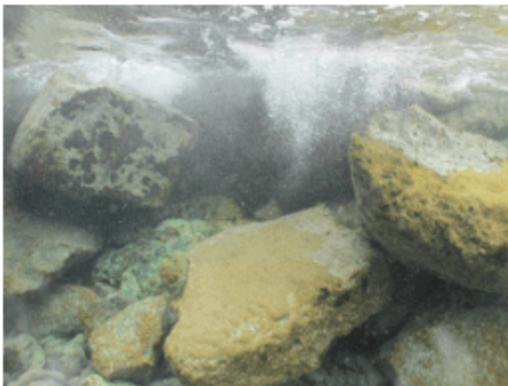
Approaching the south side of the new fill material there are areas where fire coral extends out from under boulders and in one area a *Porites astreoides* has survived between two boulders. In the southern portion of the groin the new boulders were placed on top of areas with abundant boring urchins *Echinometra luncata* in the rocks, fire coral colonization and scattered small head corals.

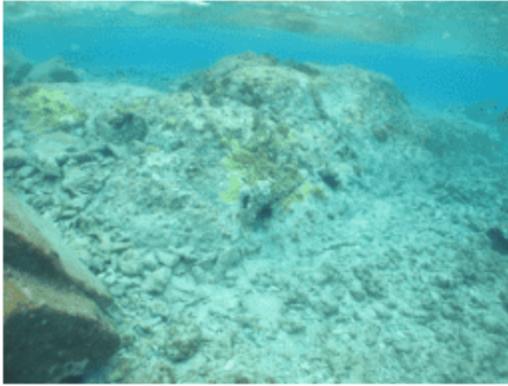
The *Porites astreoides* amid the boulders on a natural rock shows that corals were present in this area of the hard bottom where the rocks and riprap were placed.

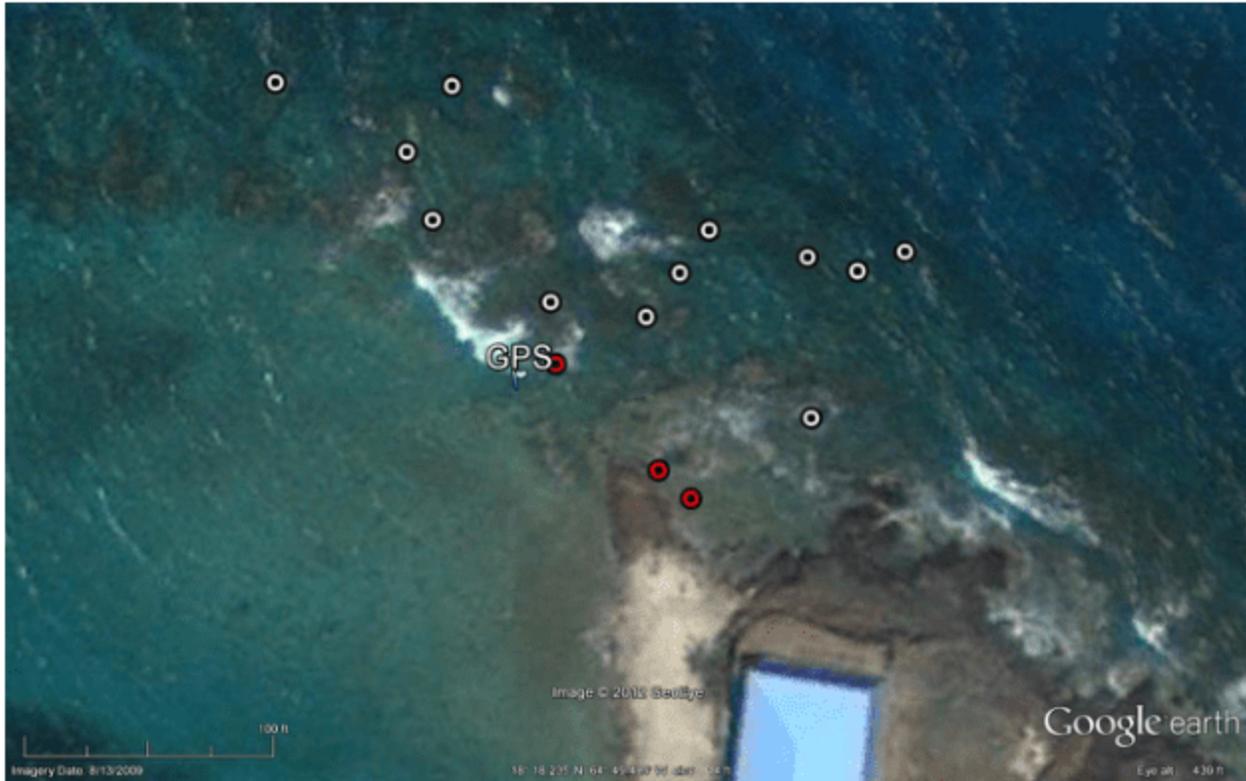
The locations of the 2009 *Acropora* have been mapped on the current aerial and based on the mapped fill, 3 *Acropora* were directly impacted by the filling activity.

Figure 4: The *Acropora* which were impacted by the placement of fill are shown in red.

Because of the additional damage that would occur to remove the materials. Nautilus Inc. is proposing to conduct off-site, in-kind mitigation by protecting additional *Acropora* habitat. Nautilus Inc. would fund placement of 3 public mooring buoys protecting a total of 1250 sq. ft. of coral habitat placed in locations selected by DPNR. Nautilus, Inc. would also protect additional *Acropora* habitat through the cleanup of debris from areas where wrecked vessels have impacted the shallow water environment and the continued presence of this debris continues to pose a threat to nearby corals as it is moved in the waves. The proposed sites of cleanup will be selected and approved by DPNR. Cleanup of the selected

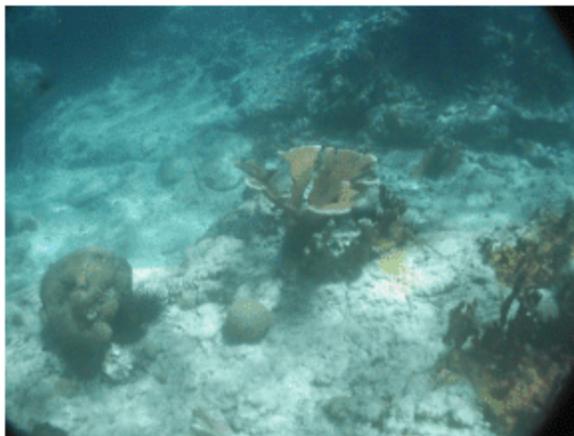
Acropora palmata off the point.

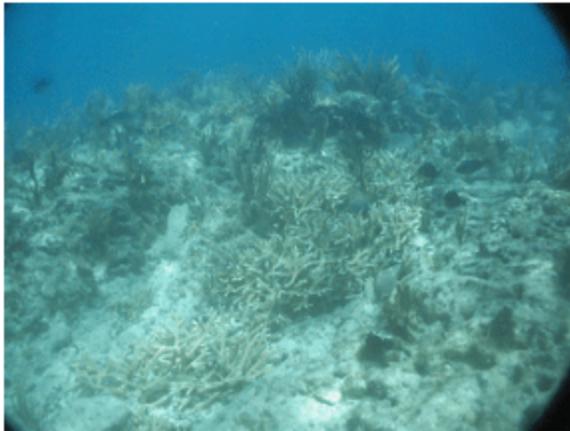
Acropora cervicornis on the northern side of the rocks

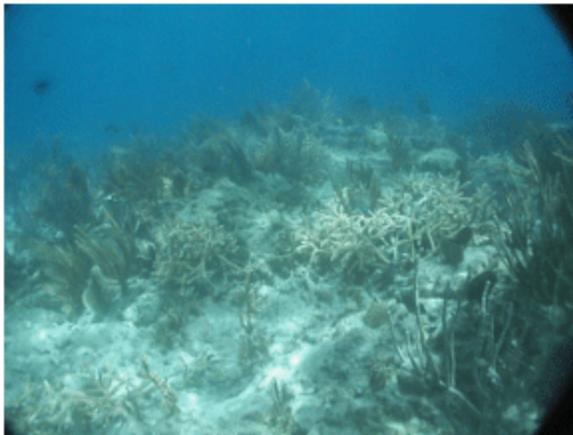
Acropora cervicornis on the northern side of the rocky outcropping

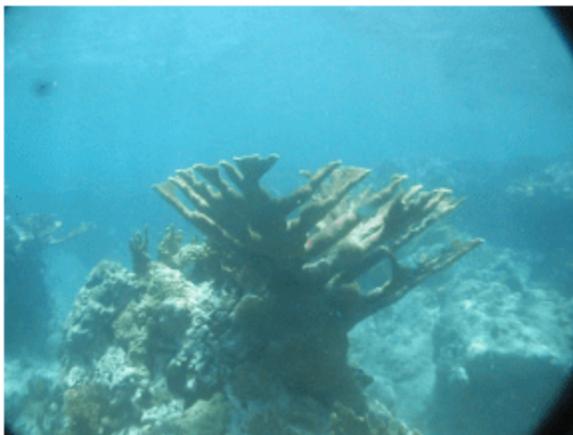
Acropora palmata on the shallow rocks

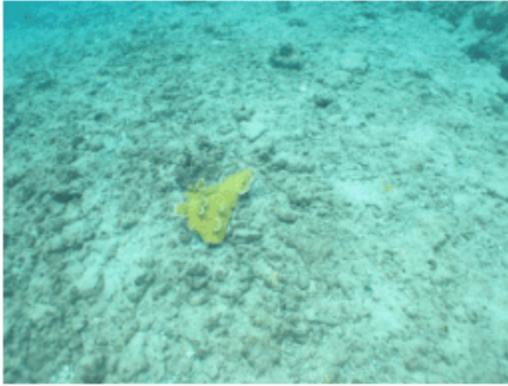
To the north it appears that the new riprap was placed on top of areas with encrusting fire coral as well as encrusting gorgonians (*Erythropodium caribaeorum*), and hard corals including at least 3 *Acropora palmatas*.

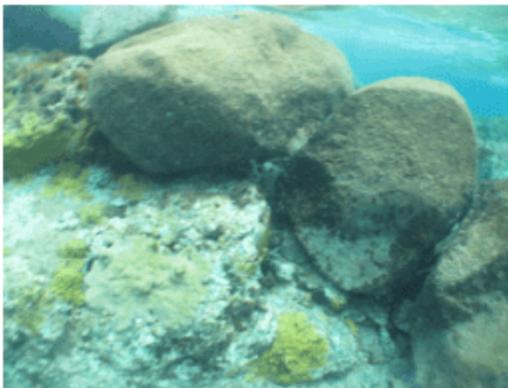
Another broken limb of *Acropora palmata* at the edge of the new riprap, this fragment is not doing as well because of its location in a crevice.

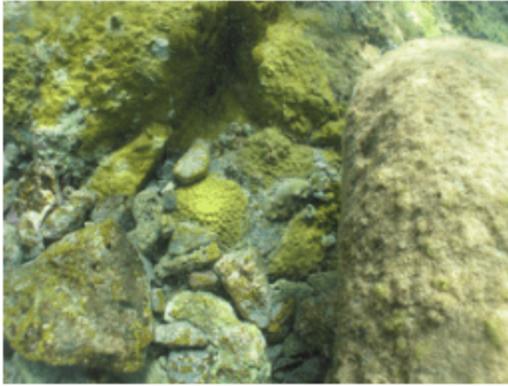
The boulders here are sitting on top of fire coral as well as a *Porites astreoides*.

Corals extending out from under boulders and small stones along the northern edge of the groin.
