484
Greenwich
St.

Building and
Mechanical
Inspection

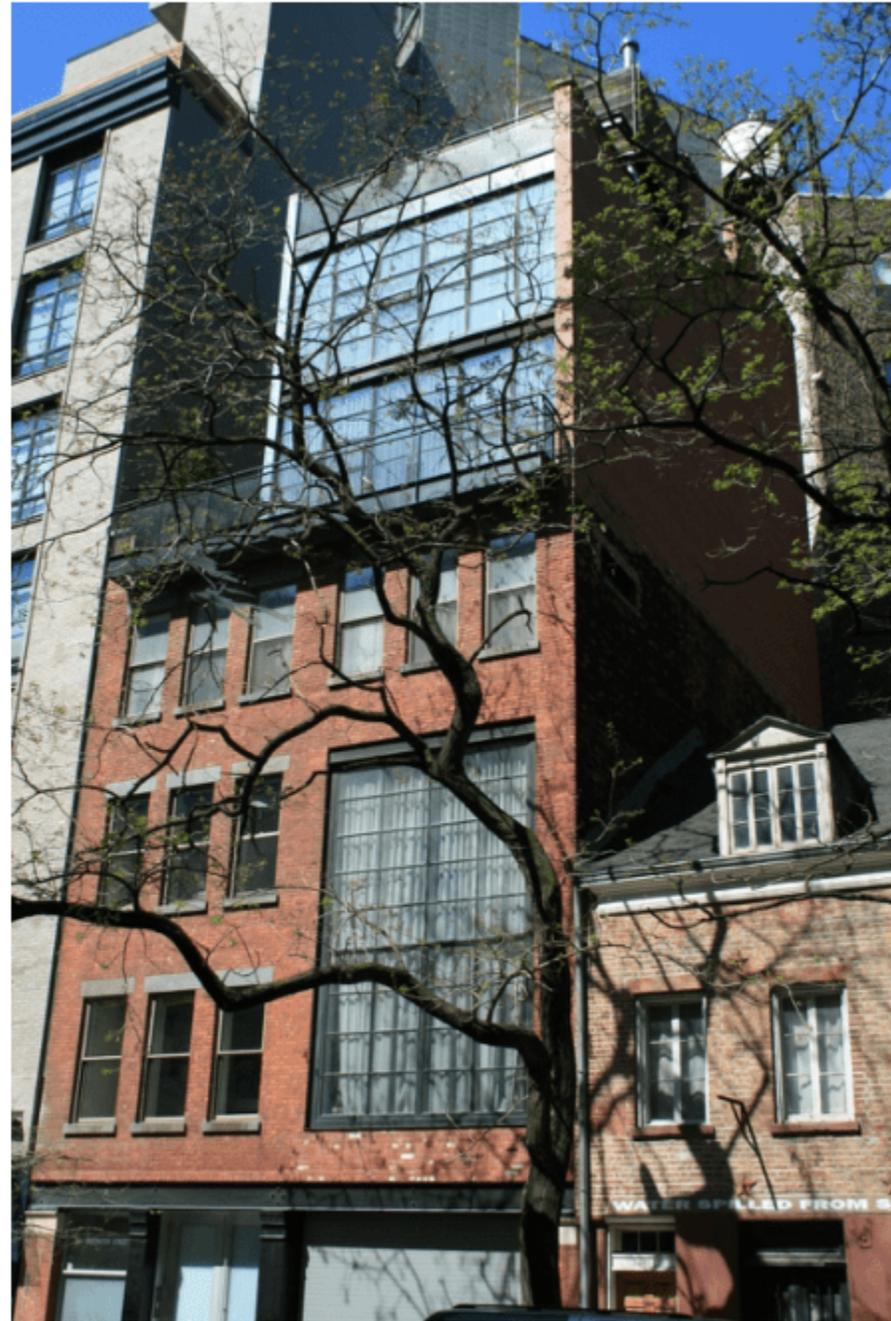
Front of building showing brick pointing maintenance needed.

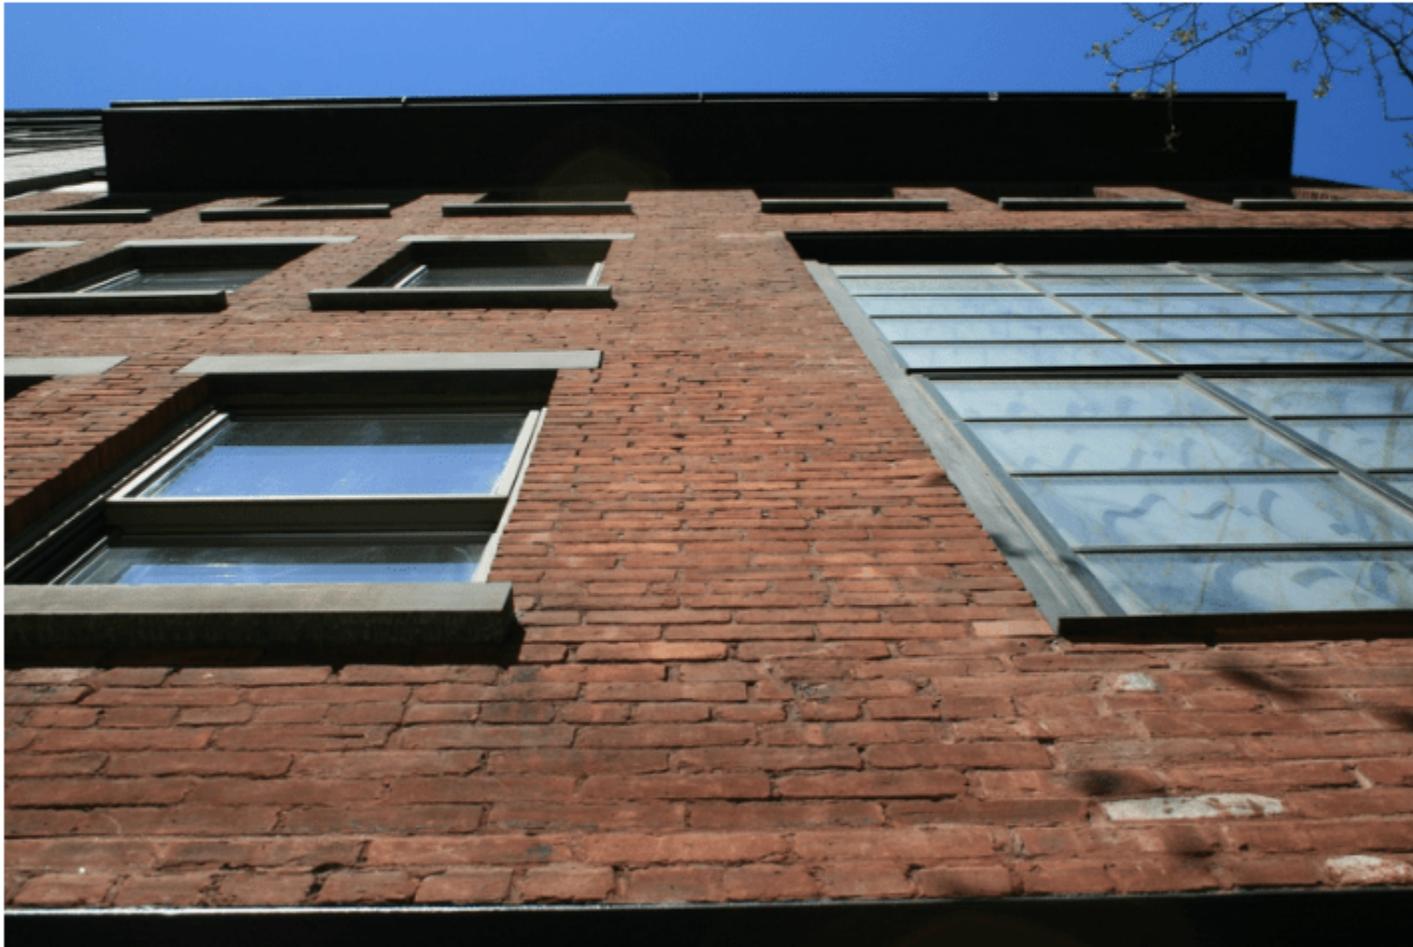
Exterior Brick – front façade of building needs brick pointing maintenance

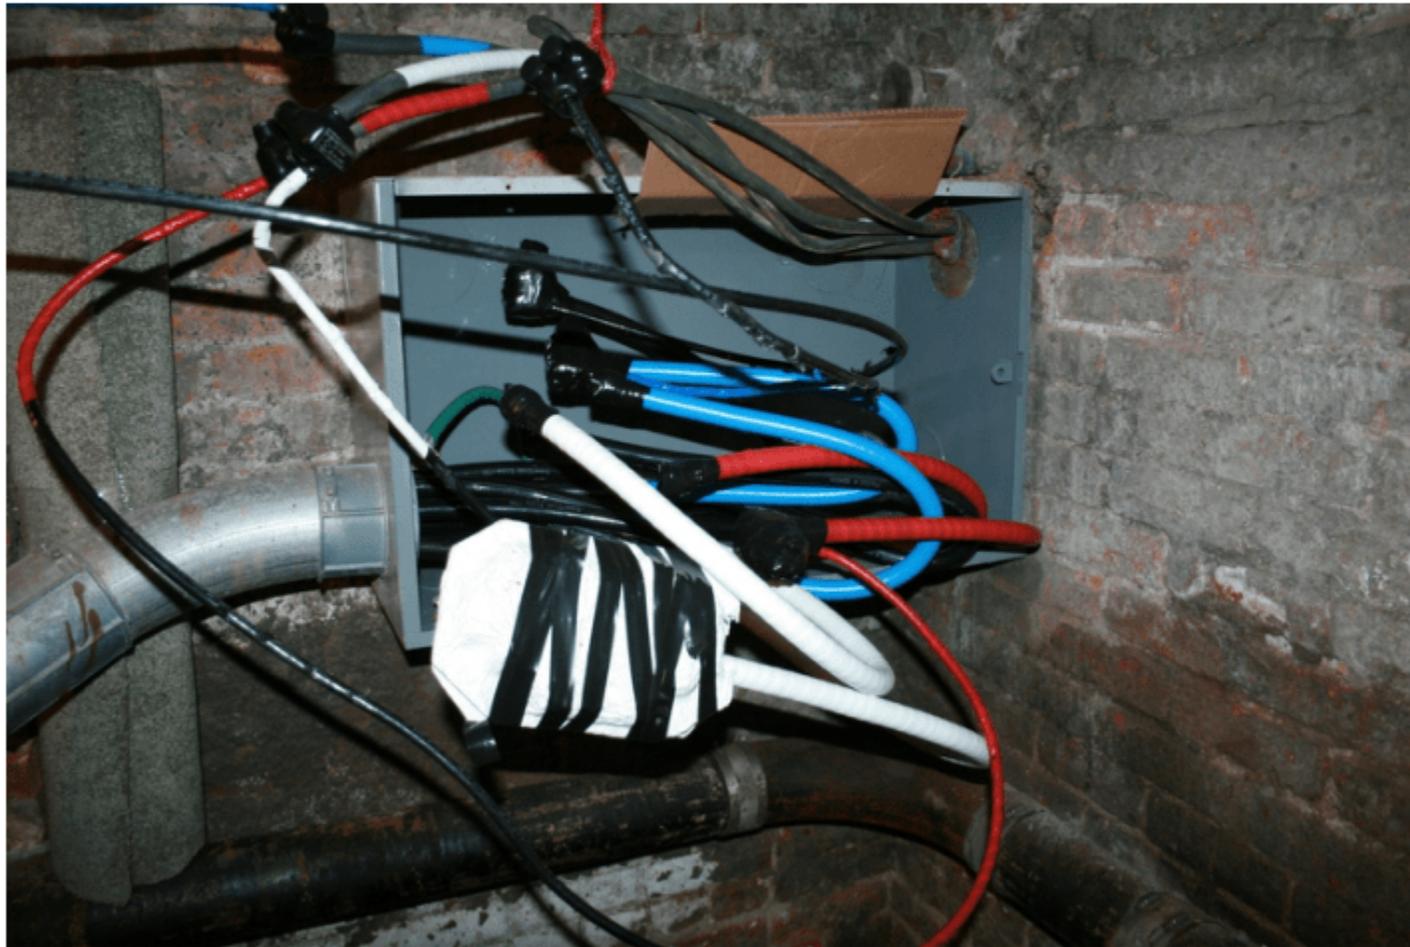
New three phase service junction box installed, left open by electrician, replaced after Hurricane Sandy

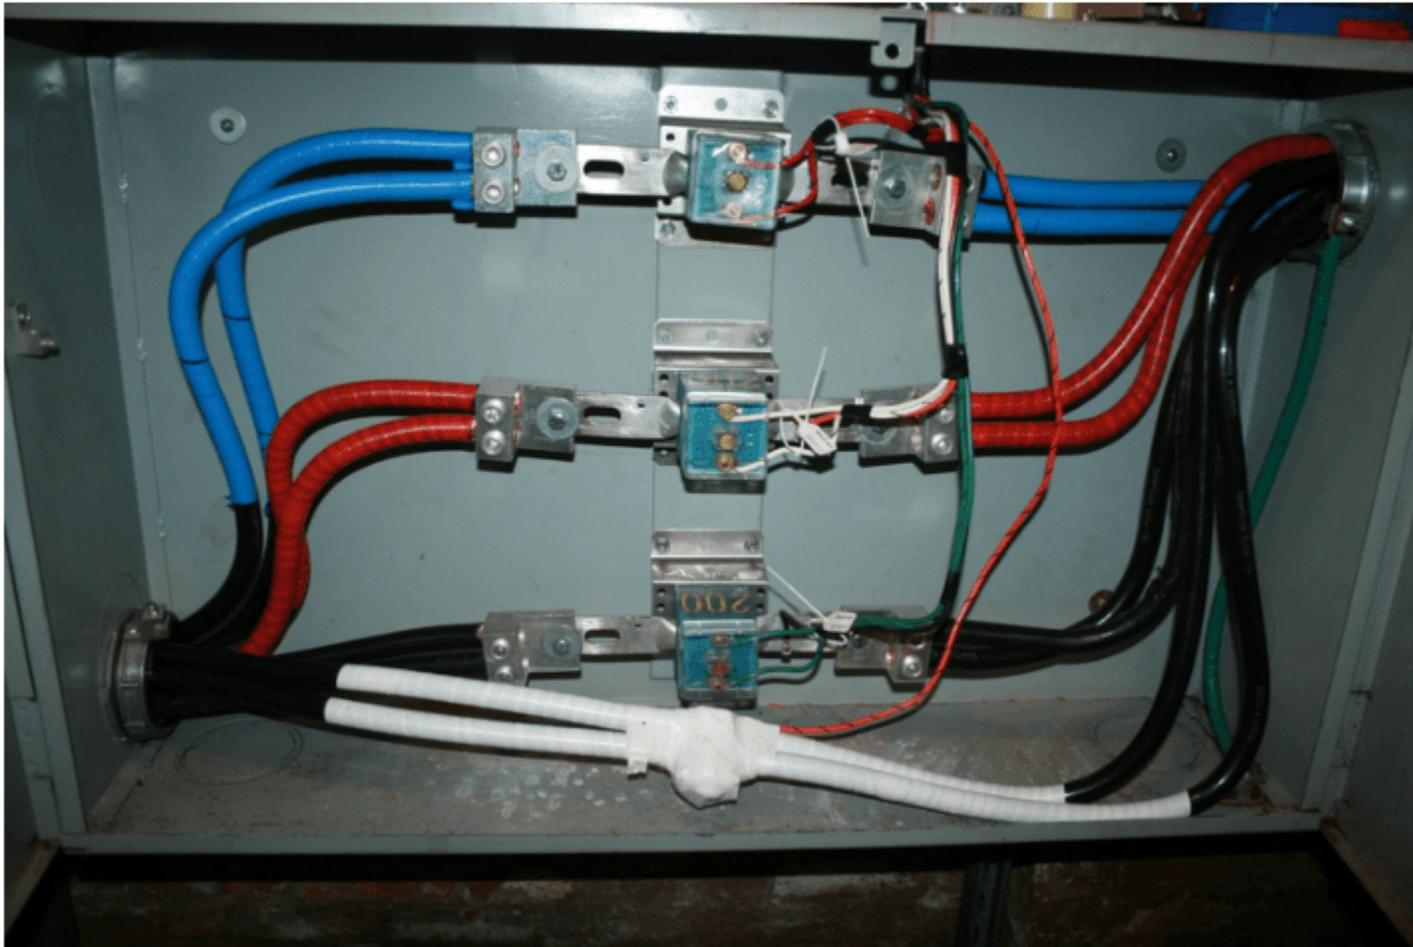
New electrical equipment breaker panel installed and left open by electrician. Check to see if the owner had new panels inspected by NYC

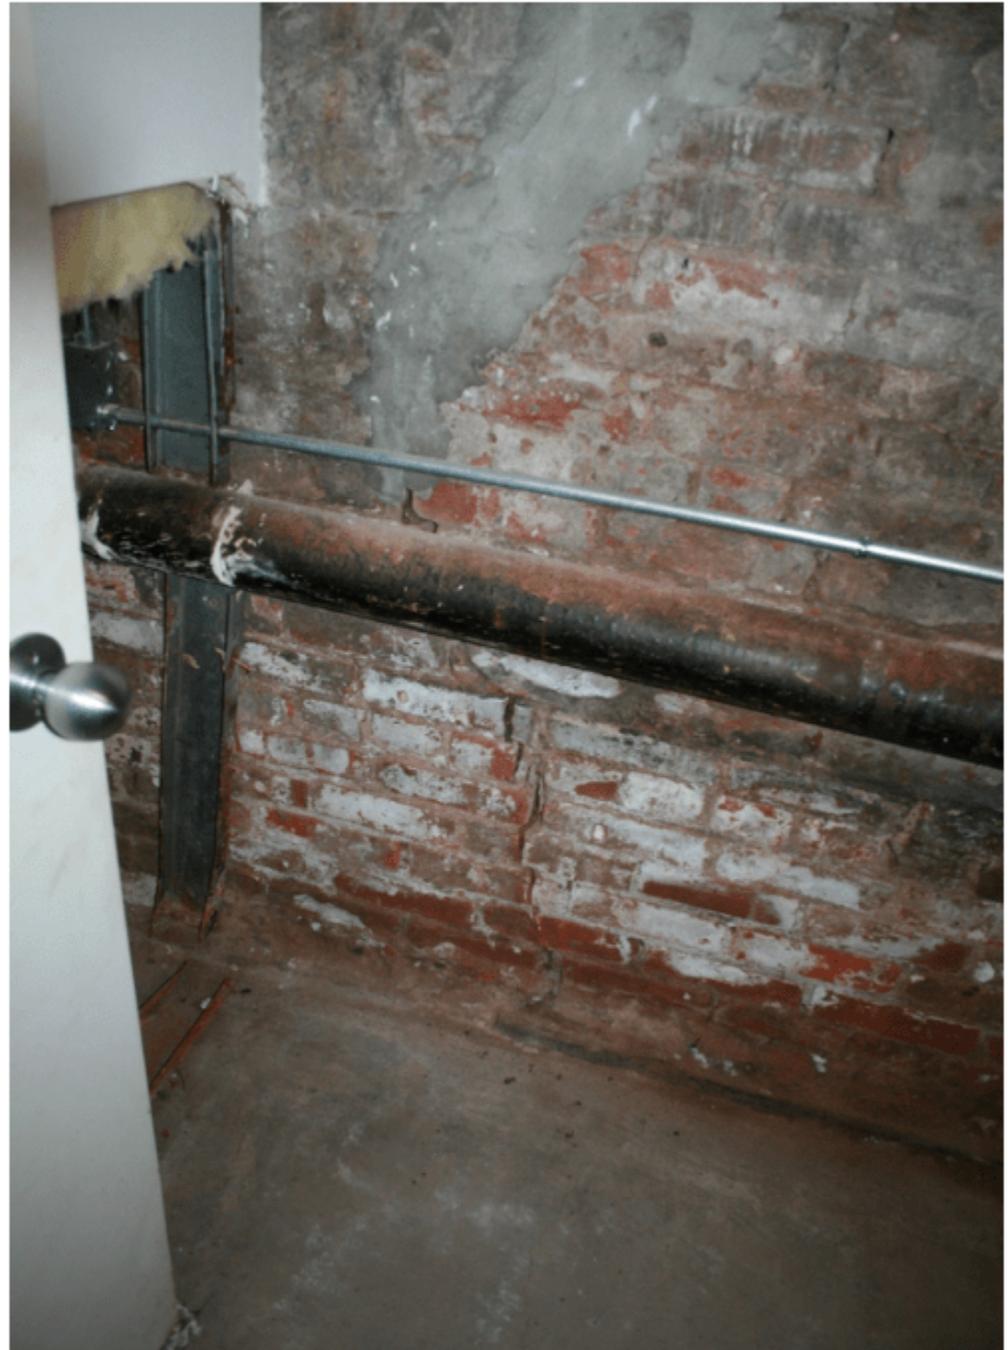
Large Masonry crack in basement wall was previously repaired with hydraulic cement, should be checked by structural engineer

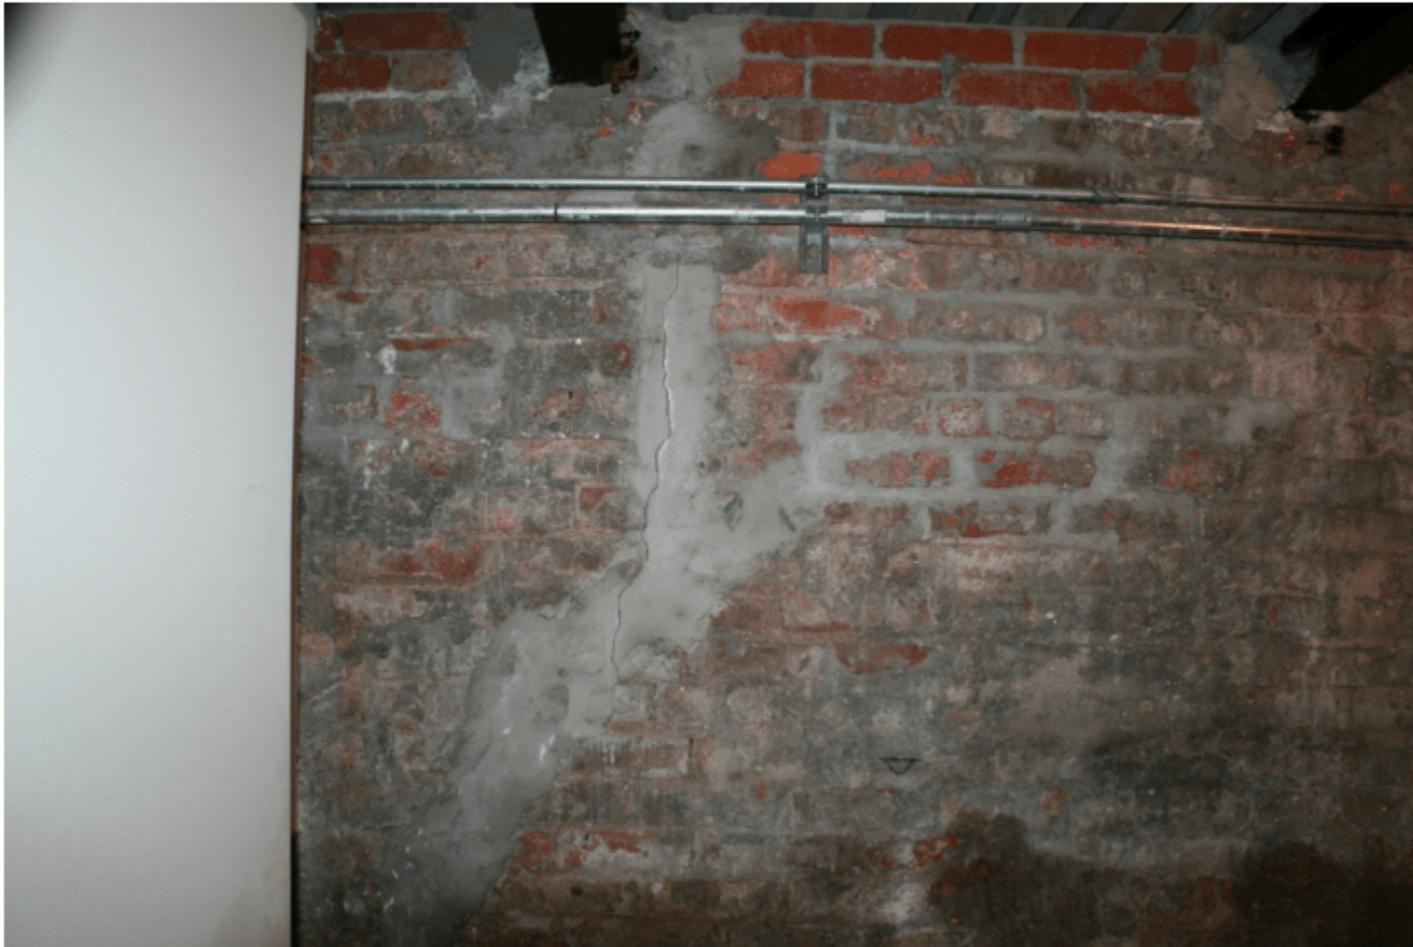
Main Stair well wall brick patching, possible water seepage

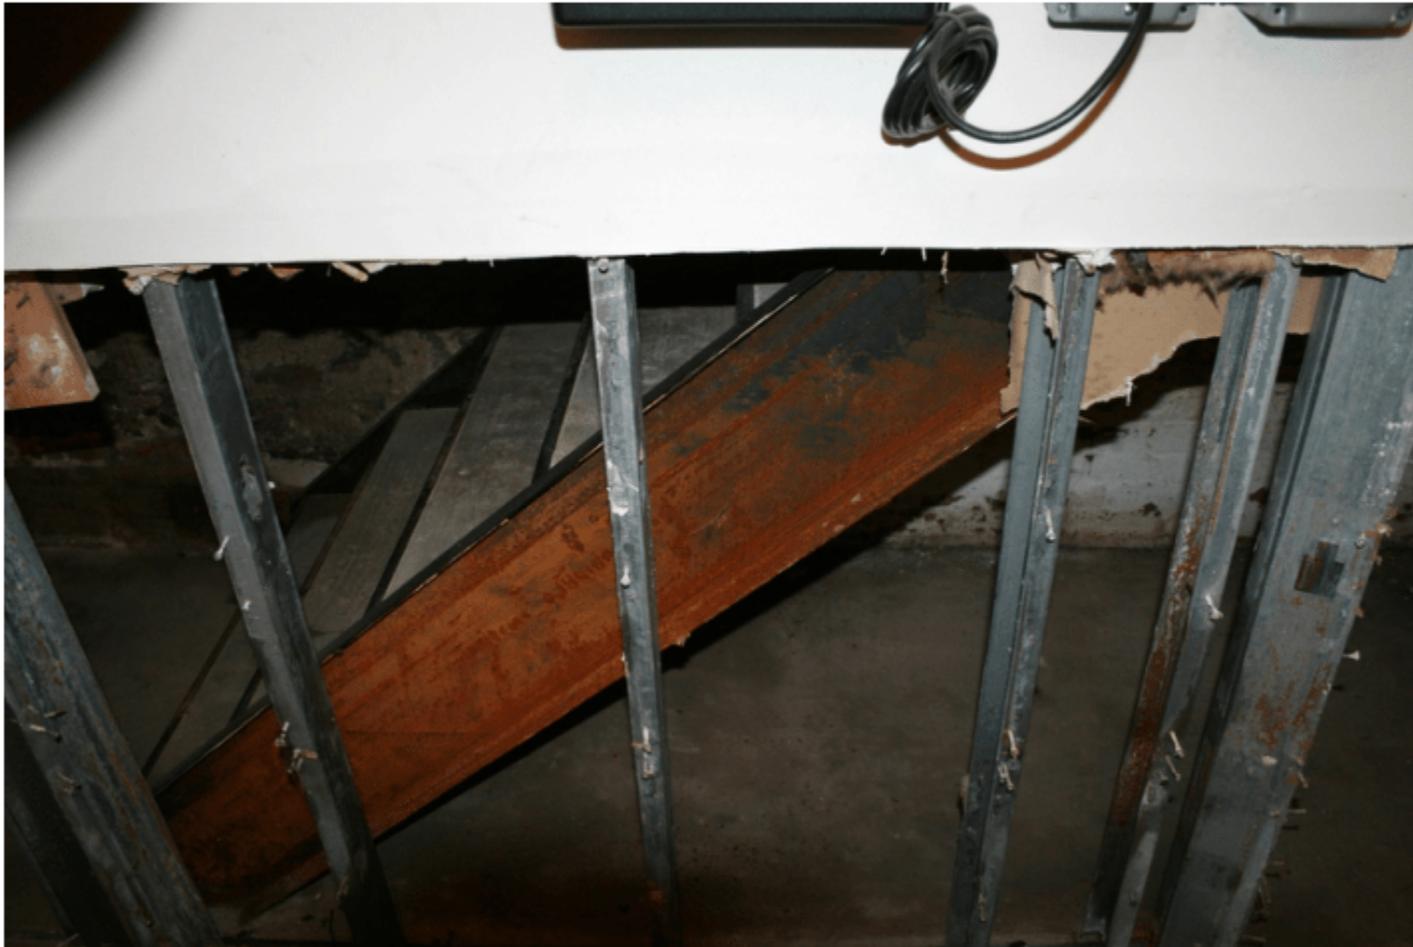
Basement at building next to 484 Greenwich pumped out on 11/08/12

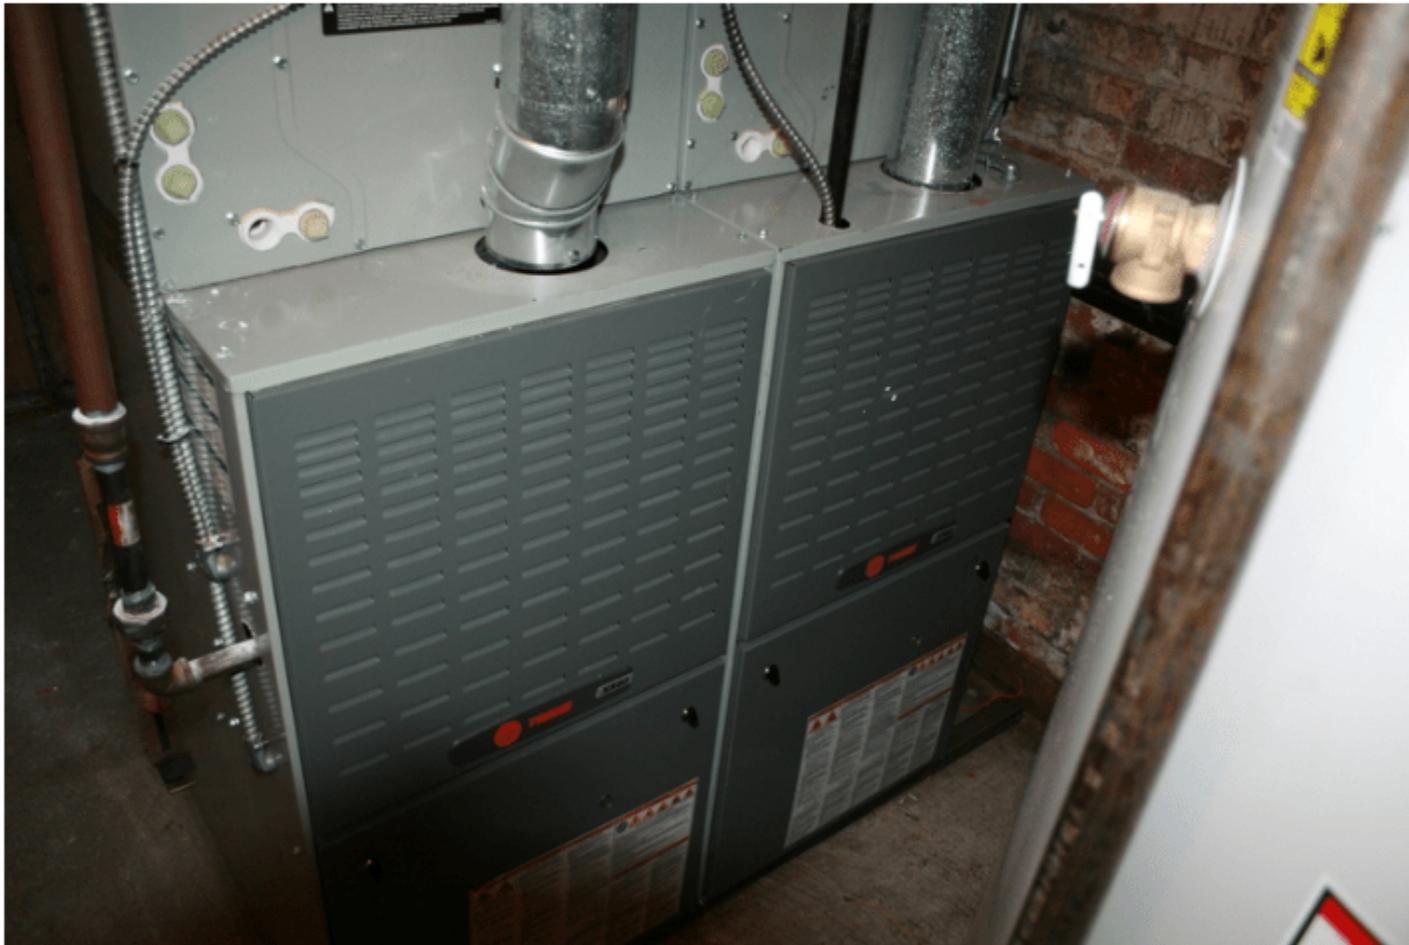
Trane Heating /AC unit in basement
cooling coil for ac not connected to
condenser unit on roof no ac on
floors,1,2&3

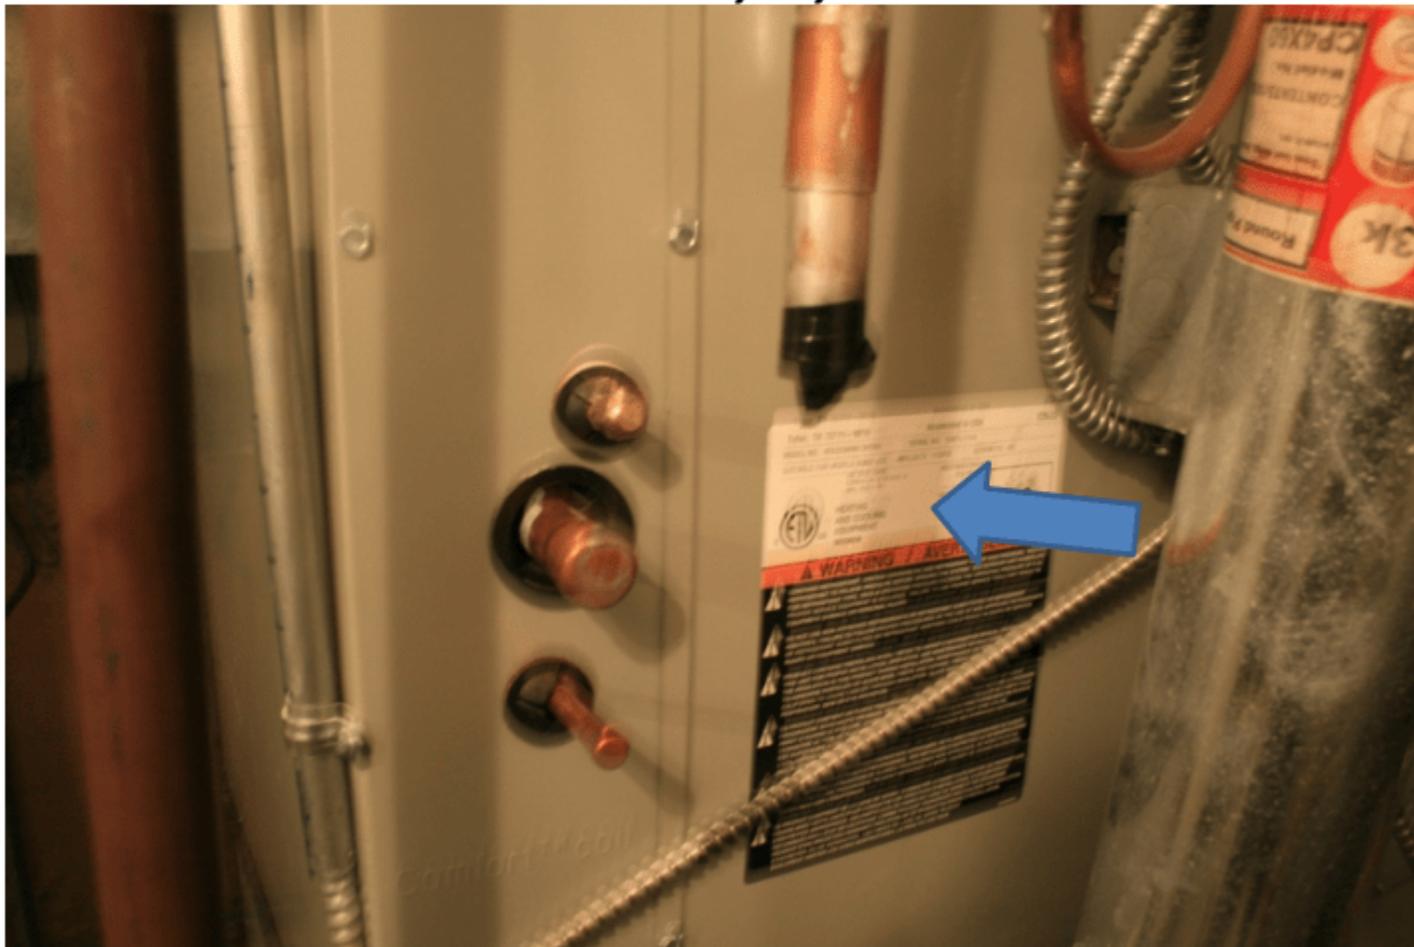
Trane RX80 units picture shows no ac/coils hooked up
for Air Conditoning

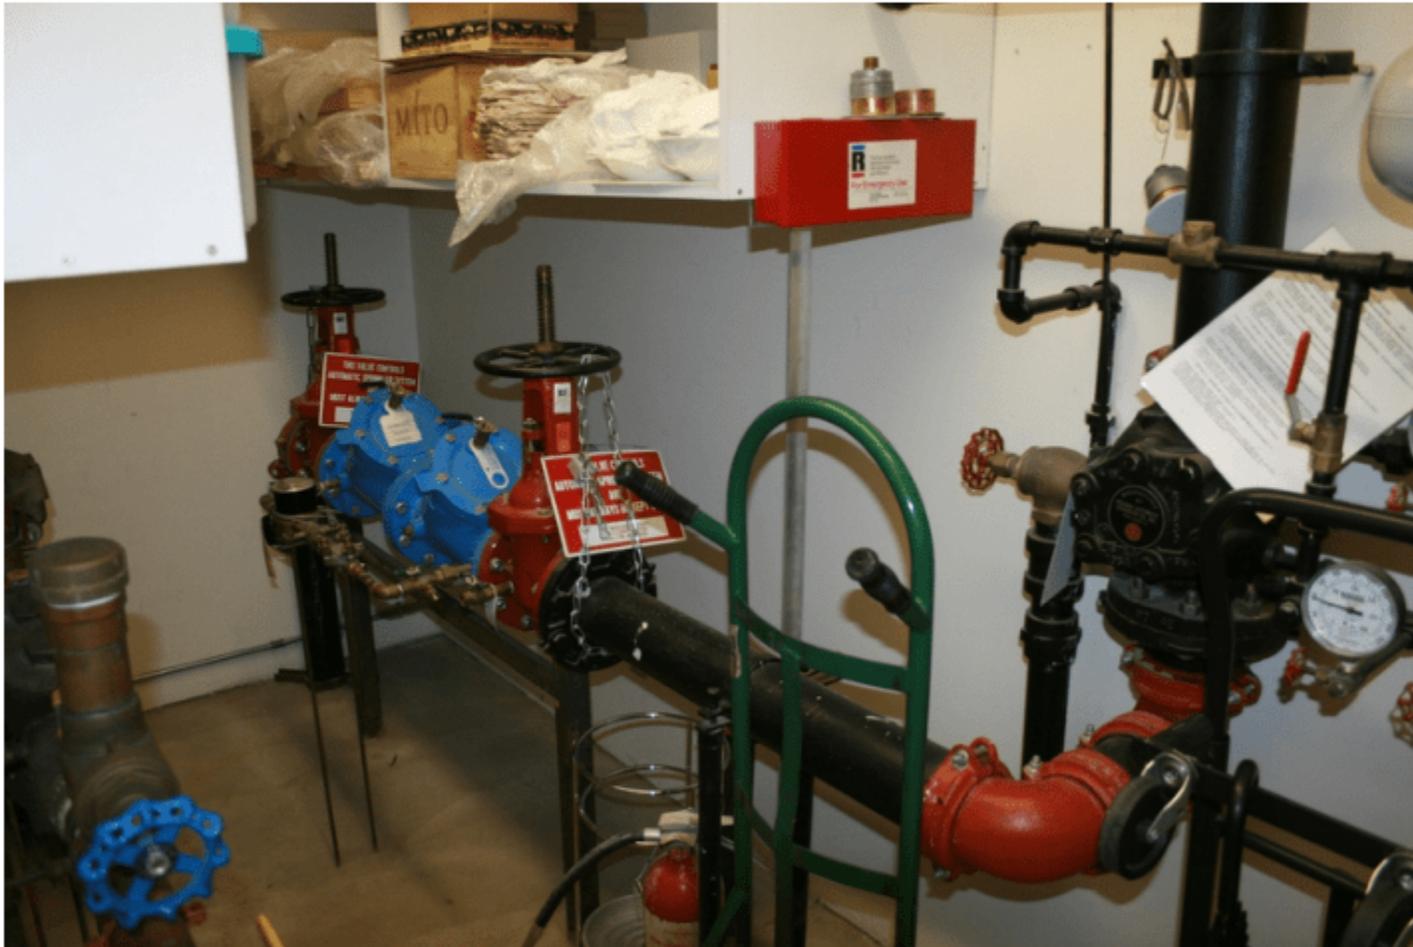
Fire dry pipe in good operating order

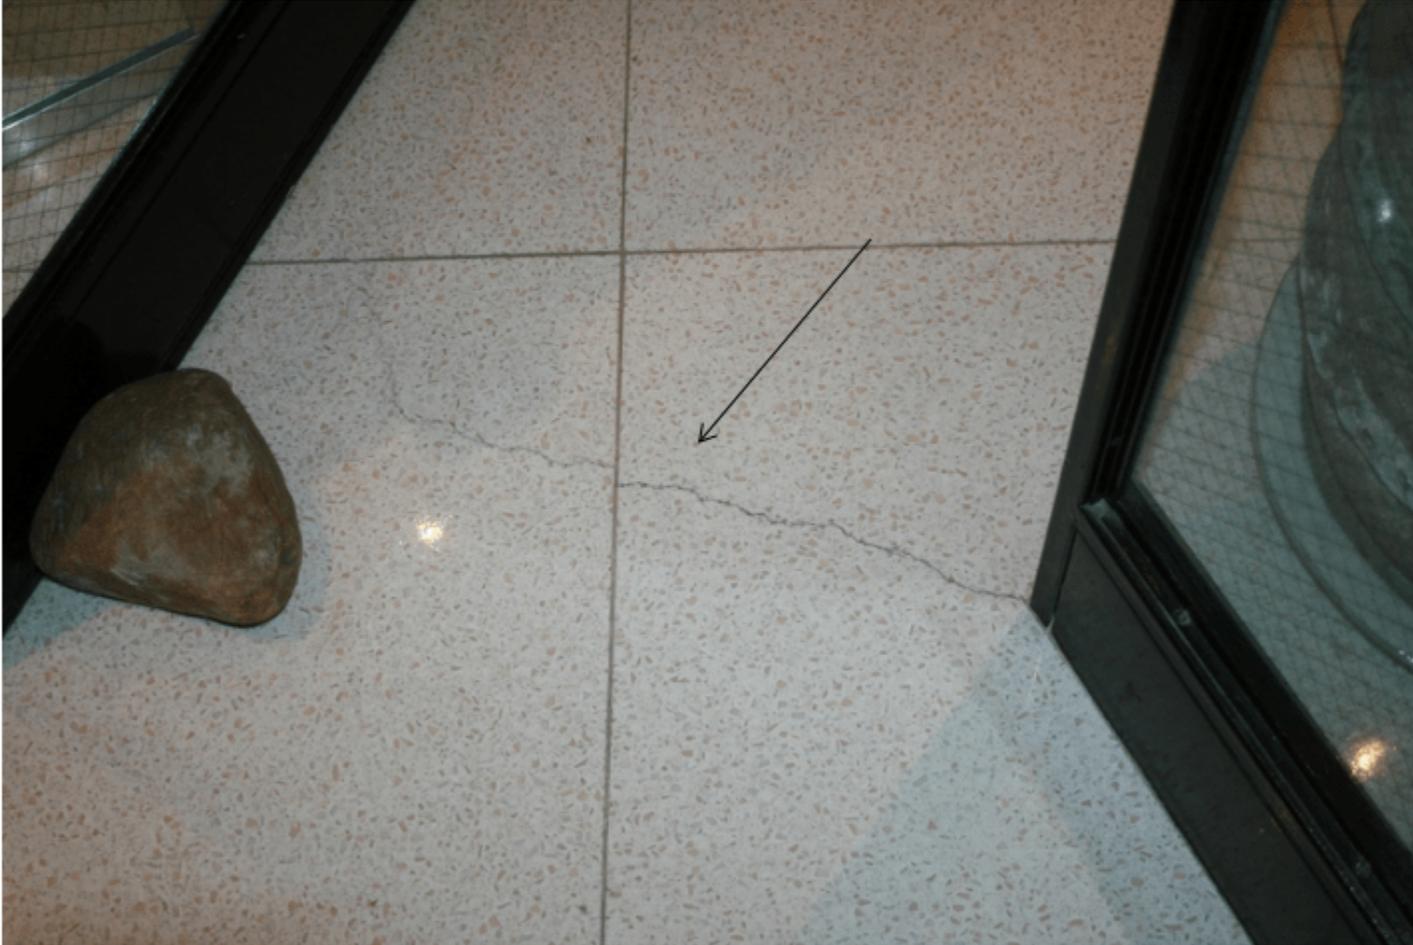
Entrance lobby floor crack damage

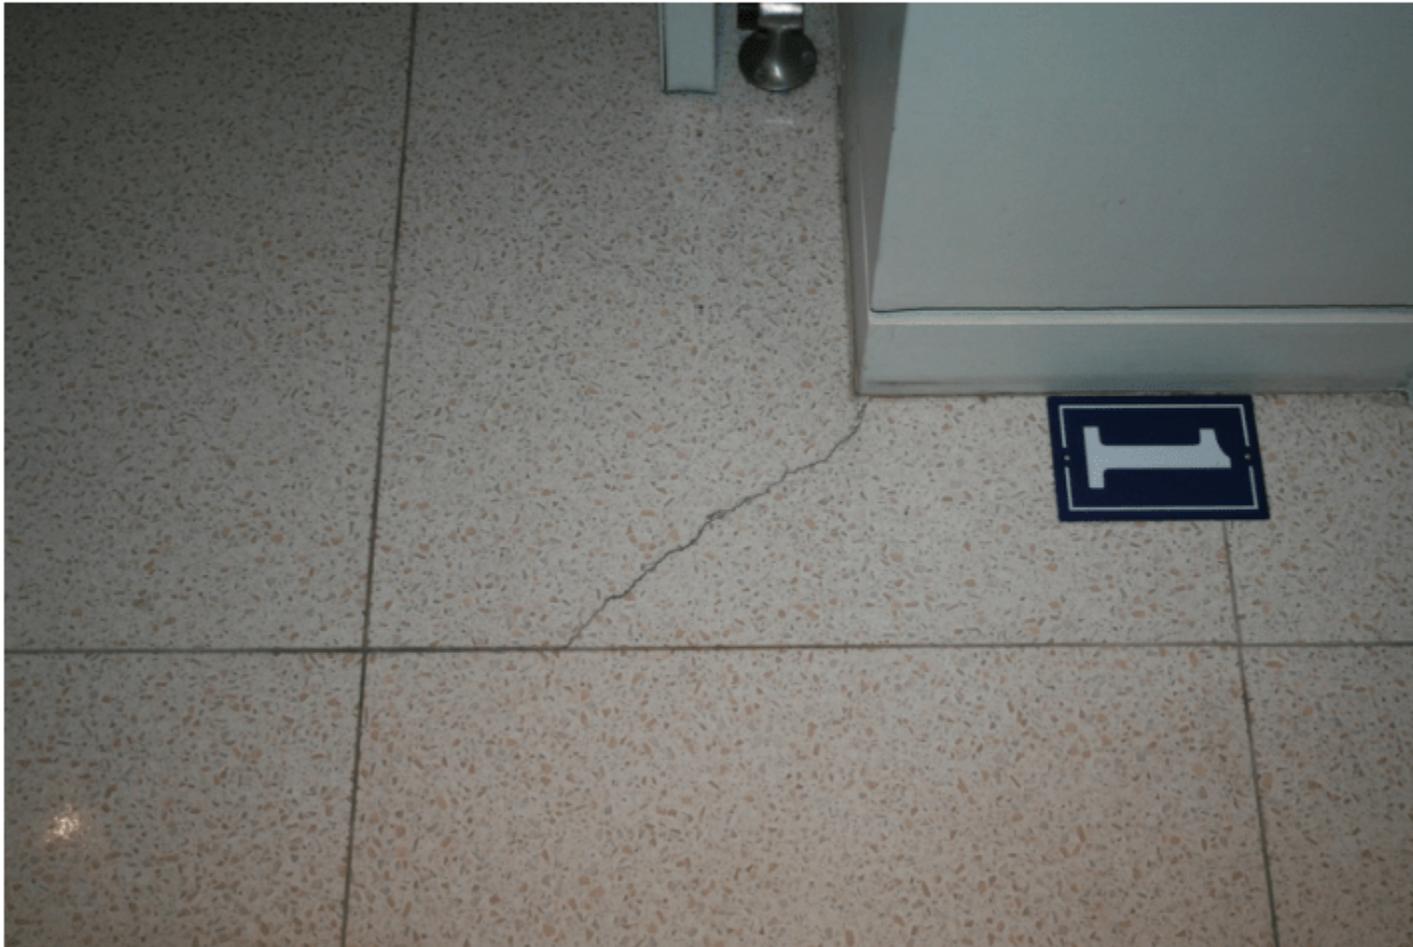
Lobby floor Cracked in many areas

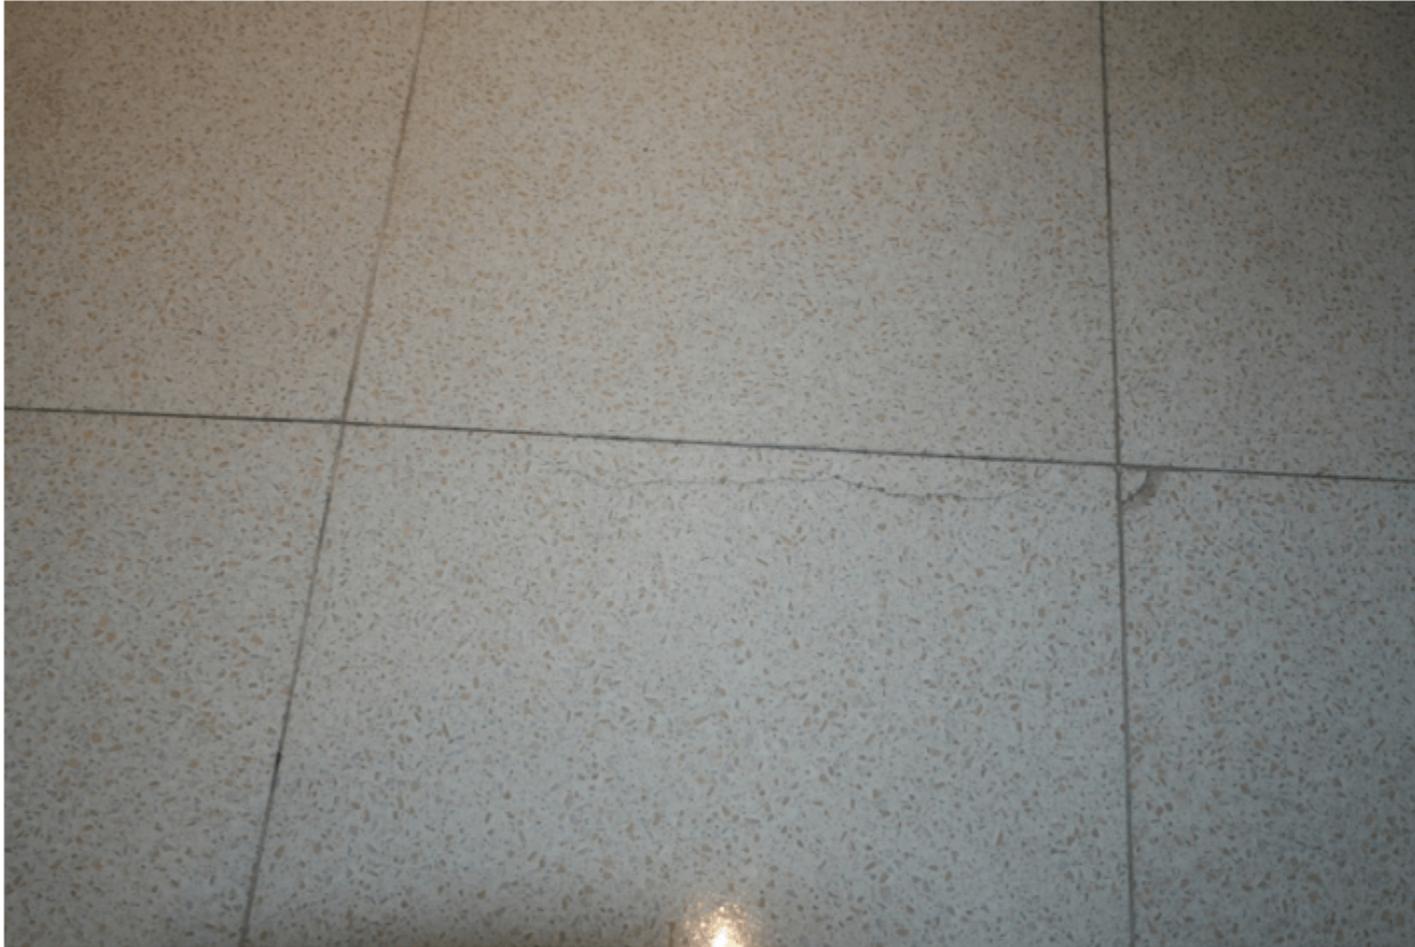
Lobby Floor cracks

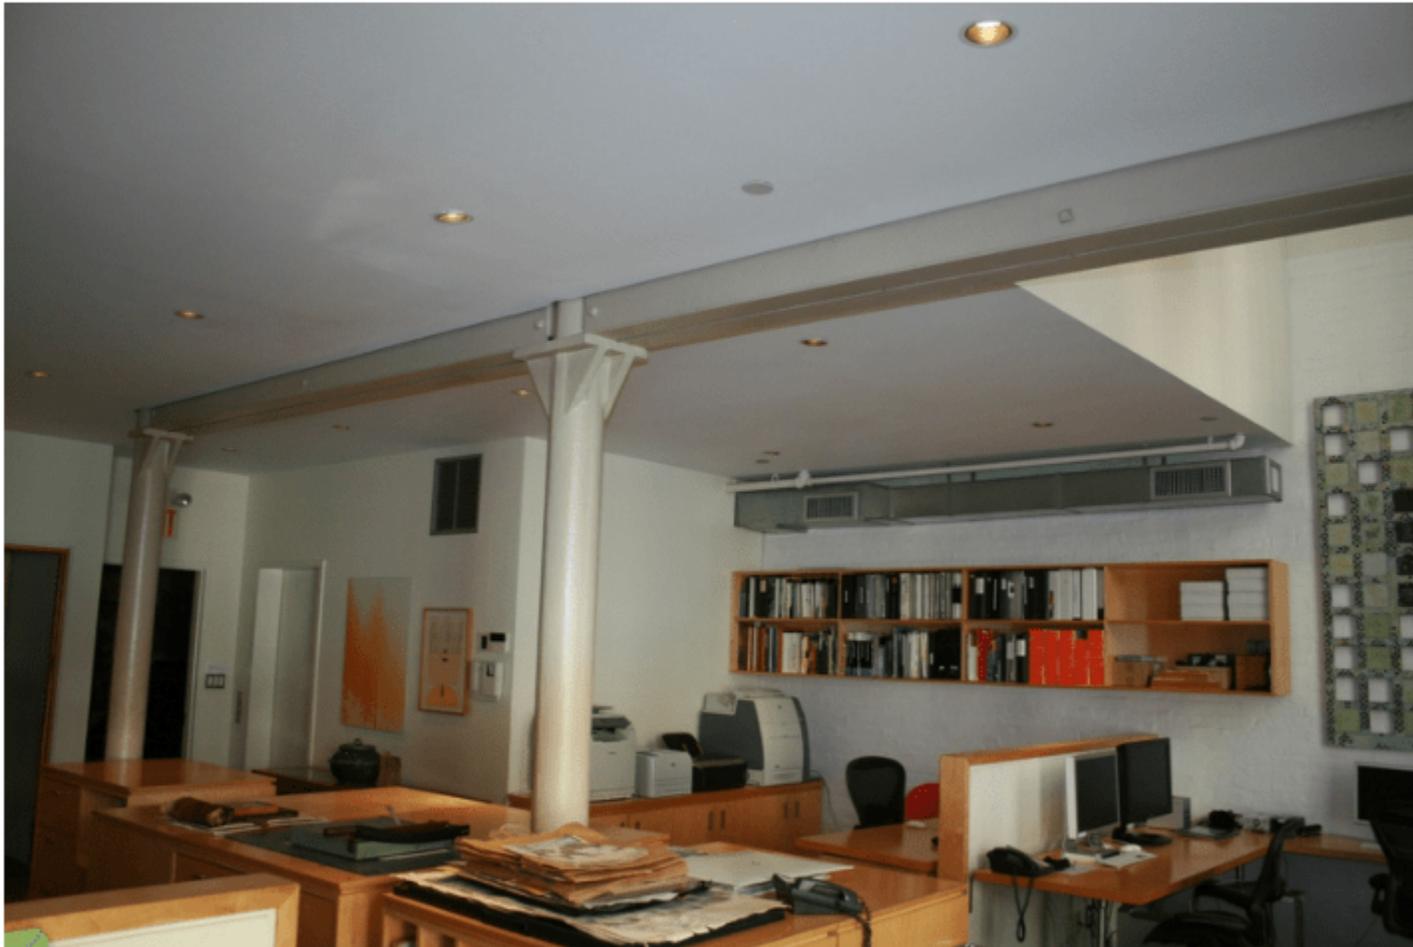
Office floor Wood floor worn from office chairs.
