Paul Ferreras, PE
Structural Engineer

March 19, 2013

Subject: American Yacht Harbor
Emergency Repairs to Columns
Red Hook, St. Thomas, USVI

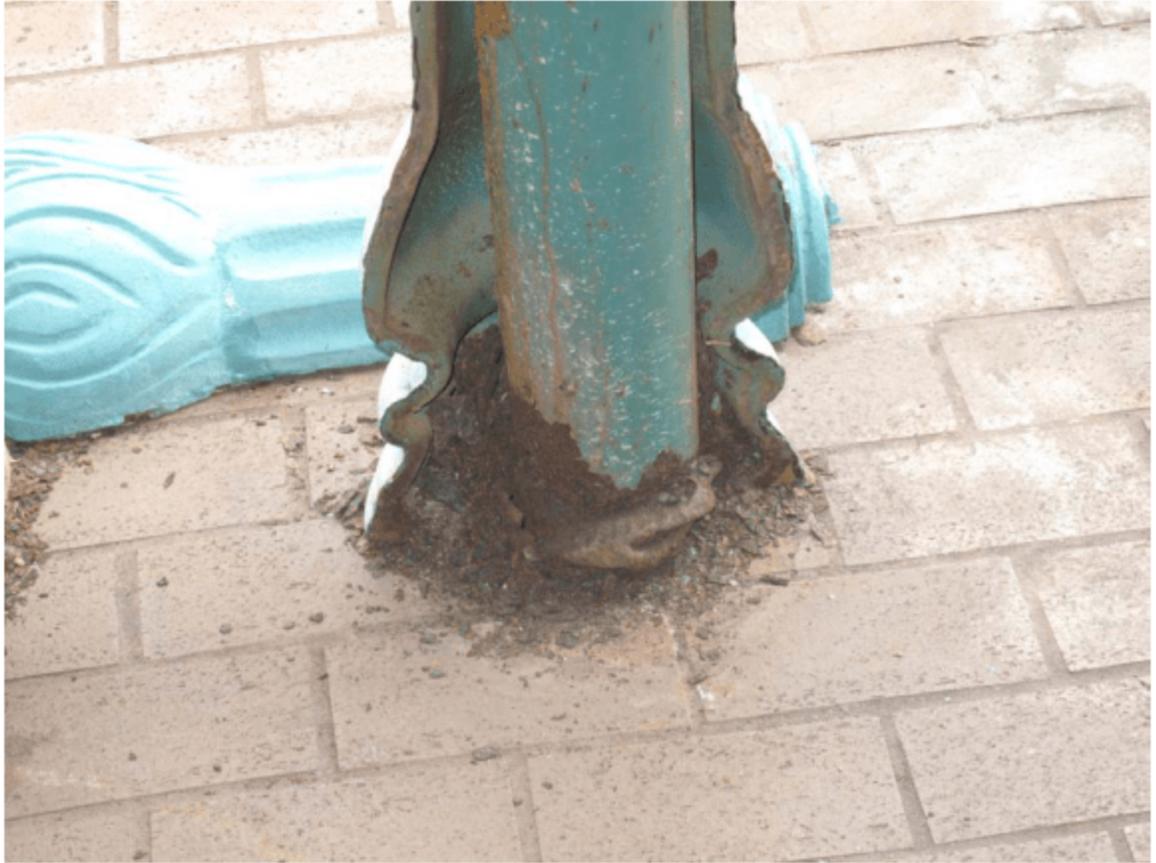
I was informed that on Sunday (the previous day) that occupants had been on the upper level and felt a drop in the structure. The upper level was at that point cleared of the occupants and it has not been occupied since that time.

I observed at the main level (above the parking garage) that on the rear of the building that 4 inch diameter steel columns support the upper level. Two of these columns have a problem at the base. It appears that water has caused a corrosion issue at the base of the column and reduced the column section to a point that the base has failed and collapsed about 2 inches in height (see attached photo).

Photo of Column Base - note corrosion at base and crushed base section.

- 1) Support the column on each side.
- 2) Jack the structure back to level (about 2 inches)
- 3) Cut out the damaged column section from a few inches below the top girder to the base plate on the lower support.
- 4) Bevel cut the existing column section to remain and weld a new top plate to the existing section.
- 5) Inspect the lower base plate and either replace or reuse the base plate.
- 6) Install the new 4 inch diameter, X-Strong steel pipe column by bevel welding the pipe to the top plate and base plate.
