Little St. James

***SWRO Plant Assessment and Operation and
Maintenance Proposal***

June 29, 2017

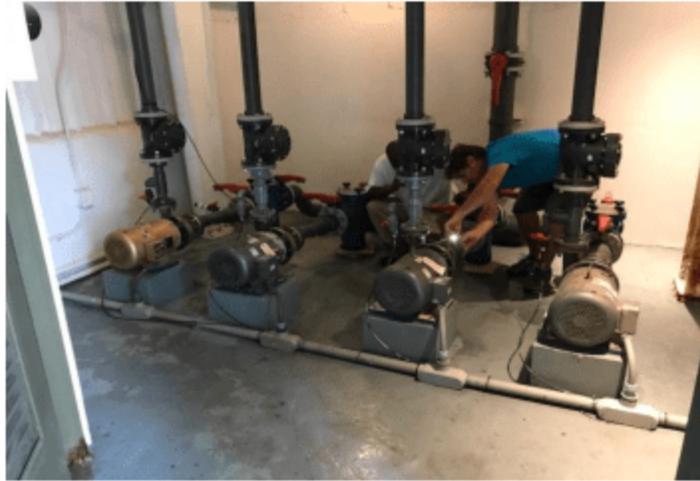
Figure 1: Intake Pumps

During our visit, it was noted that only two of the four intake pumps were operational, intake pumps A and D. Intake pump B had a cracked basket strainer lid, and intake C pump had a cracked flange on the suction side of the pump. Both of these pumps were started in hand and worked. The priming system was also started in hand and worked. The staff reported that the priming pump is not used in normal operation because it takes too long to prime the system and they opt to flood the system with a garden hose. The intake control panel appears to be in good condition.

- Replace Pump B basket strainer lid.
- Repair Pump C suction header and cracked flange.
- Provide shelf spare of priming pump and mechanical seals for intake pumps.

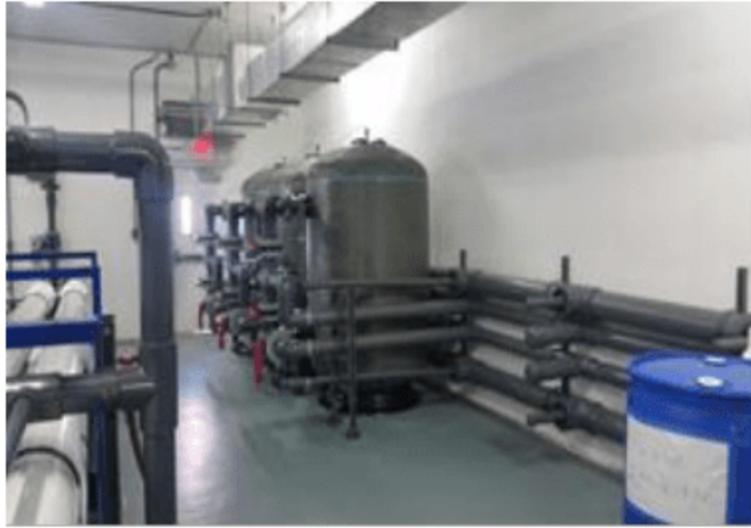
Figure 2: Media Filters

The plant's pre-filtration system consists of three 48-inch diameter mixed media filter vessels that provide removal of fine particulates from the raw seawater. These filters must be monitored and backwashed manually on a regular basis – at least weekly, if the plant sees regular use. At the time of our visit, this system appeared to be well maintained and clean.

- The media filters should be backwashed on a regular basis, once a week. This will eliminate any channeling that may occur in the filter bed.
- The cartridge filters should be changed approximately every two to four weeks or when delta pressure across them exceeds 5-8 psi.

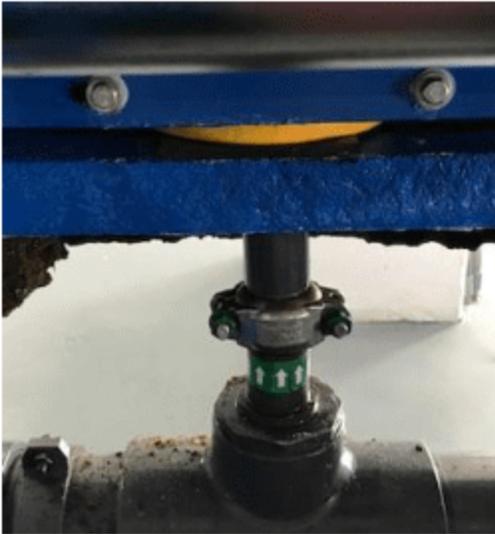
Figure 3: Pressure Exchanger

The energy recovery system allows the pressure energy from the reject brine to be transferred directly to a portion of the incoming raw seawater. This allows the unit to utilize a smaller high pressure pump and therefore use less energy. This system's high and low pressure flows need to be carefully balanced for correct operation of the pressure exchangers. The pressure exchangers depend on a continuous supply of water for lubrication. The grove fitting on the low pressure discharge of Pressure Exchanger A appeared to be leaking. The Boost Pump mechanical seal showed signs of salt build up indicating need of replacement. Failure of this system will result in the plant not operating.

- Repair leaking PX.
- Replace the mechanical seal on the boost pump.

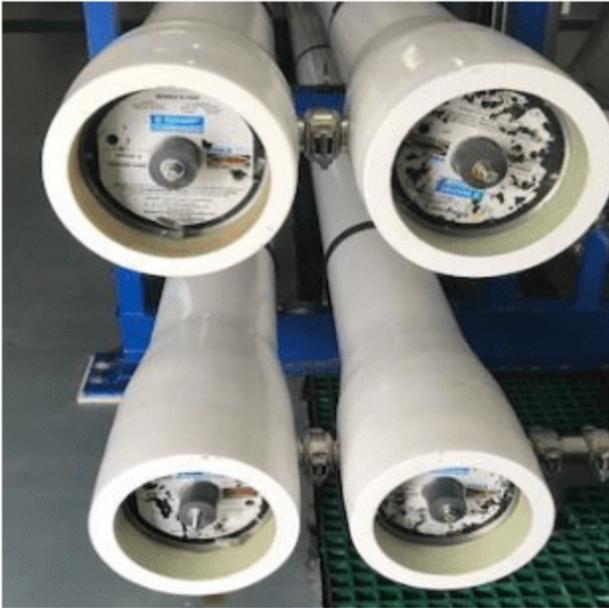
Figure 5: Vessel Auto-Shims

The installed auto shims are no longer supported by the vessel manufacturer ProTec. The manufacturer highly recommends that these be replaced with “dummy” product ports. The auto shims could increase the salt passage due to corrosion and faulty seals resulting in diminished water quality.

- Conduct regular membrane profiling and probing to detect future problems.
- Replace auto shims with dummy product ports.
- Replace corroded Victaulic style couplers and hardware.
- Clean membranes as needed using in place cleaning system.
- Calibrate analytical instruments.

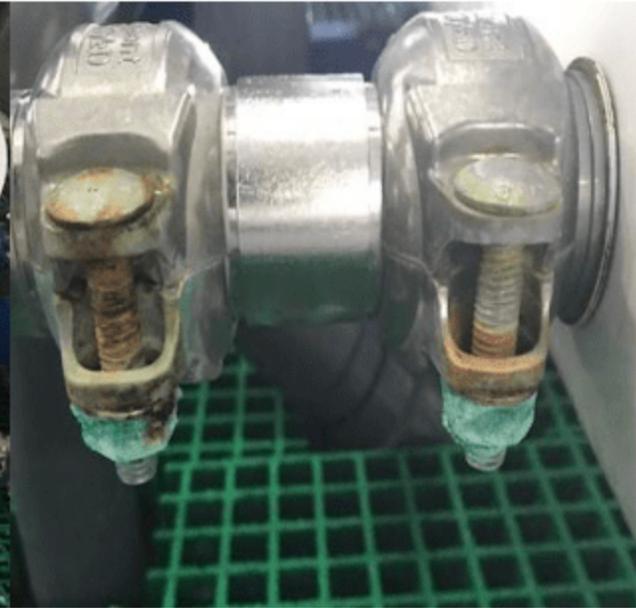
Figure 6: High Pressure Couplings

The high pressure Victaulic couplers and hardware show signs of extensive corrosion. A failure can result in complete failure which can present a severe safety issue.

The high pressure couplers and high pressure tubing connectors are a major safety concern and should be addressed immediately.

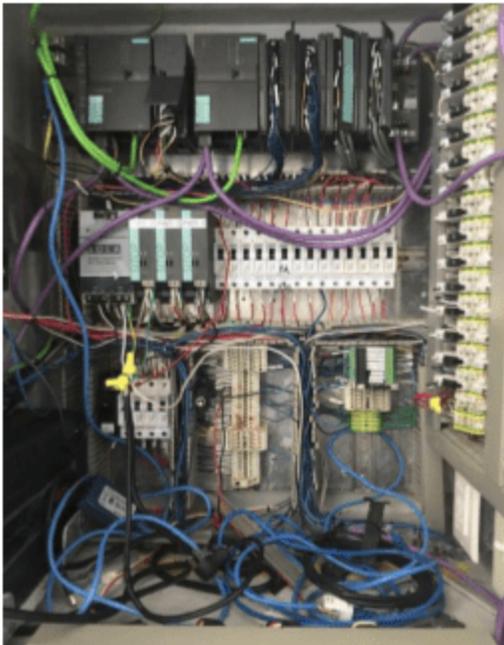
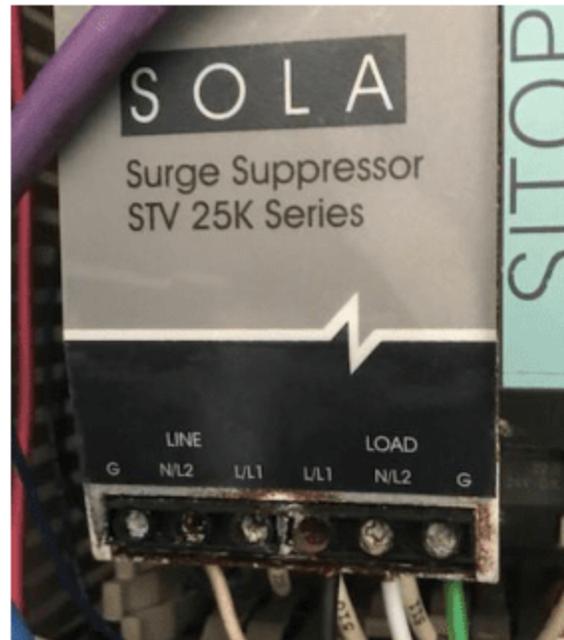
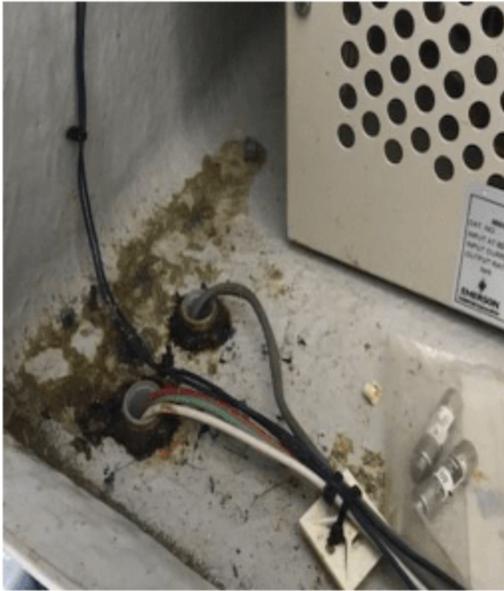
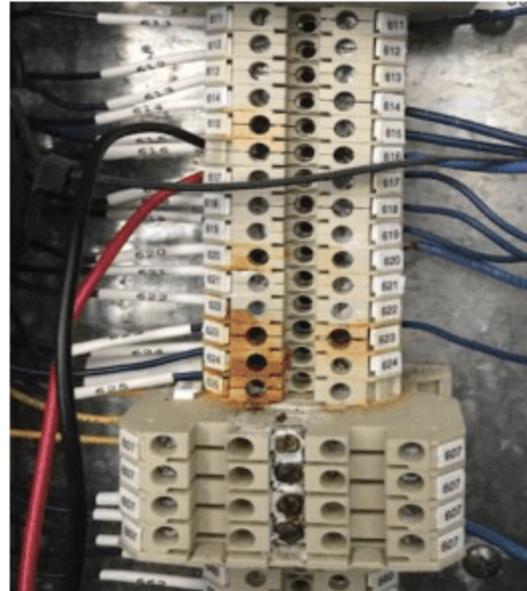
There is evidence of salt water intrusion in both the main power panel and the main control panel as shown in Figures 7 through 10. Although it appears the system is operating correctly long term issues most certainly will arise. Corrosion and salt residue will wick into the individual conductors which will result in electrical issues and plant failure.

- Clean as much salt residue and corrosion as possible with contact cleaner
- Replace Sola Surge Suppressor immediately and closely monitor other components for possible failure.
- Maintain critical spares of individual components.
- Install a Tosibox system which will allow for remote monitoring of the plant and provide a gateway if any programming changes need to be made by offsite programmers.

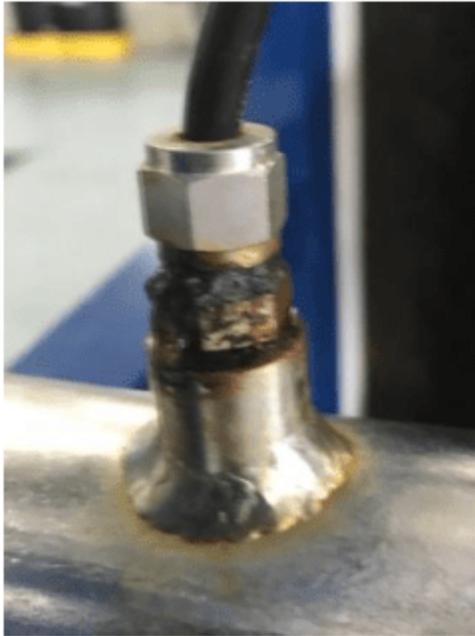
Figure 11: HP Tubing Connector

It is imperative that accurate flow and pressure information is monitored, analyzed, and recorded daily. This is the primary indication of the overall operation of the plant. All of the analytical pressure transmitters and gauges were displaying faulty readings and the tubing connectors all showed signs of degradation, corrosion, and leaks. This is causing the displayed values on both the dial gauges and touchscreen to be inaccurate.

- Replace all high and low pressure connectors and tubing.
- Adjust flowmeter settings to bring both the local and remote displays closer together
- Calibrate all analytical instrumentation with the proper calibration standards
- Verify scaling of all instruments on touchscreen
