March 15, 2010

Re: Agreement for Design Services dated May 15, 2009 ("Design  
Services Agreement") by and among Juan Pablo Molyneux, J.P.  
Molyneux Studio, Ltd., L.S.J., LLC and Jeffrey Epstein

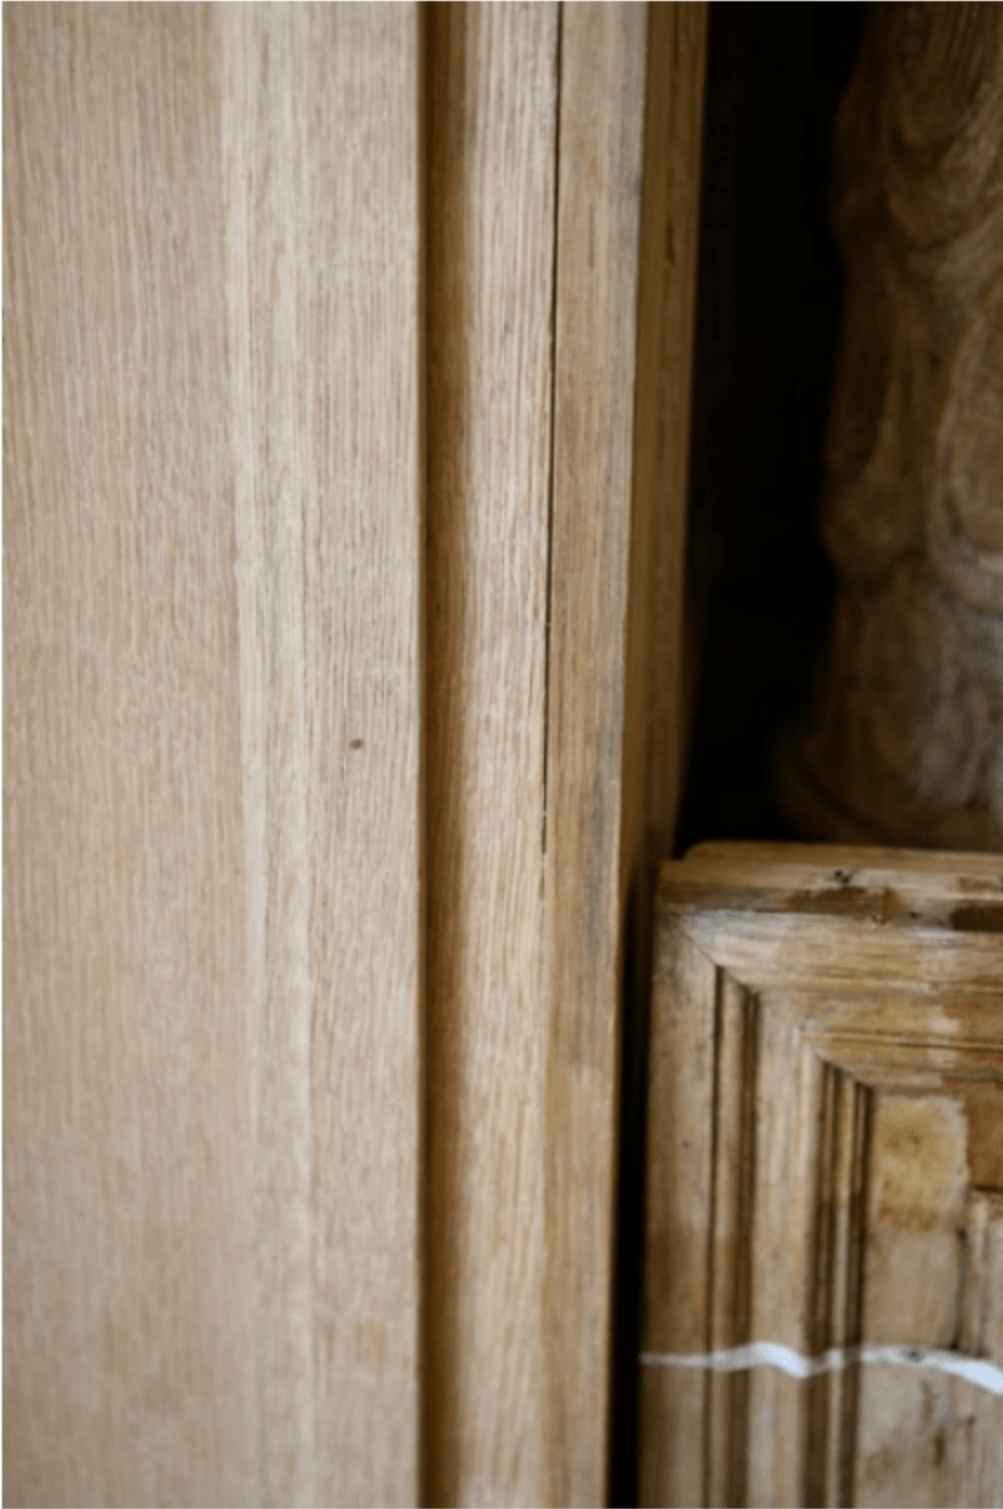
Discoloration, white stripe of foreign material evident, uneven application of stain.

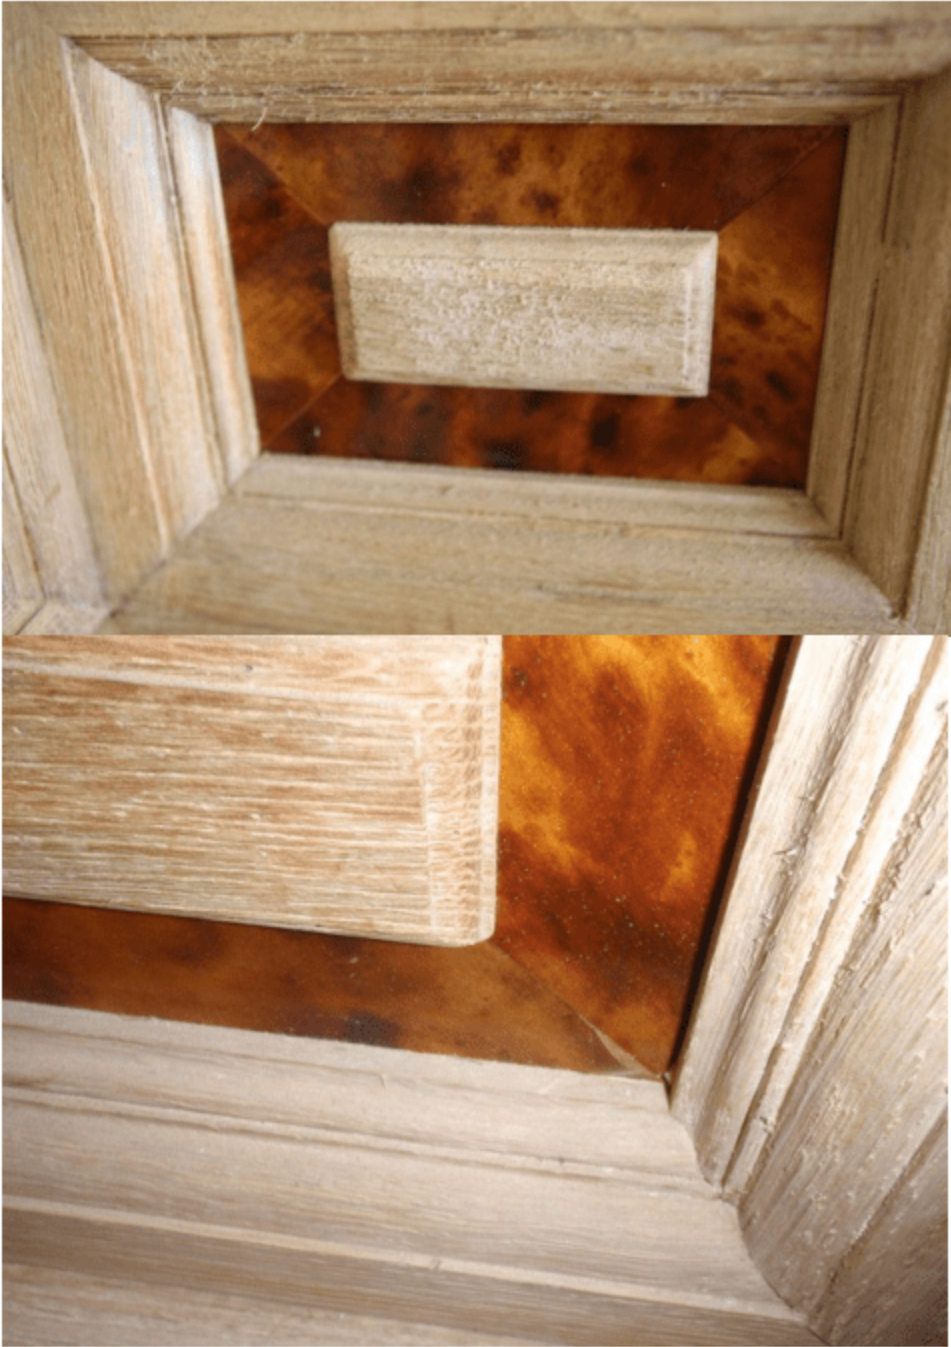
Splintery, rough and pocked wood, uneven application of stain, and apparently no finish in many places. Tortoise shell application marred at bottom right hand corner of bottom photo.

In connection with Mr. Molyneux's correcting the problems with the cabinetry and its finish, as the photos clearly demonstrate, the tortoise shell application on the cabinetry is cheaply done and patched and must be replaced. In addition, as I advised you in my March 1, 2010 letter, the blackboards provided by Mr. Molyneux are unusable. They are not built of typical blackboard material, and chalk literally slides off the surface when you try to write on them. They too need to be replaced.

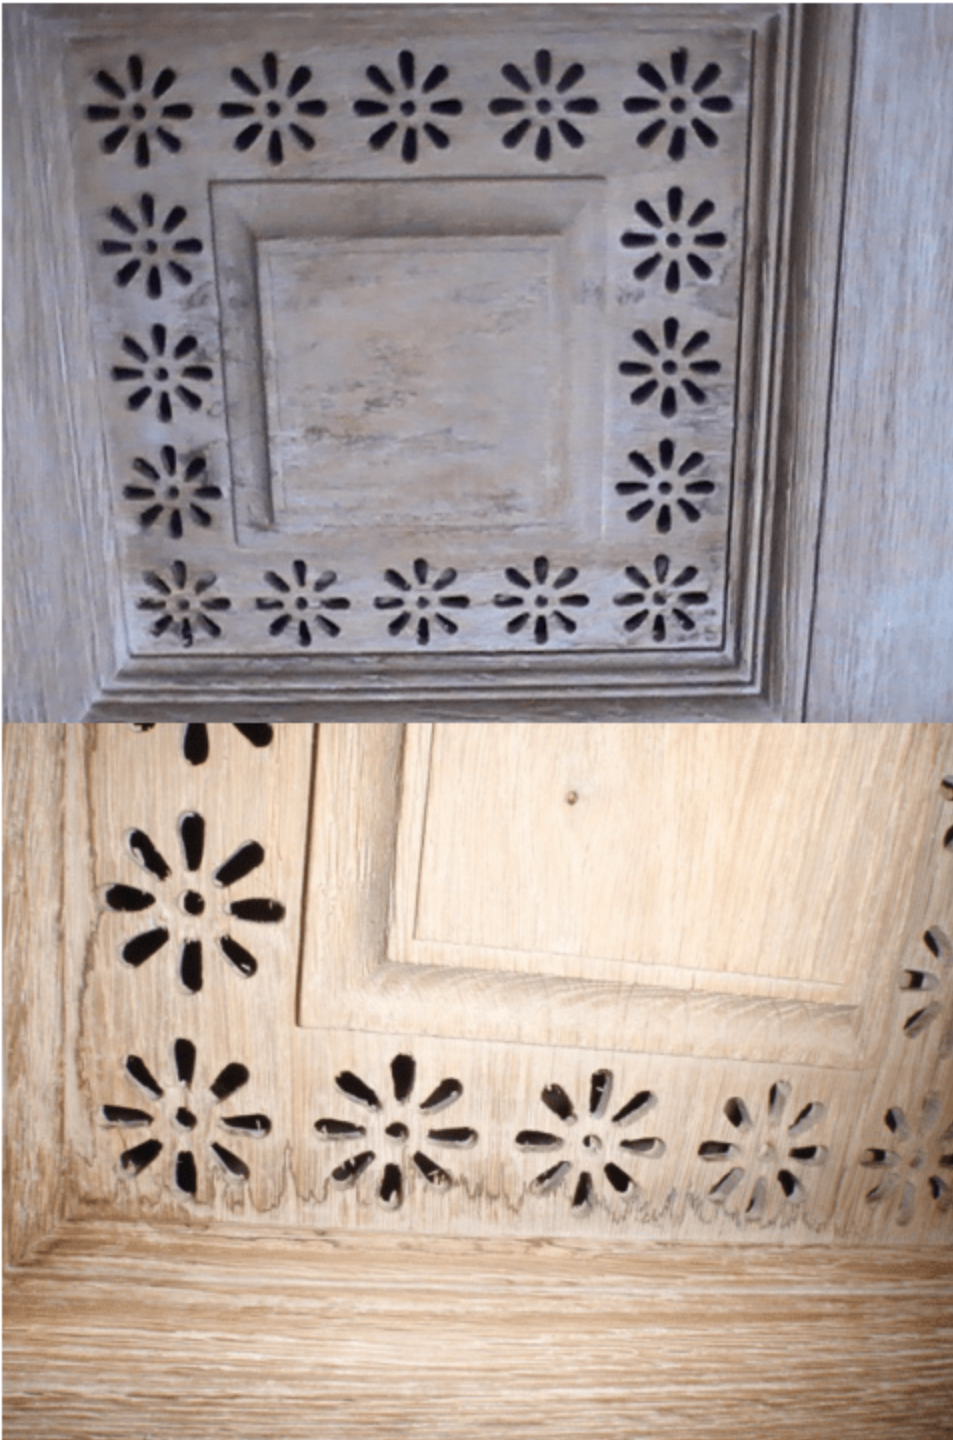
Wood materials and finish substandard in the top picture. In the top picture, shoddy materials with discoloration throughout. Bottom picture shows finish which looks like it was not applied in some places and appears water stained in other places. Decorative holes uneven, not drilled through and not sanded.

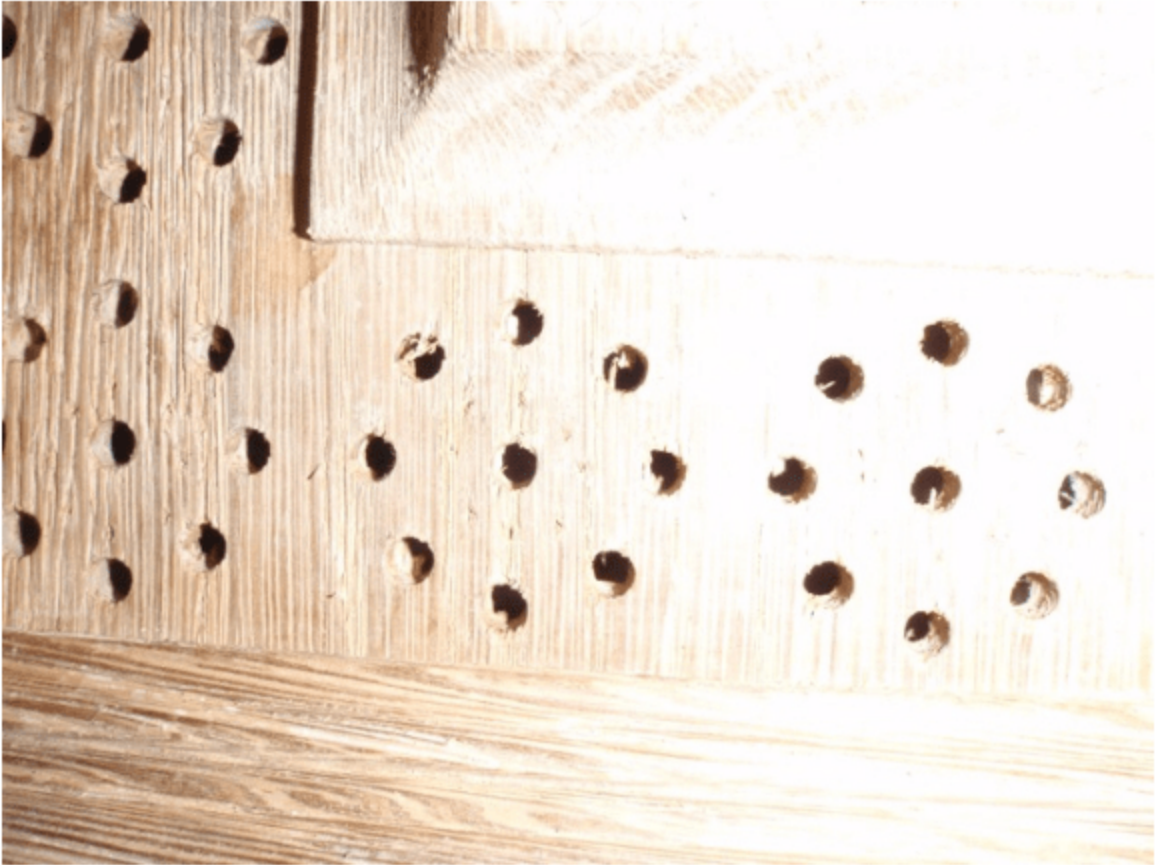
Unsanded holes. Rough unfinished appearance.

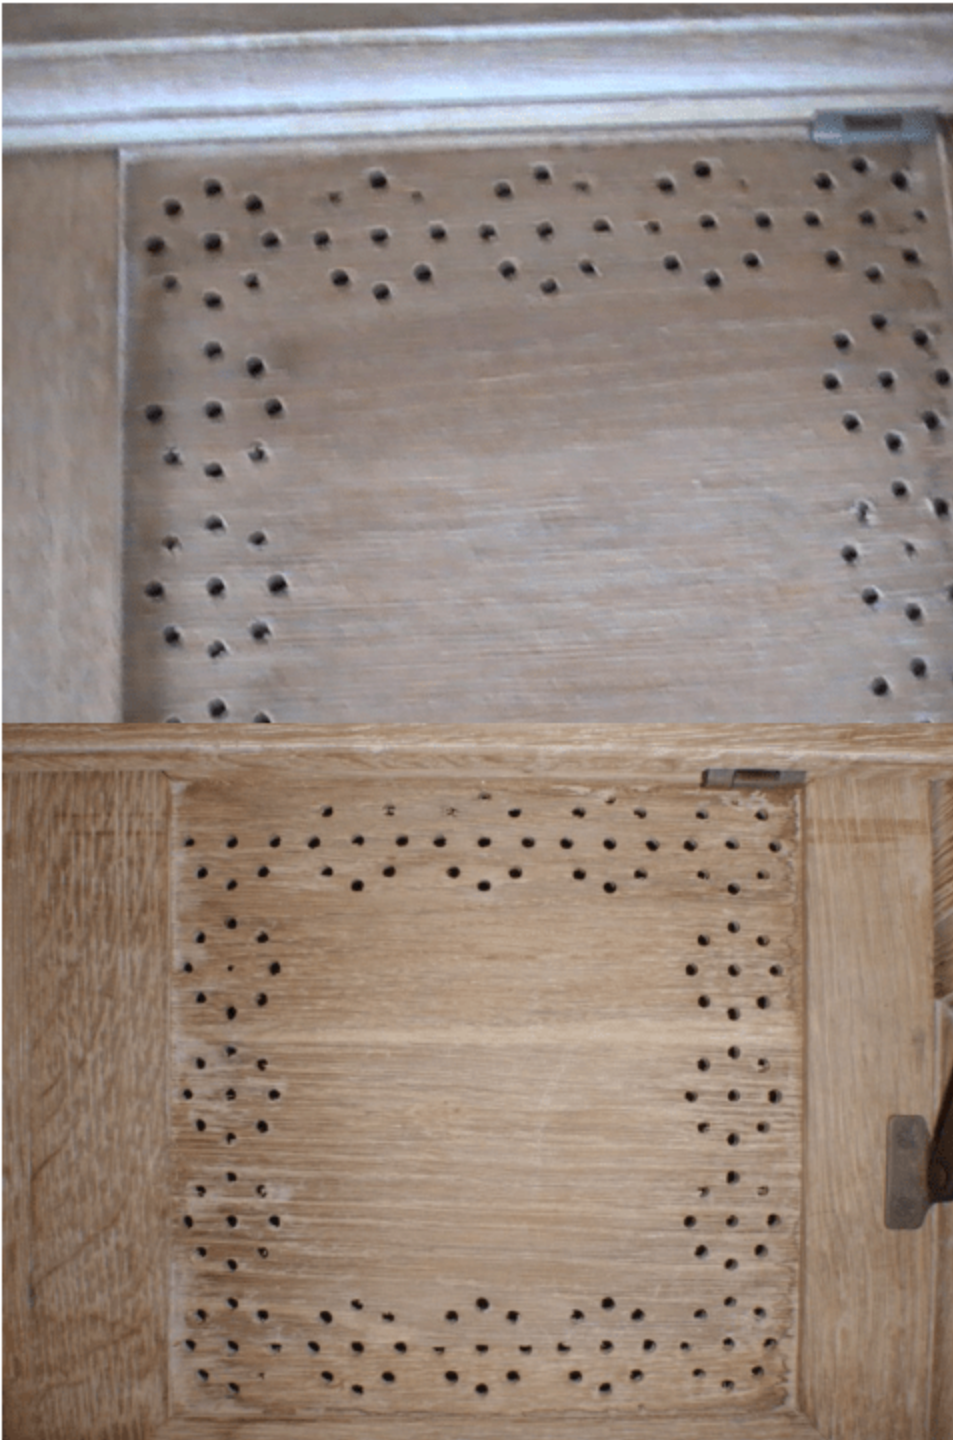
Uneven application of stain. Water stained appearance. Holes not completely drilled through or sanded.

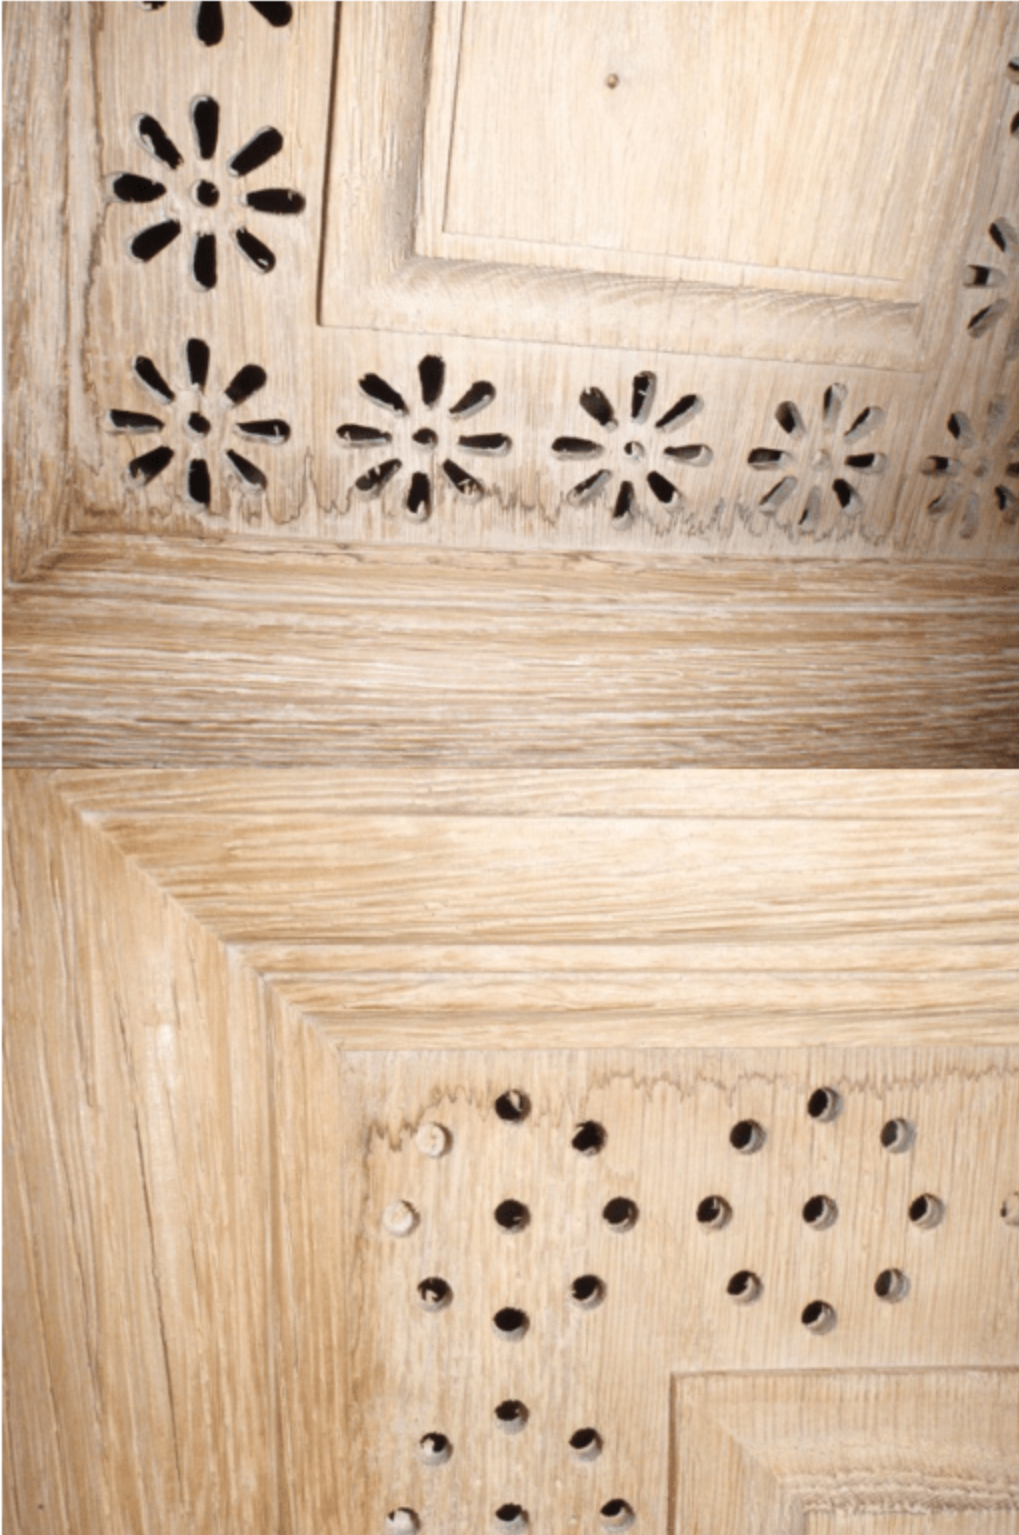
More examples of holes not drilled through and sanded and uneven application of stain appearing like water stains.

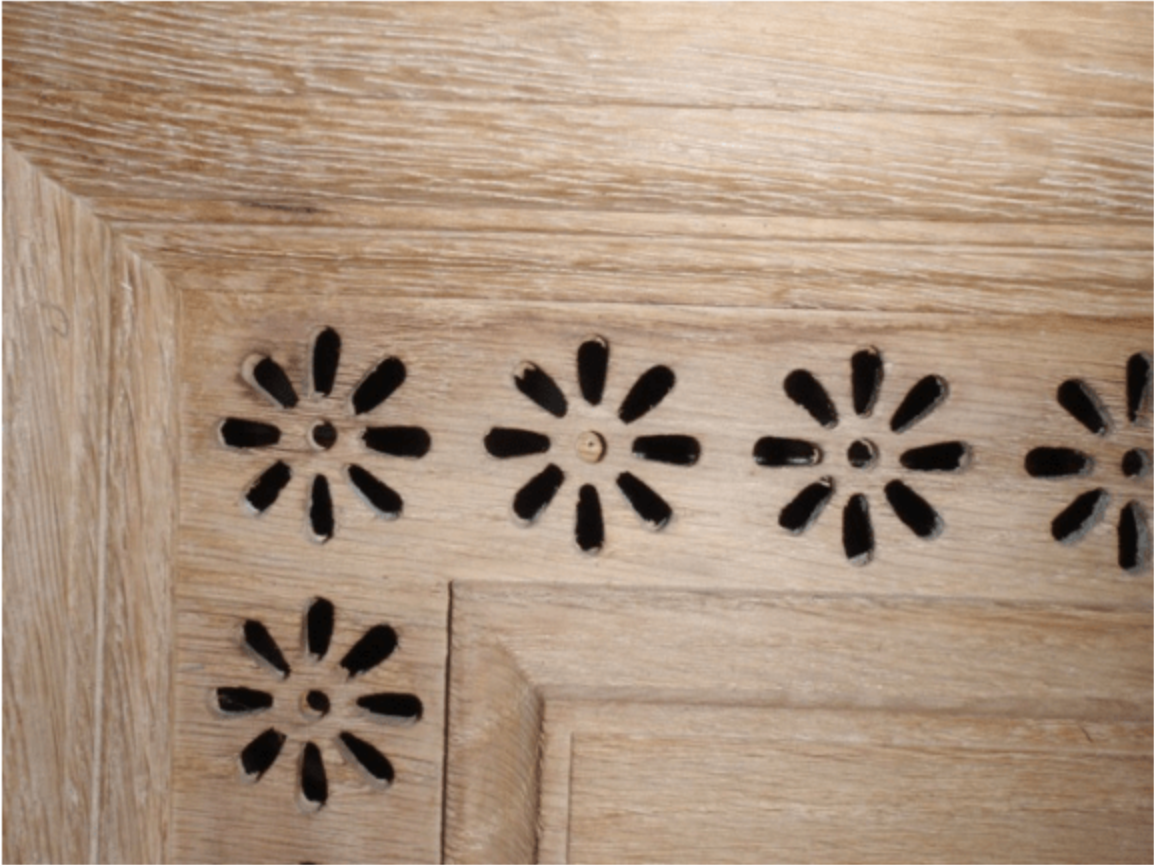
Additional example of holes not drilled through. Again no even application of staining.

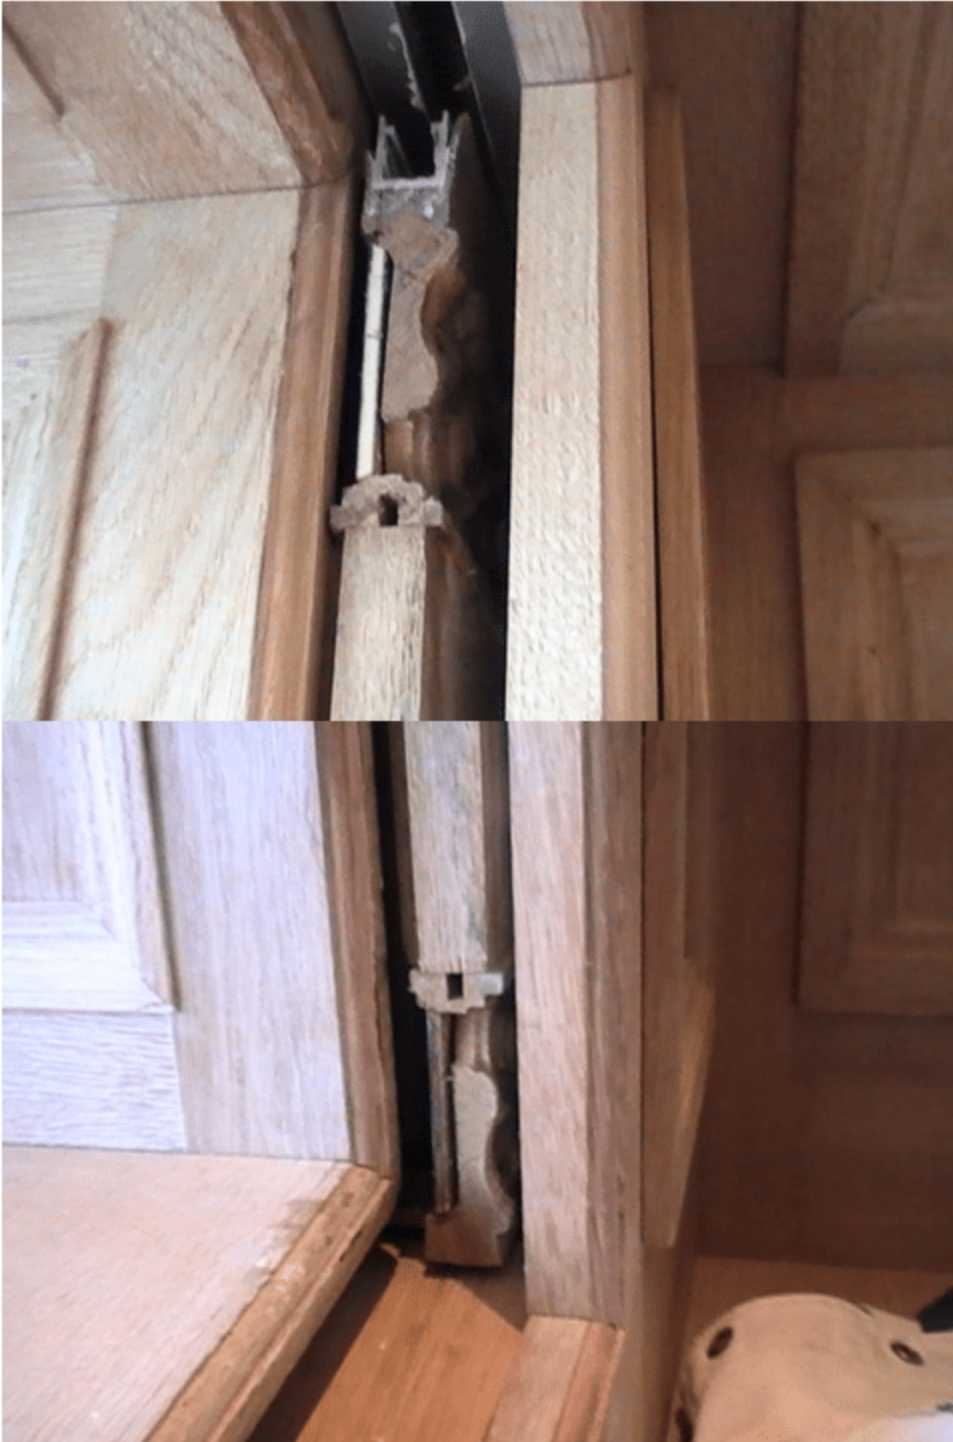
Shoddy workmanship. Edges and surface of wood rough and uneven; discolored and unfinished appearance.

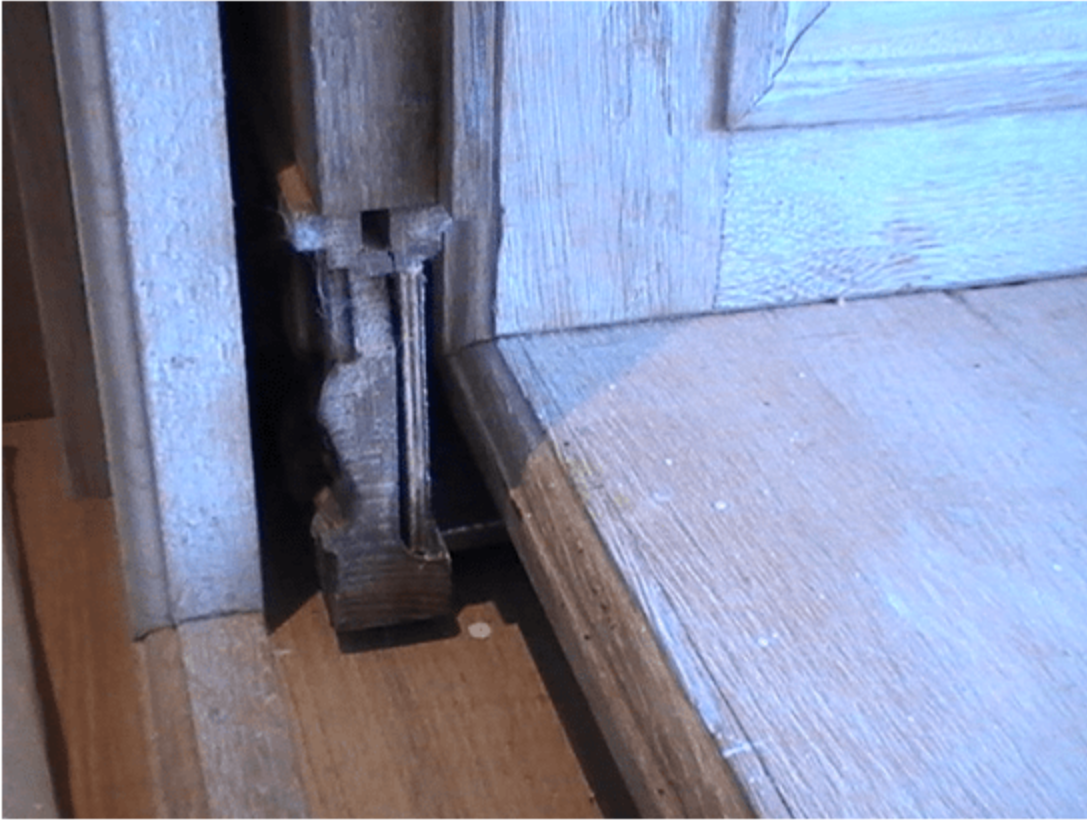
Shoddy workmanship. Edges and surfaces of wood rough, uneven, chipped and cracked. Discoloration and unfinished appearance.

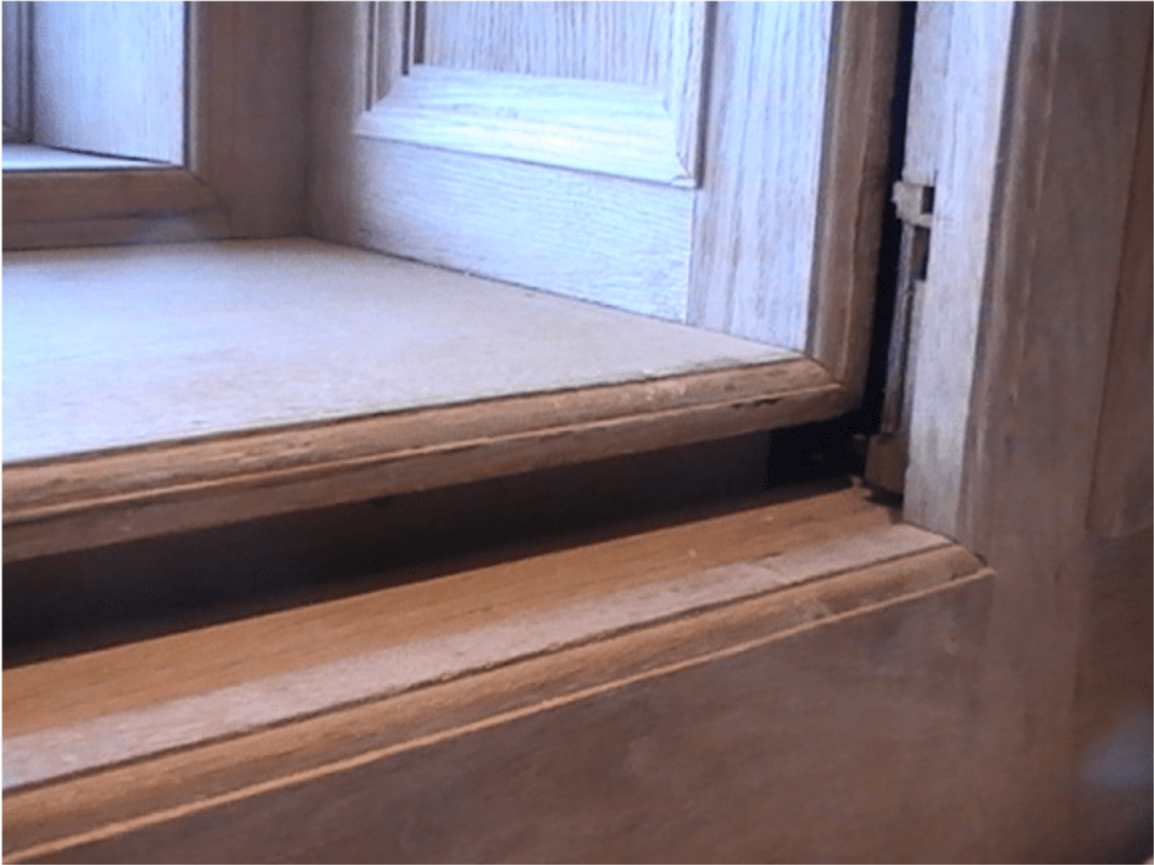
Edges of wood discolored, chipped. Enormous gap between window frame and outside frame. Unfinished appearance.

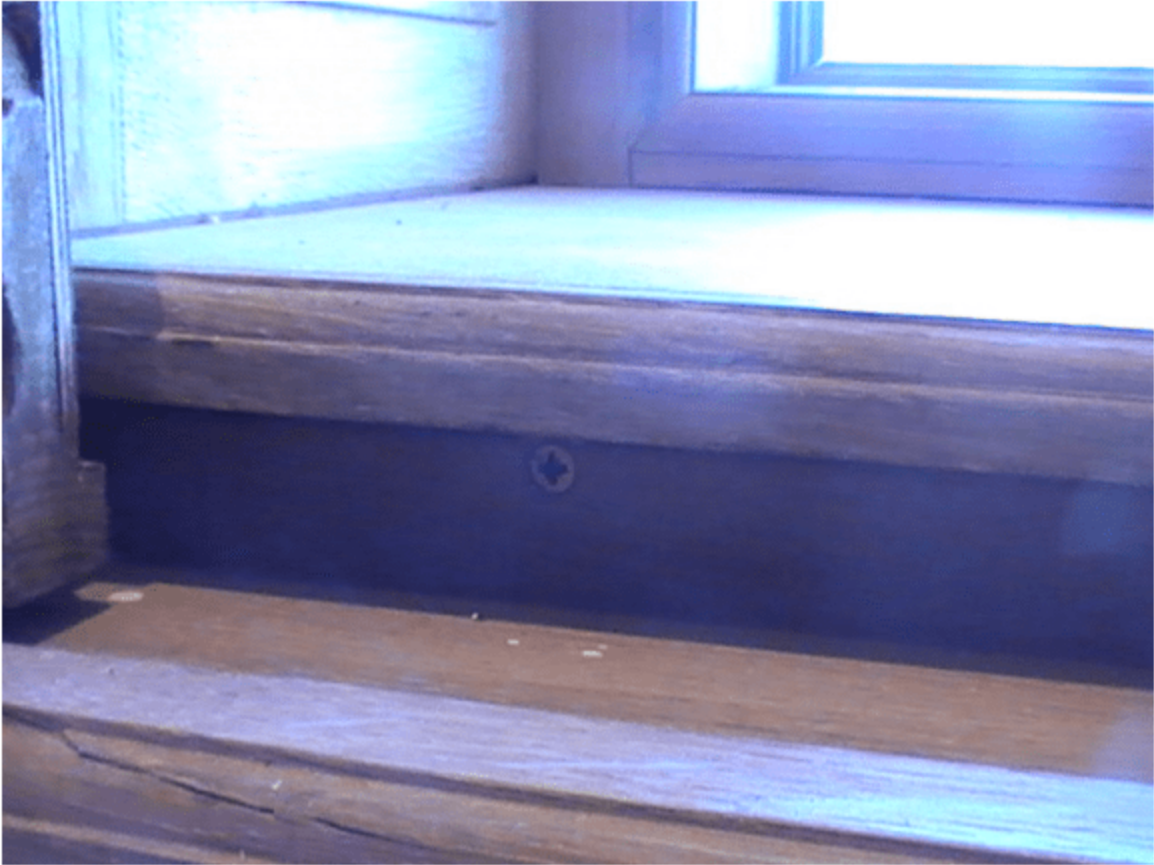
Cracked wood. Rough unfinished edges and surfaces. Screw apparent. Gap between Window frame and outside frame. Discoloration.

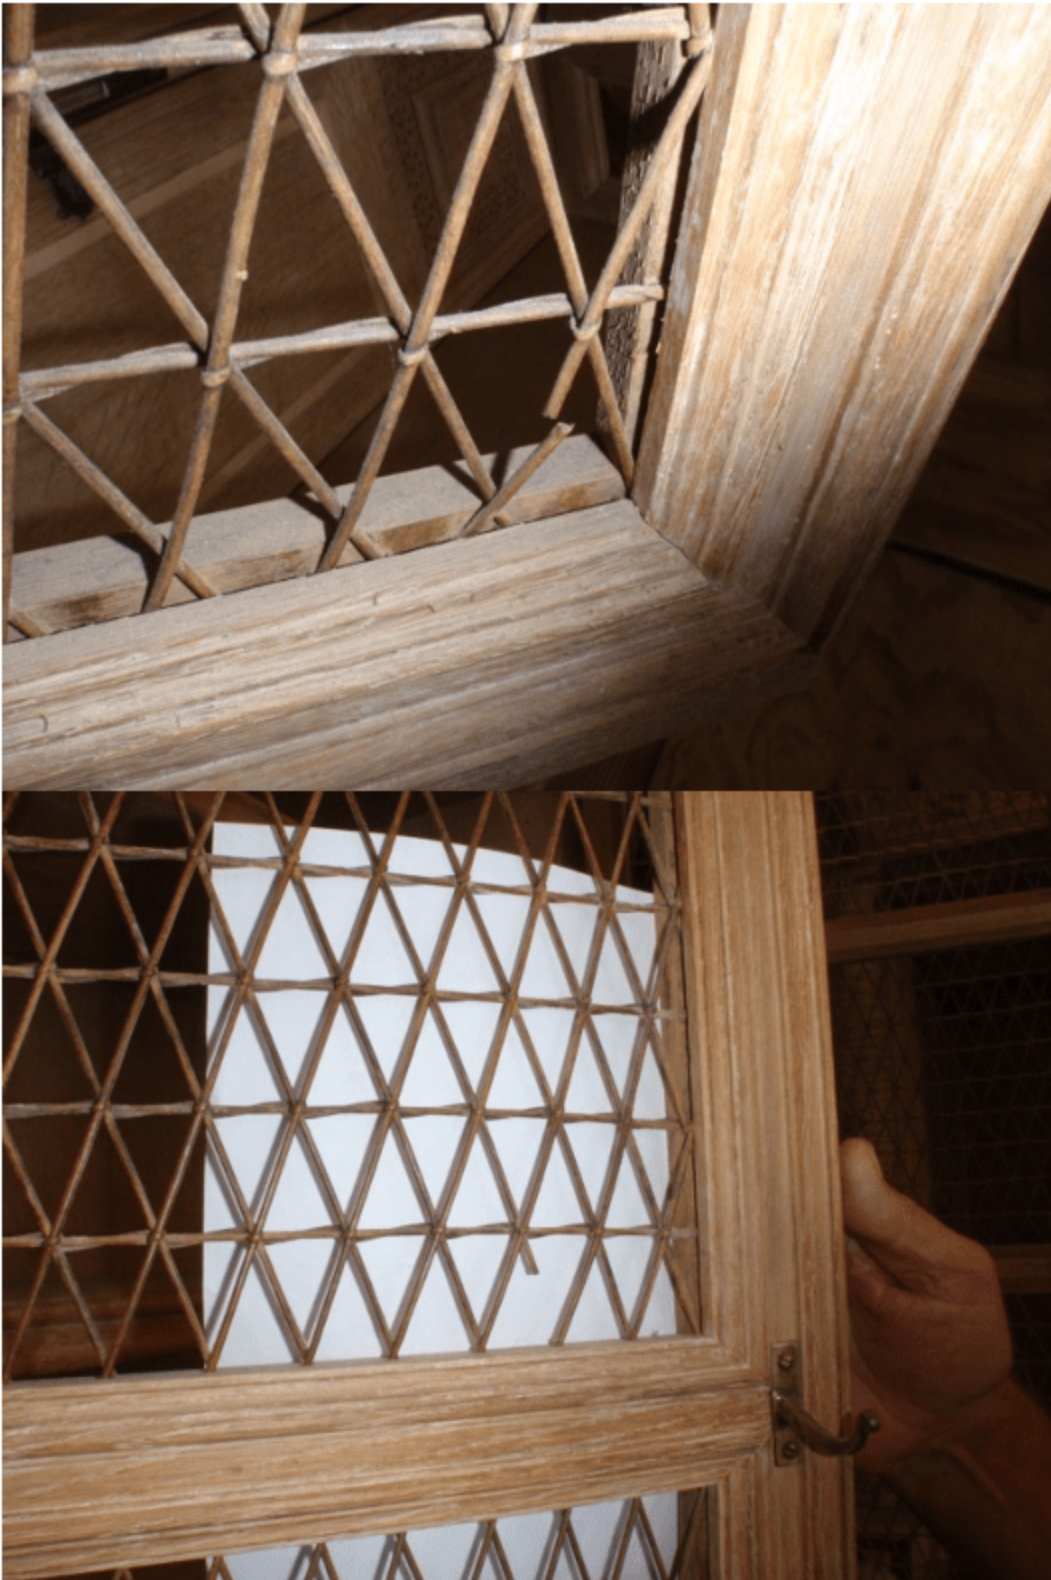
Examples of broken mesh work on cabinet doors. Poorly finished wood. Rough splintery wood. Uneven application of color.

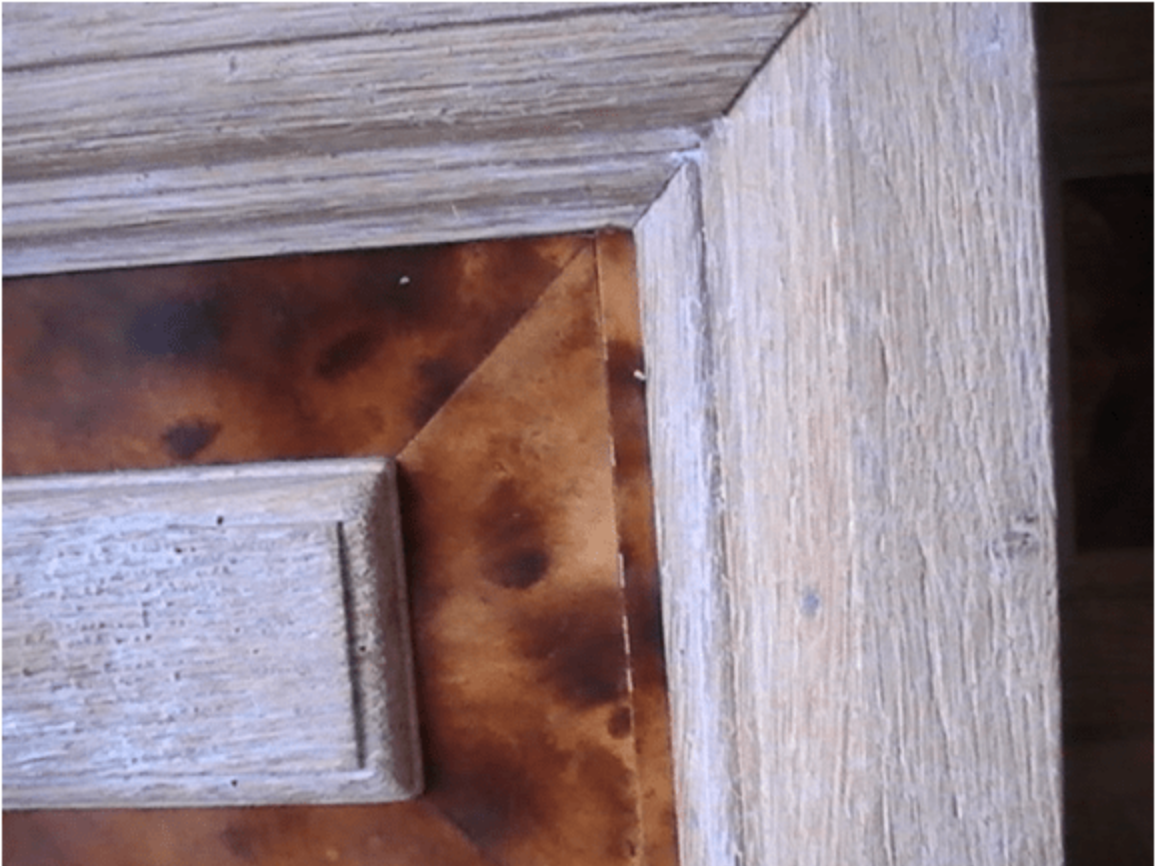
Rough, pockmarked wood with no apparent or poor finish. Tortoise Shell application patched and chipped.

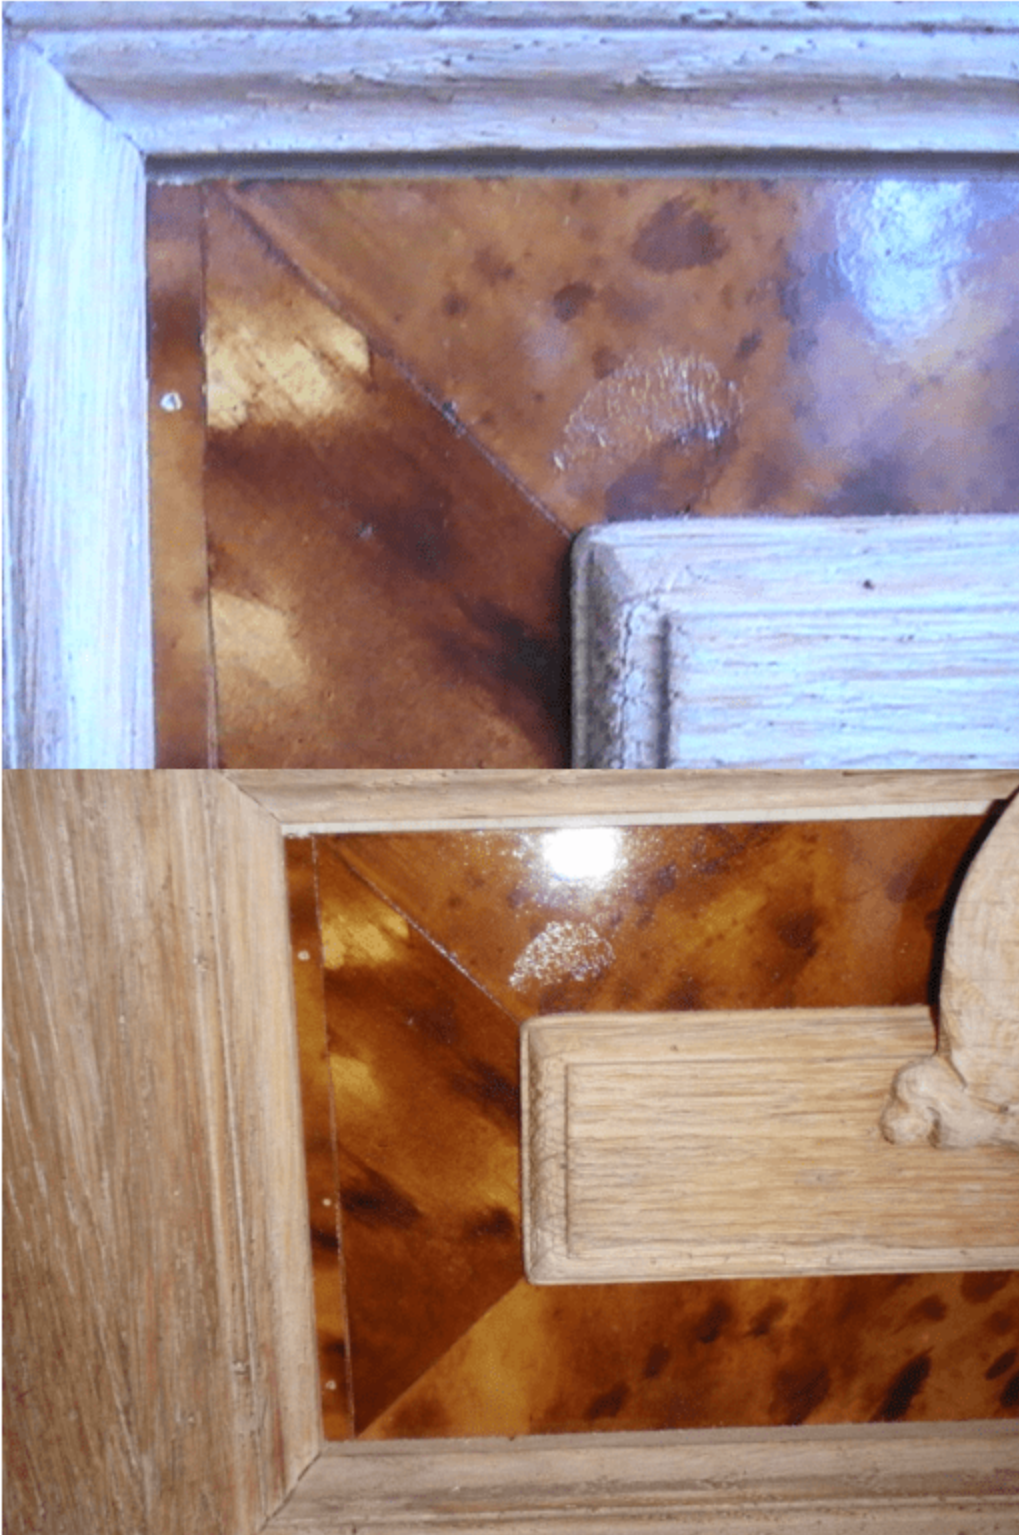
Rough, pocked unevenly finished wood. Fingerprints on tortoise shell application. Patchwork on tortoise shell. Pinholes in tortoise shell. Poor finish on additional applied butterfly carving.

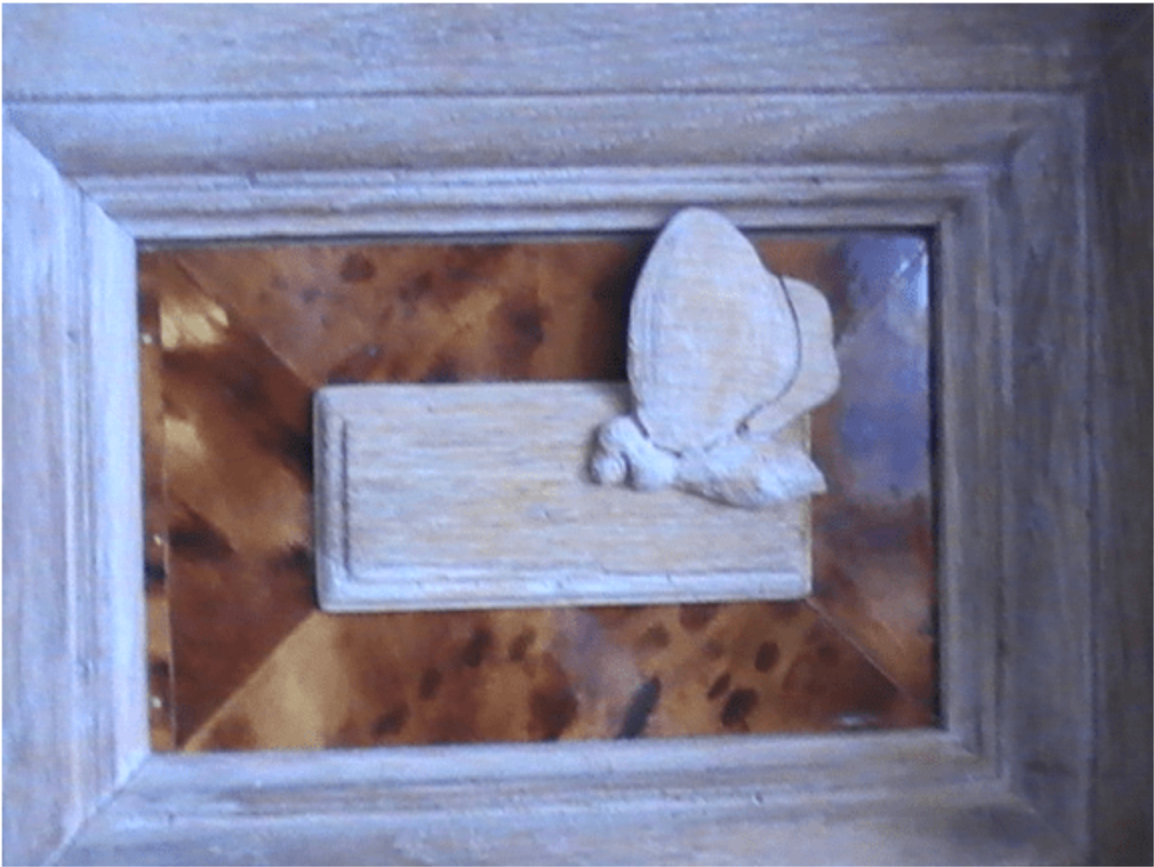
Larger picture of shoddy workmanship. Tortoise shell surface unclean. Patchwork tortoise shell. Butterfly unfinished with wood putty still evident. Rough wood surfaces and edges. Uneven application of color. Unfinished appearance.

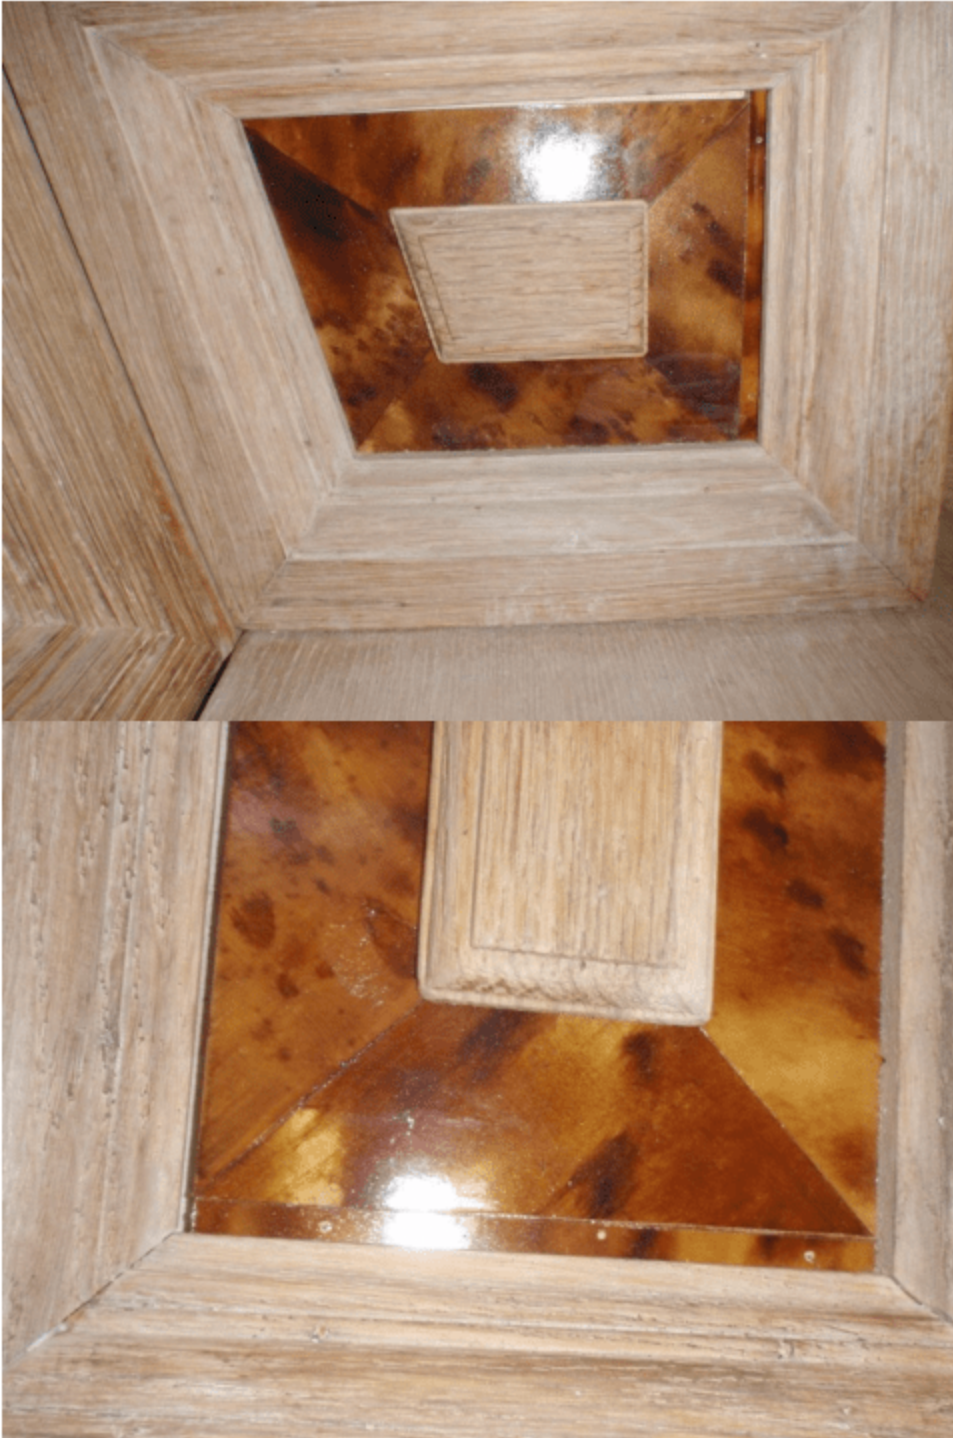
Patchwork tortoise shell. Tortoise shell not completely covering in areas (see top picture). Pin holes in tortoise shell. Surface of Tortoise shell blemished. Color finish on wood looks incomplete. Rough and pocked surface of wood. Stain color unevenly and incompletely applied.

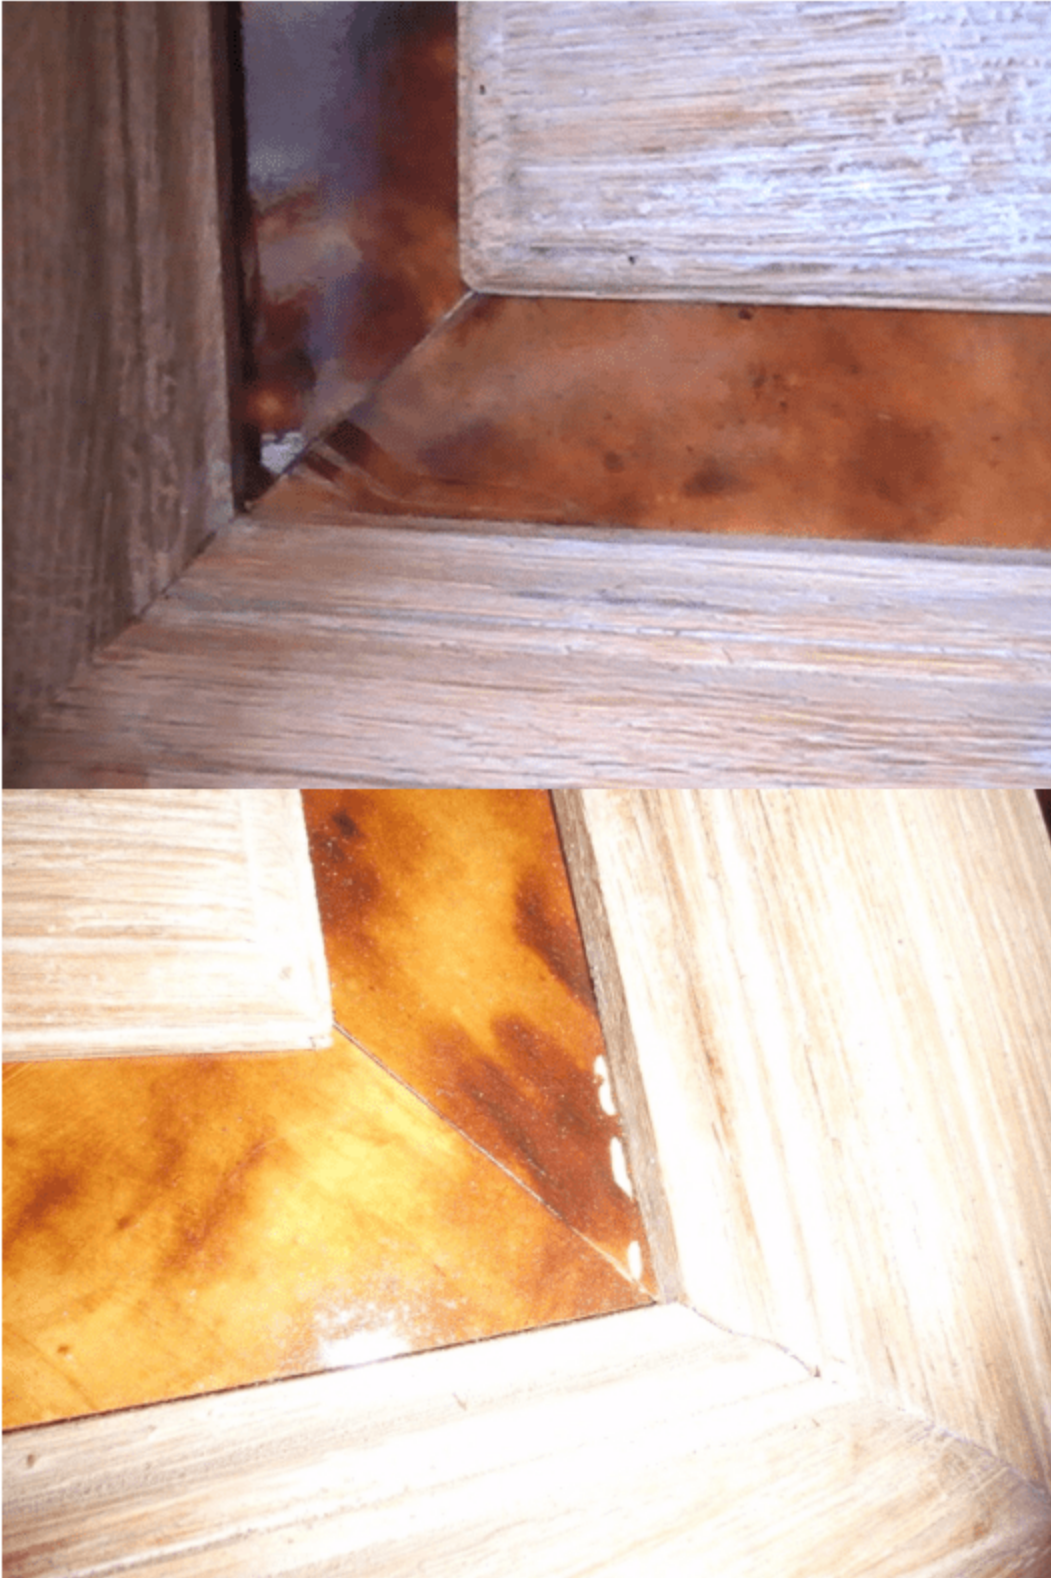
Chipped and delaminating tortoise shell. Rough and pocked wood surfaces with color unevenly applied to wood, creating substandard appearance.
