March 15, 2010

Re: Agreement for Design Services dated May 15, 2009 ("Design  
Services Agreement") by and among Juan Pablo Molyneux, J.P.  
Molyneux Studio, Ltd., L.S.J., LLC and Jeffrey Epstein

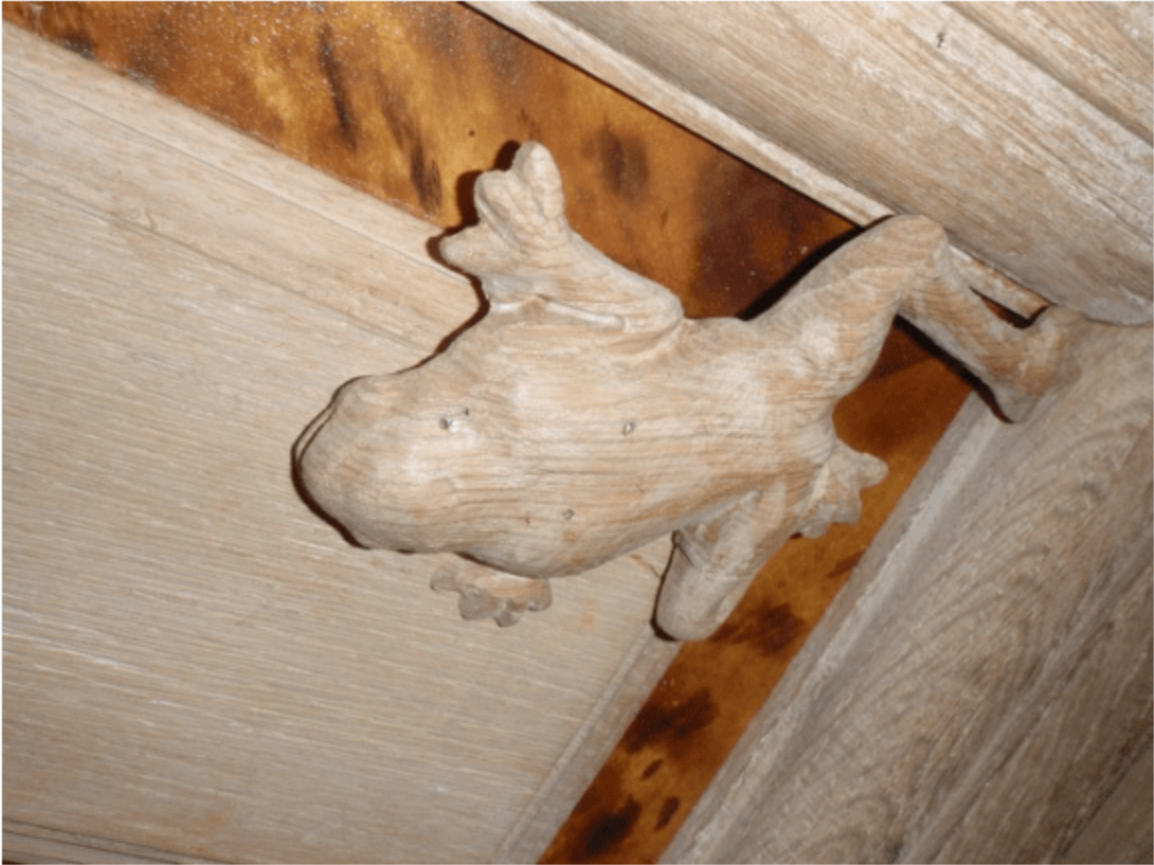
Nail holes in frog carving. Uneven application of color to frog and wood work.

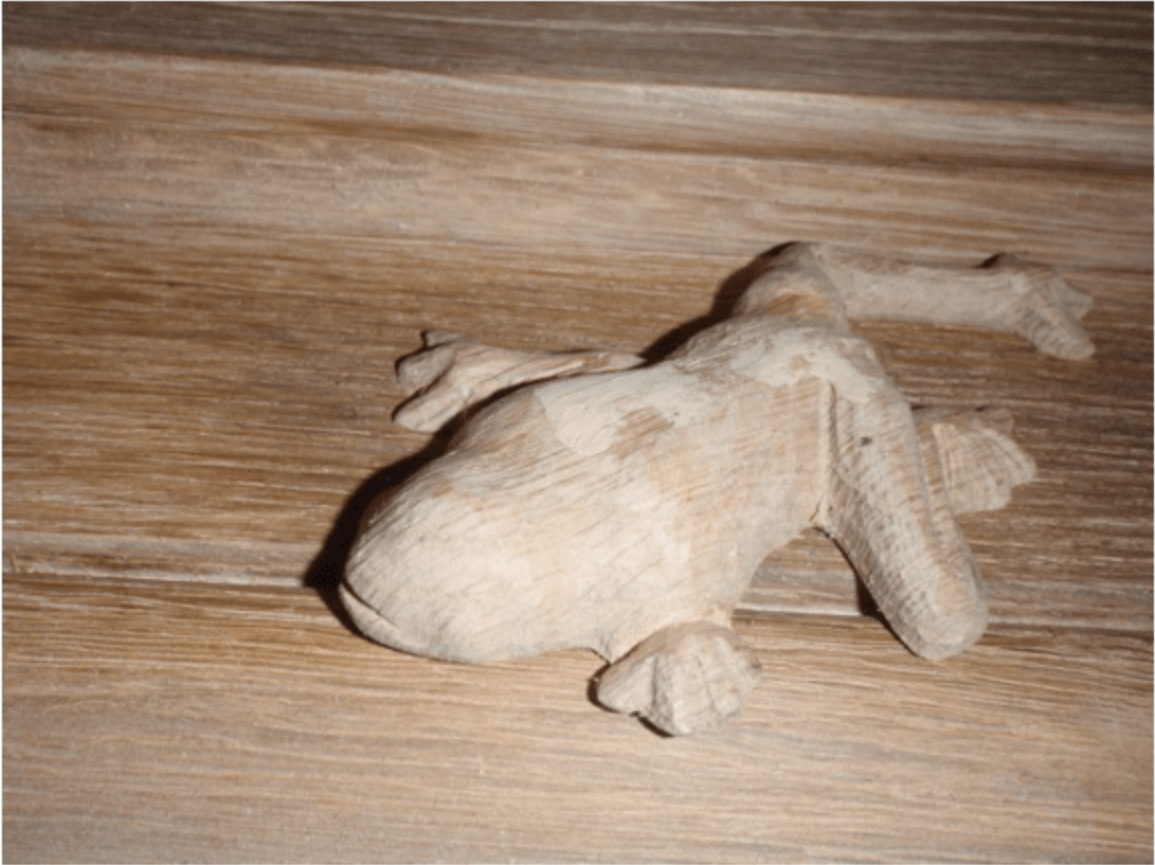
Additional frog carving unfinished. Wood putty apparent on frog. Nail hole on frog.
