**Subject:** Re: S76 update

Jeffrey and Darren,

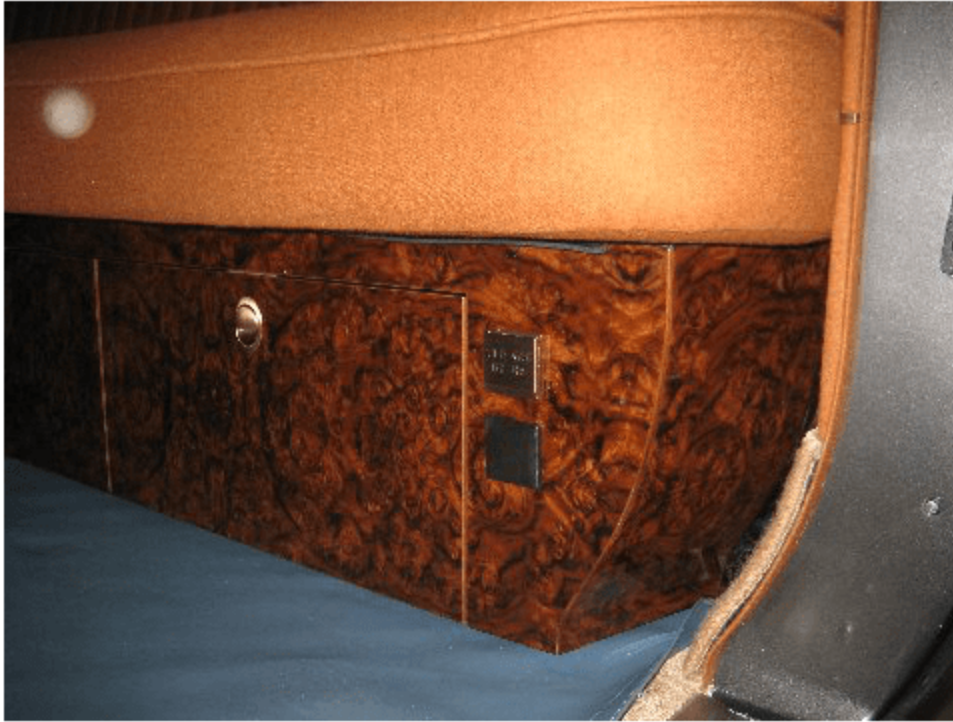
11 missing 12 Volt outlets need to be installed and functional check

**-The S76 will not be fully complete till Feb 10th, Keystone is waiting for two 12 volt outlets to be delivered, they are installed in the passenger compartment. We have four total**

installed in the passenger compartment, however Keystone realized they were missing two of these outlets, at this time they have installed cover plates: see photo below:
