**RE: Zorro Ranch – Pool/Natatorium System Analysis  
Project #9357.00**

**Zorro Ranch  
Stanley, NM**

**Pool/Natatorium System Review**

**BEAUDIN GANZE CONSULTING ENGINEERS, INC.**

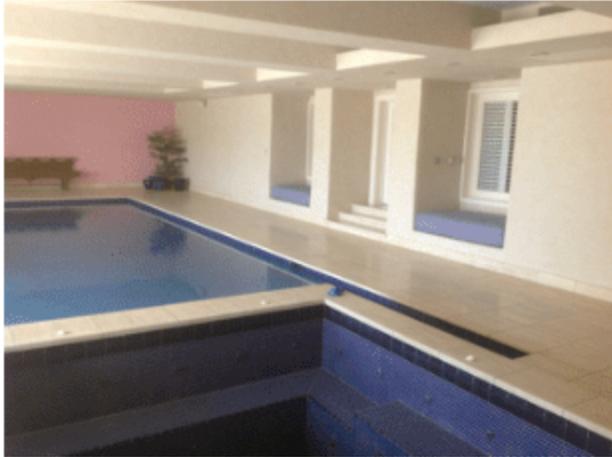
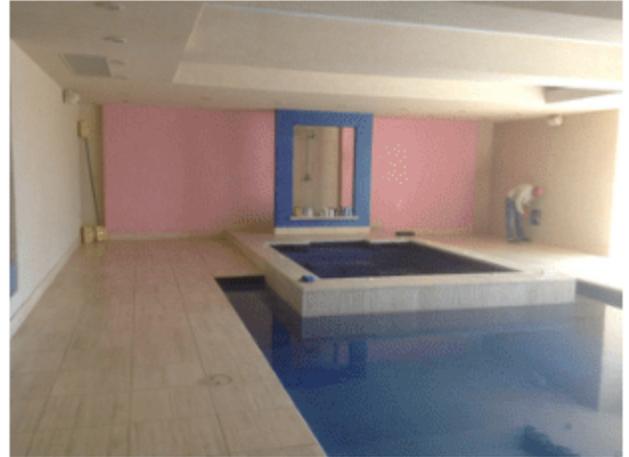
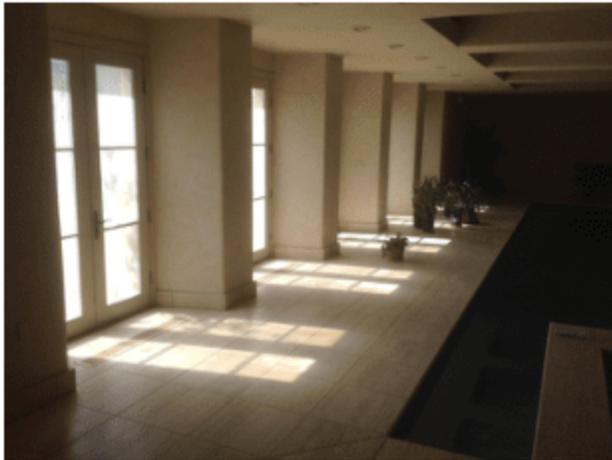
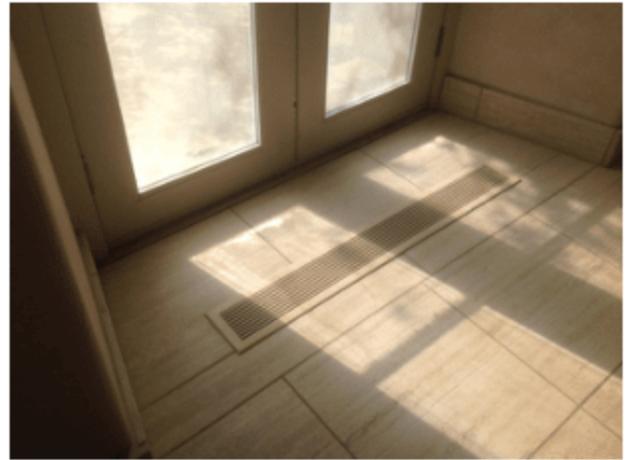
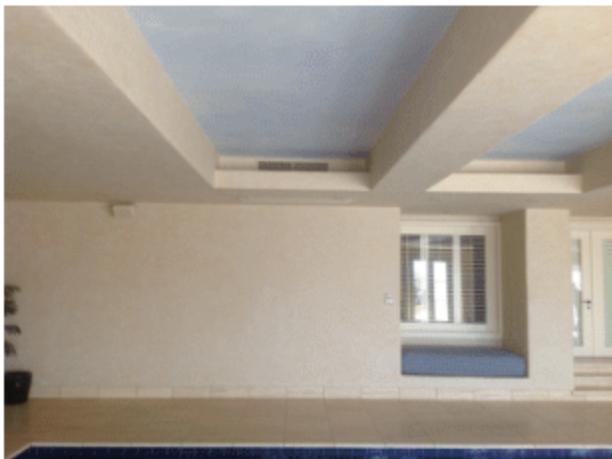
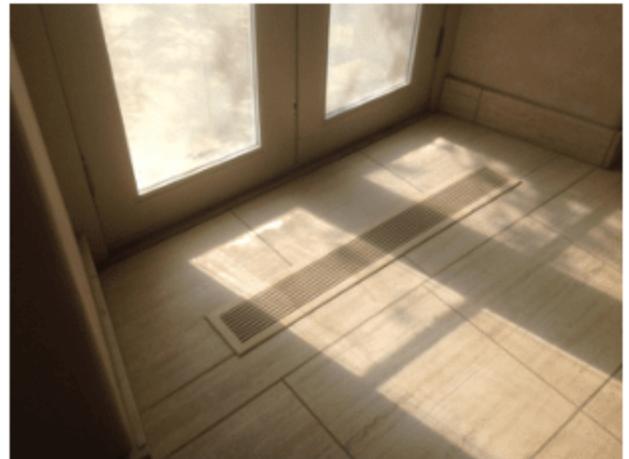
**Pictures: Natatorium Layout**

The pool room is ducted from the pool conditioning unit through a single below grade supply duct (16" diameter per design) that supplies five floor registers located at sole exterior wall with doors with integral windows. Return air is ducted back to the pool conditioning unit through two side wall and two ceiling return grilles located opposite the supply. There is no mechanical exhaust from the pool area.

The pool area is fully enclosed with five French doors leading to the exterior and a single French door leading to the interior gym. The pool is located on the ground level of the building with one exterior wall, one interior common wall (gym area) and two sub grade walls (one common to the pool equipment room). Typical wall construction is concrete. The exterior and interior common walls also utilize steel frame construction. The pool has solid surface throughout consisting of plaster ceilings/walls and concrete/tile deck. The roof of the pool is a terrace/porch/deck of the main floor of the building. The insulation values or presence of a vapor barrier cannot be determined or confirmed.

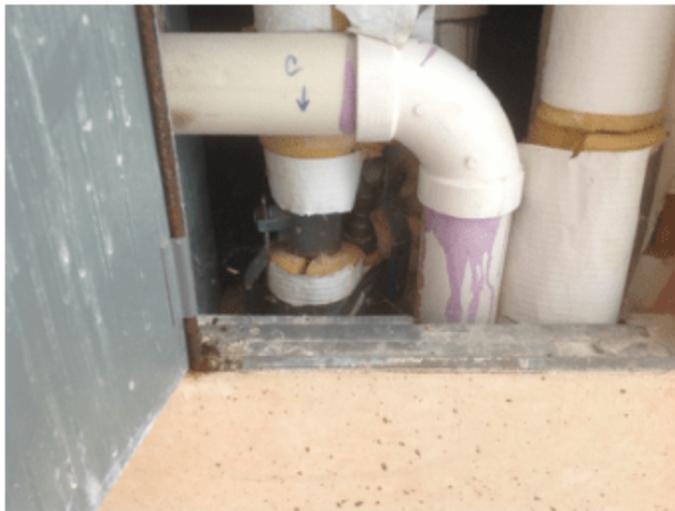
**Picture: Access panel to Wall Void – Air Leakage into chase from supply duct below grade.**

Provide a water/vapor barrier in the form of a coating that is applied to all the existing interior surfaces of the pool walls and ceiling (One common Manufacturer is Tnemec). Seal all air leaks from the exterior to interior; this includes the air leak from the supply duct into the wall cavity at the water isolation valves.
