THOMAS A. FENNIMAN
ARCHITECT

Façade Inspection & Safety Program
Cycle 8A Report

**9 East 71st Street
New York, NY 10021**

August 2015

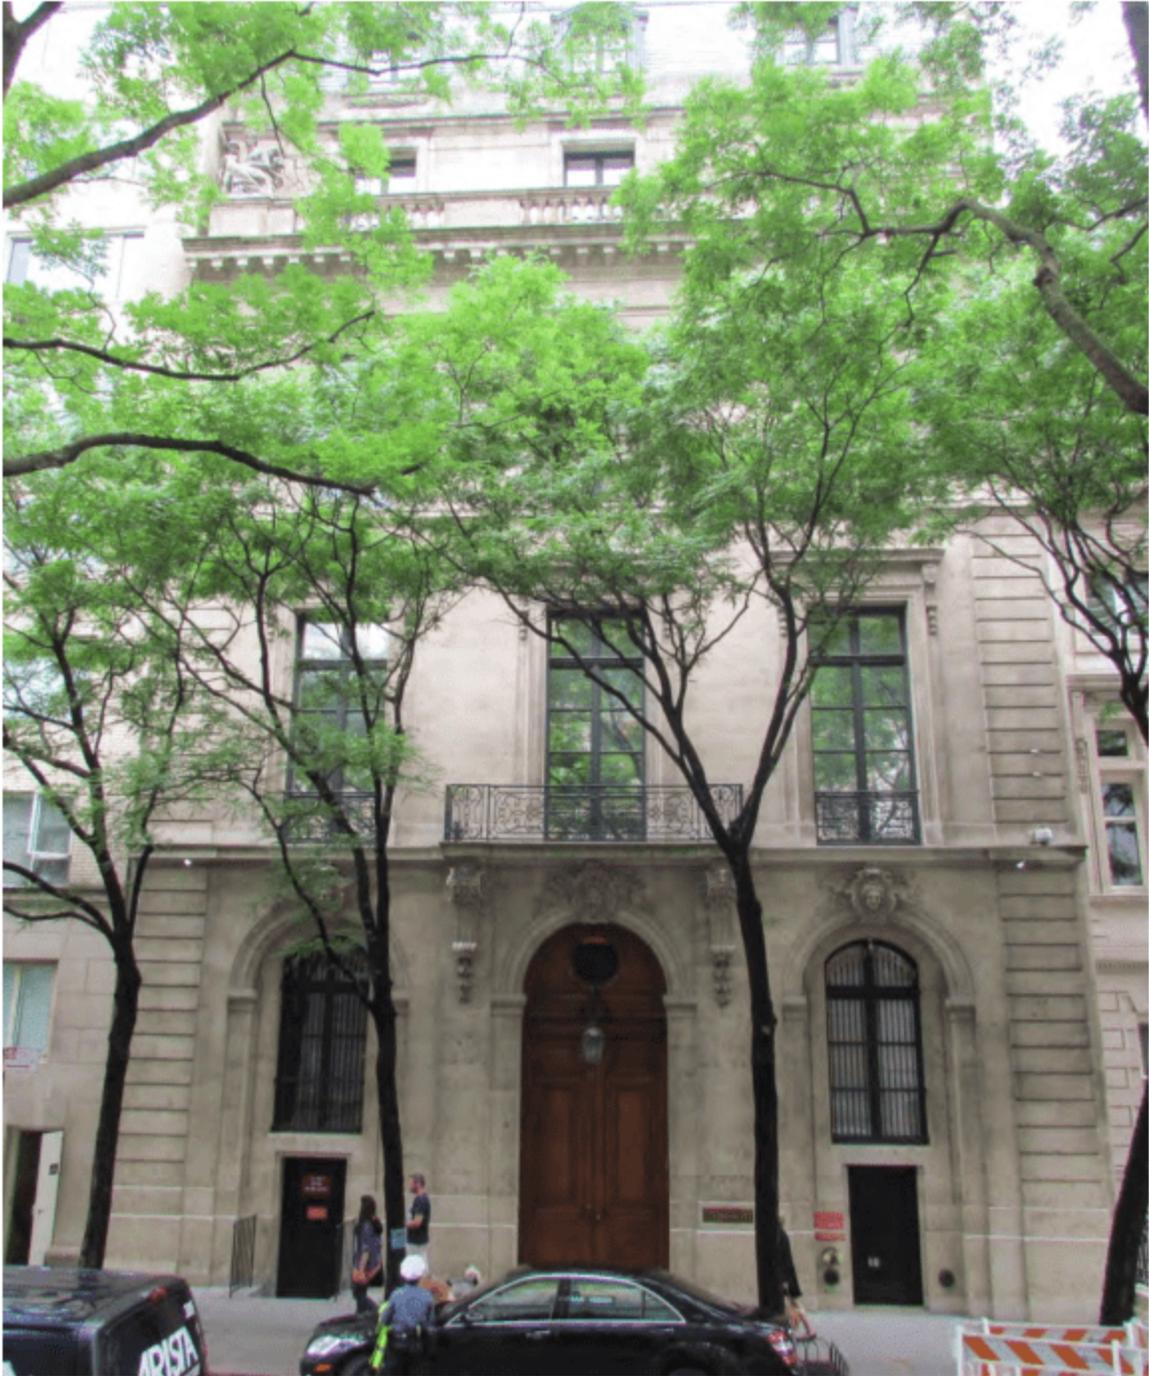
1. View of South (East 71st Street) façade.

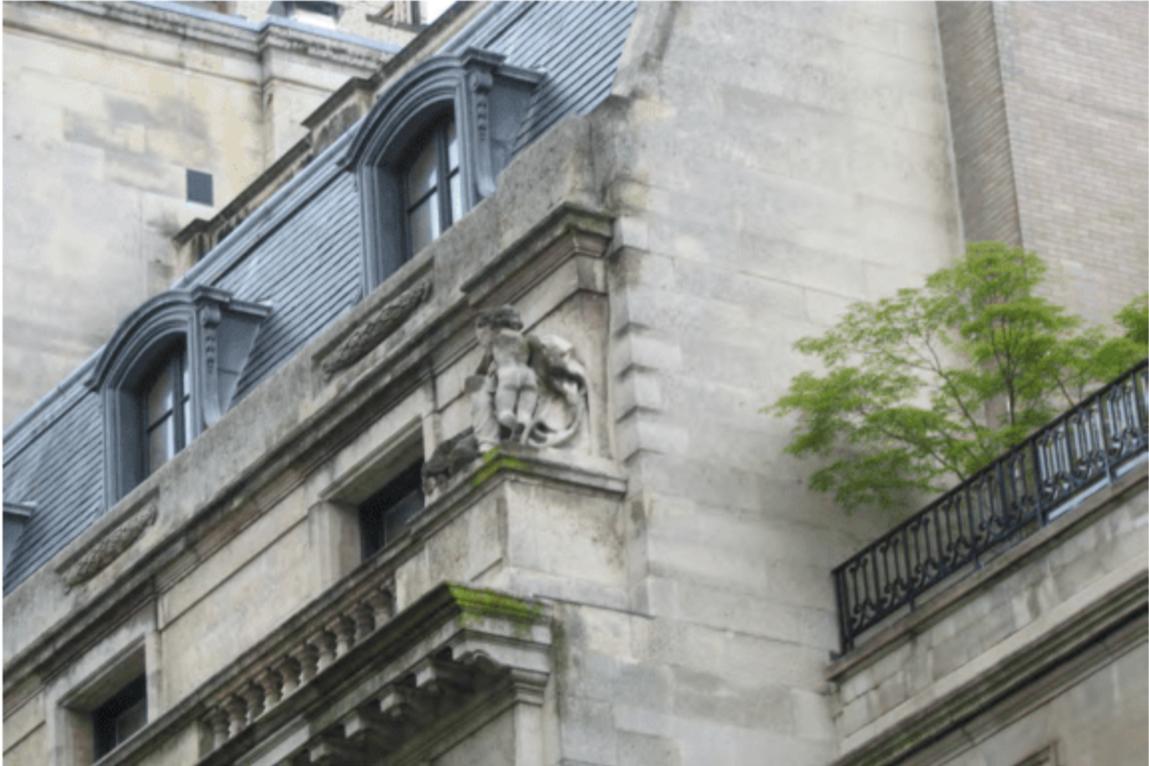
2. Detail view of Southeast Corner (East 71st Street) façade.

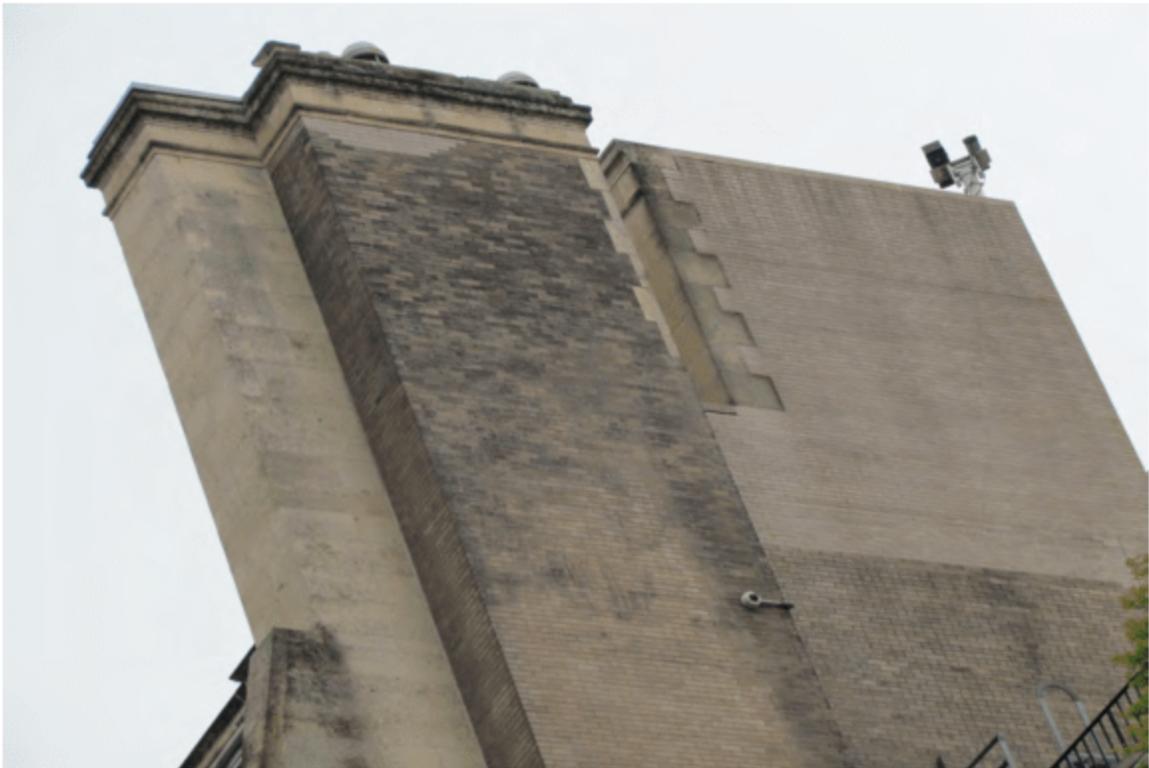
3. View of east side of east chimney and elevator bulkhead.

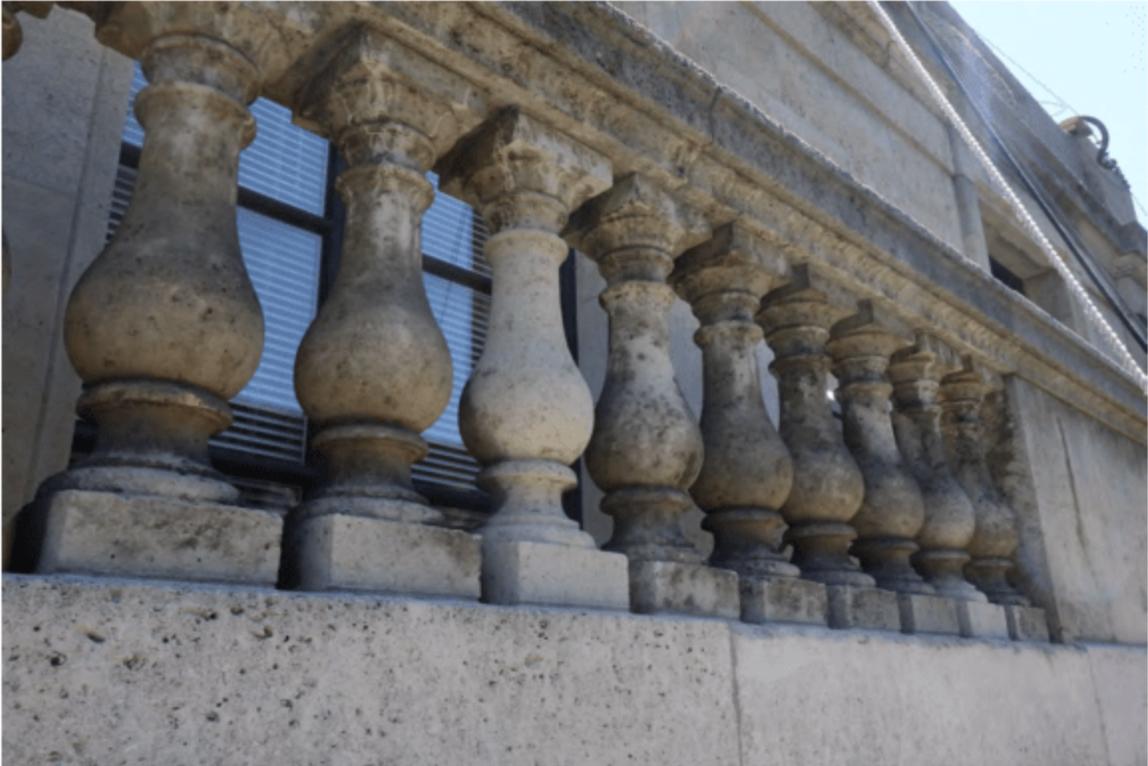
4. Detail view of 4th Floor Balustrade.

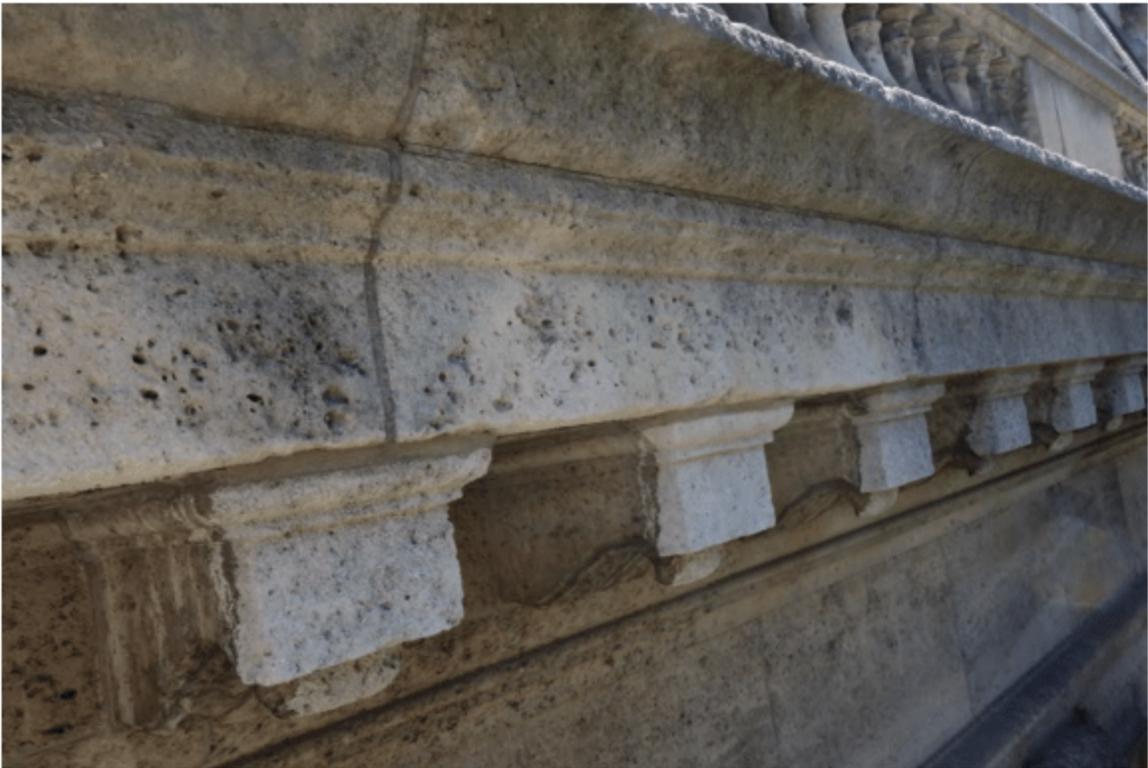
5. View of 4th floor cornice brackets in good condition.

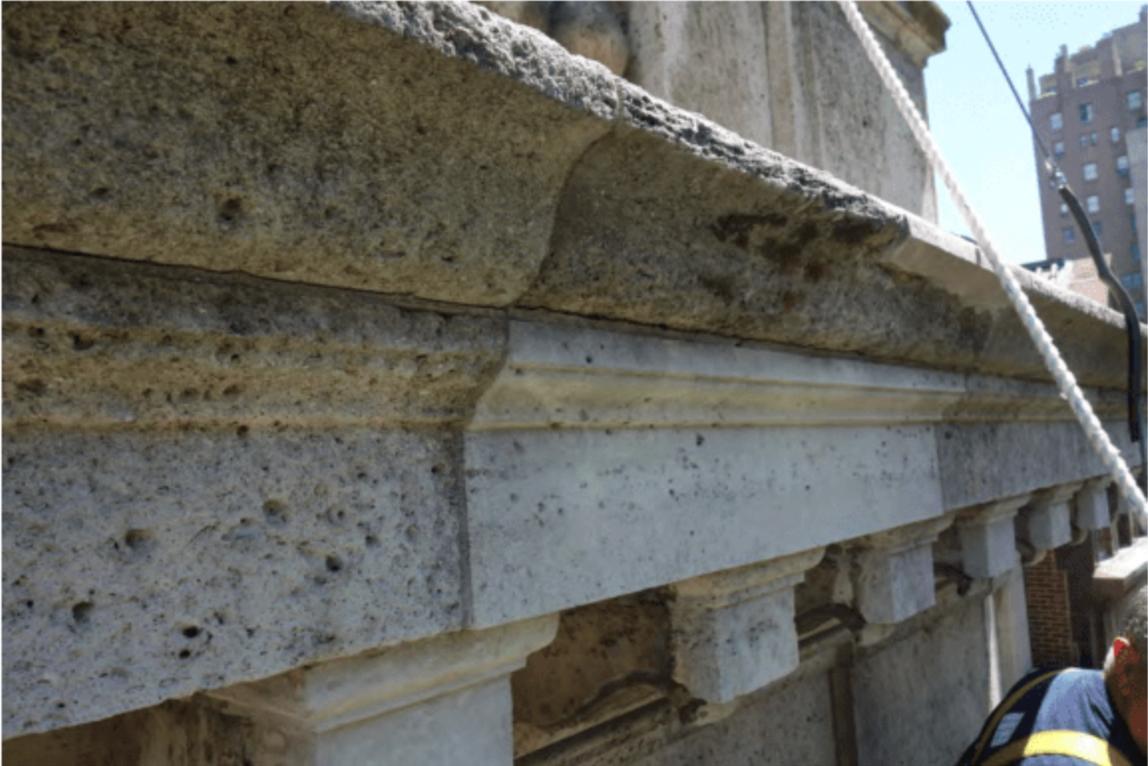
6. Replacement and patched stone at 4th floor cornice.

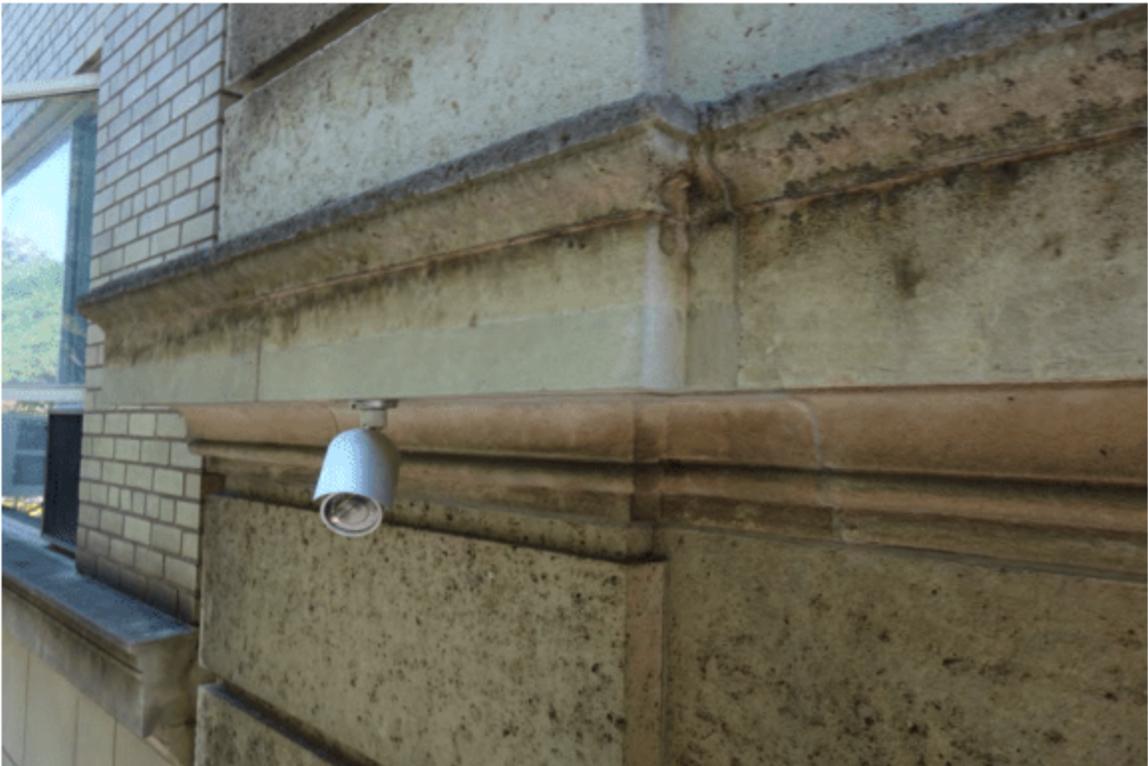
7. Patched stone at 3rd Floor southwest corner bandcourse.

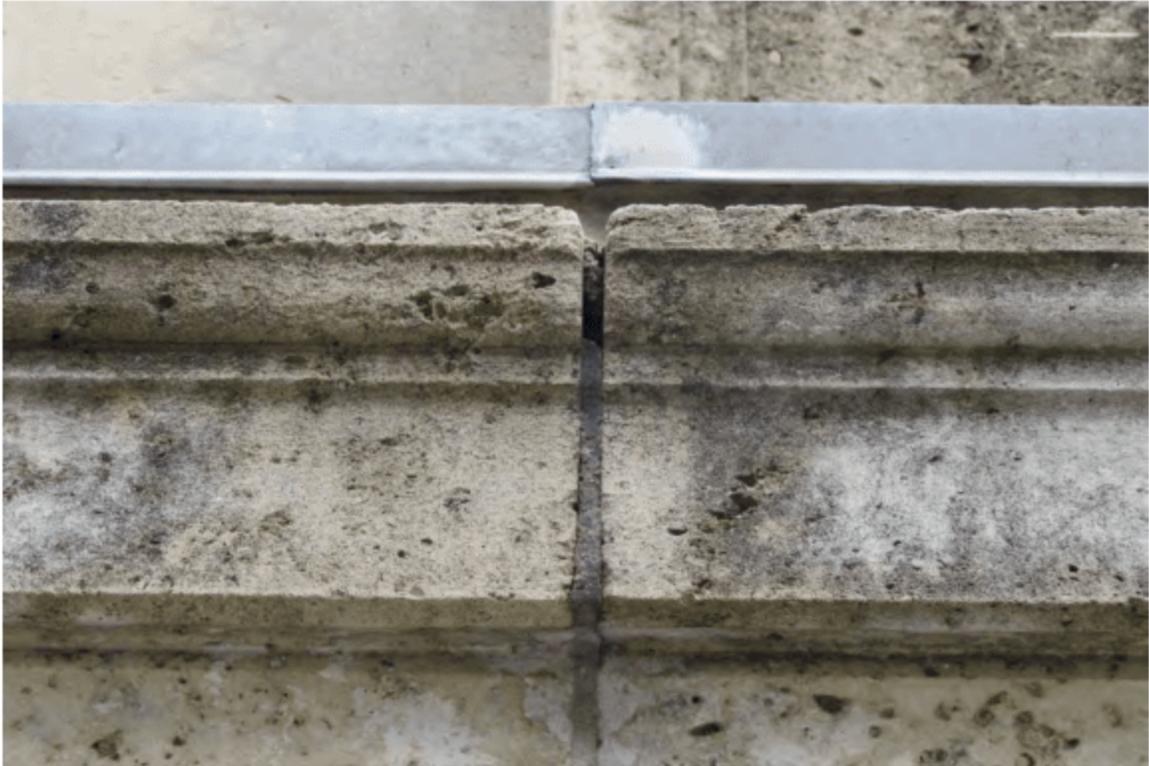
Condition	Façade	Floor	Photo
Open mortar joints -	South Façade	3 rd	8
Open joints at metal flashing -	4 th Floor Cornice South Façade	and 4 th 4 th	9 10

8. Partial open joint at upper portion of 4th floor band course.

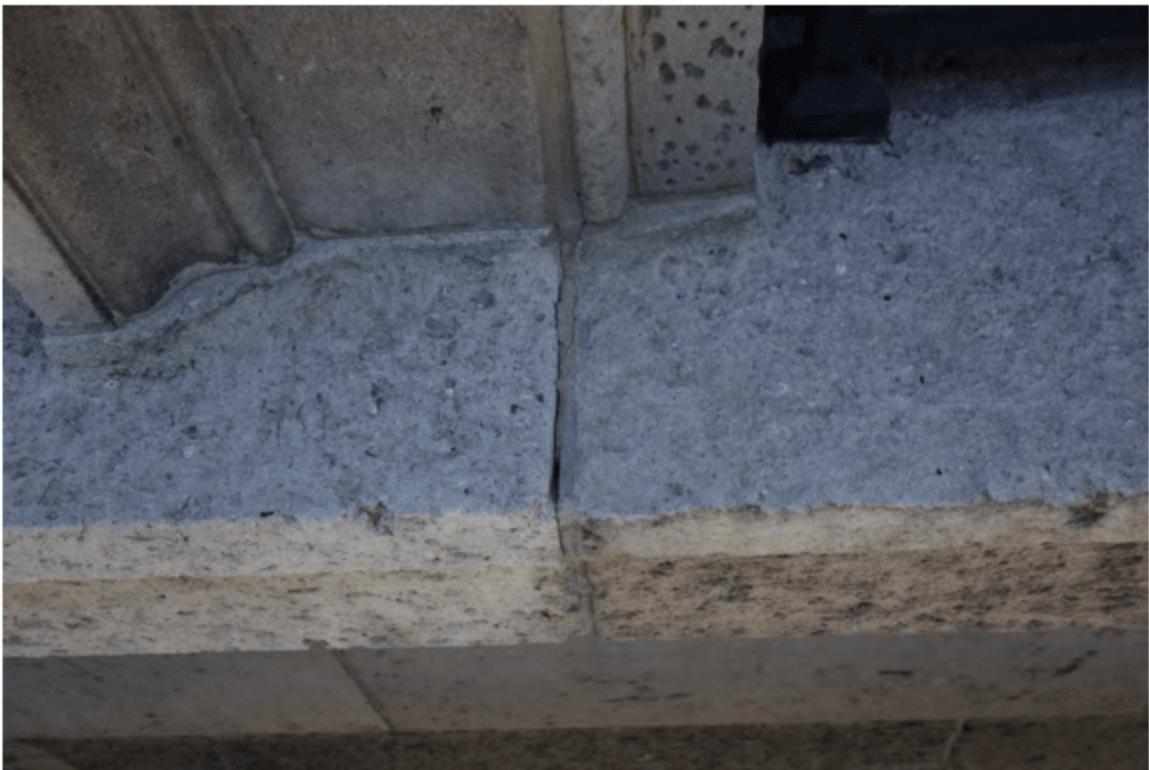
9. Partial open mortar joint at 3rd Floor.

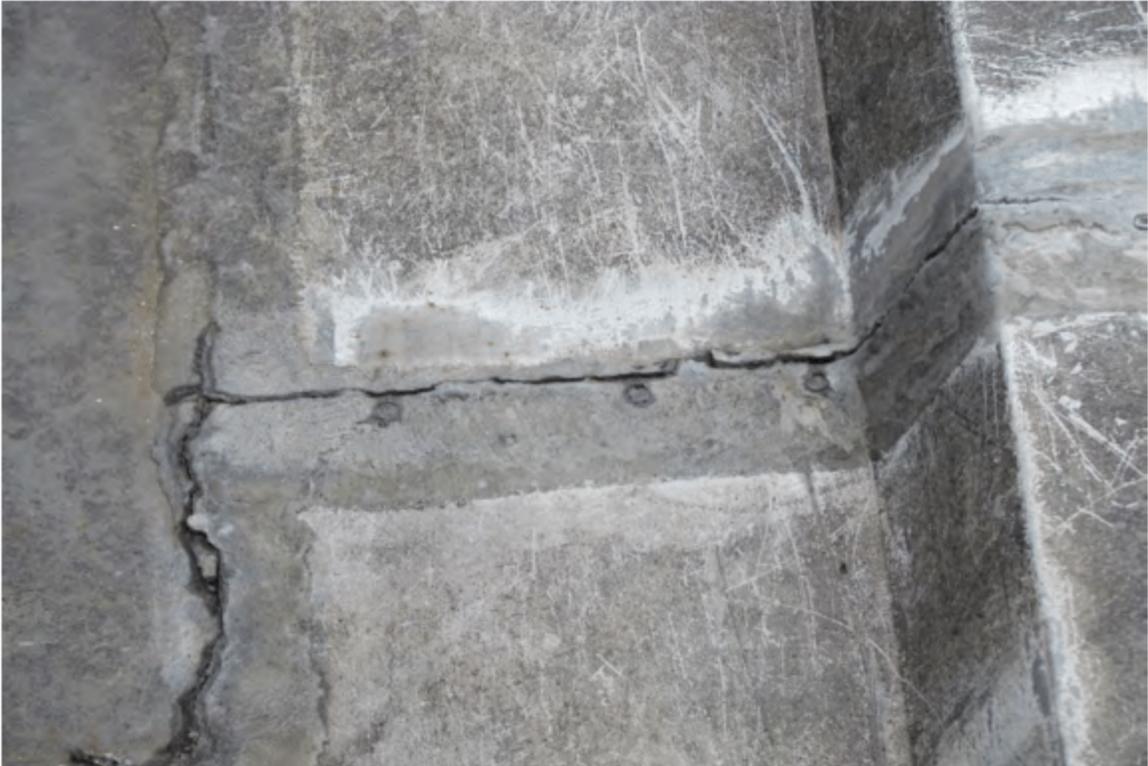
10. Partial open joint at metal flashing above 4th floor cornice.

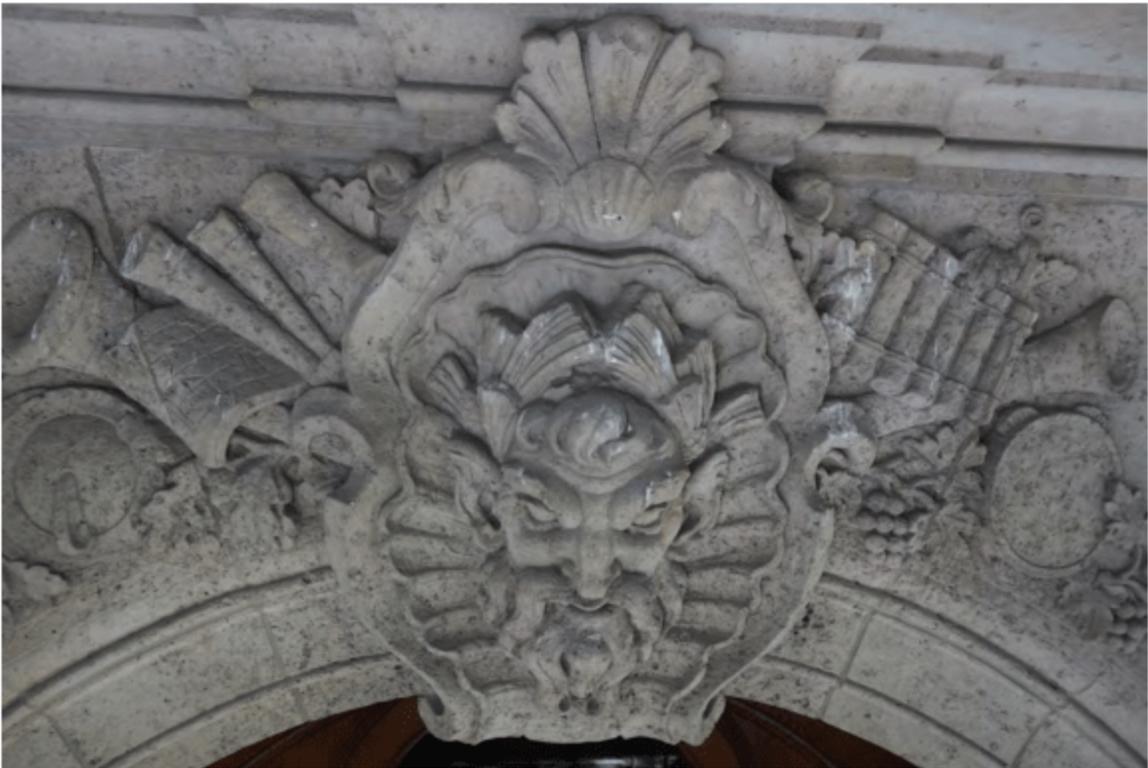
11. Detail of carved stonework above entrance in good condition.

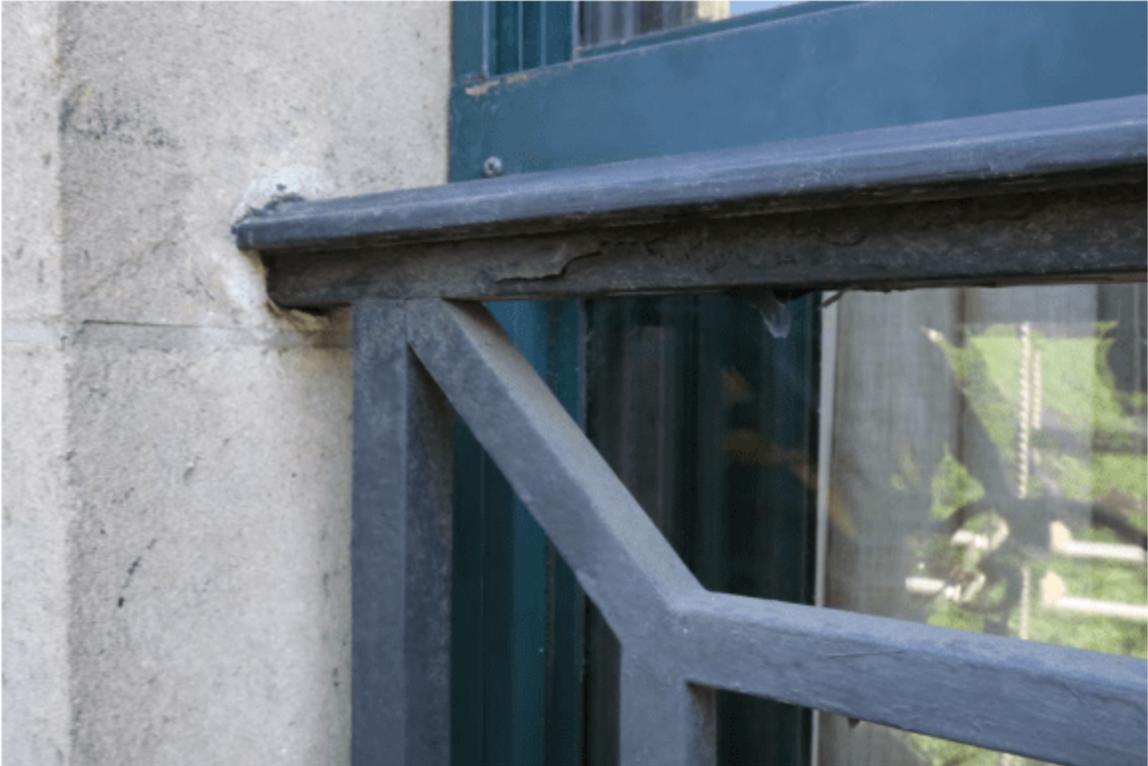
12. Evidence of rusted metal at underside of 3rd Floor metalwork.

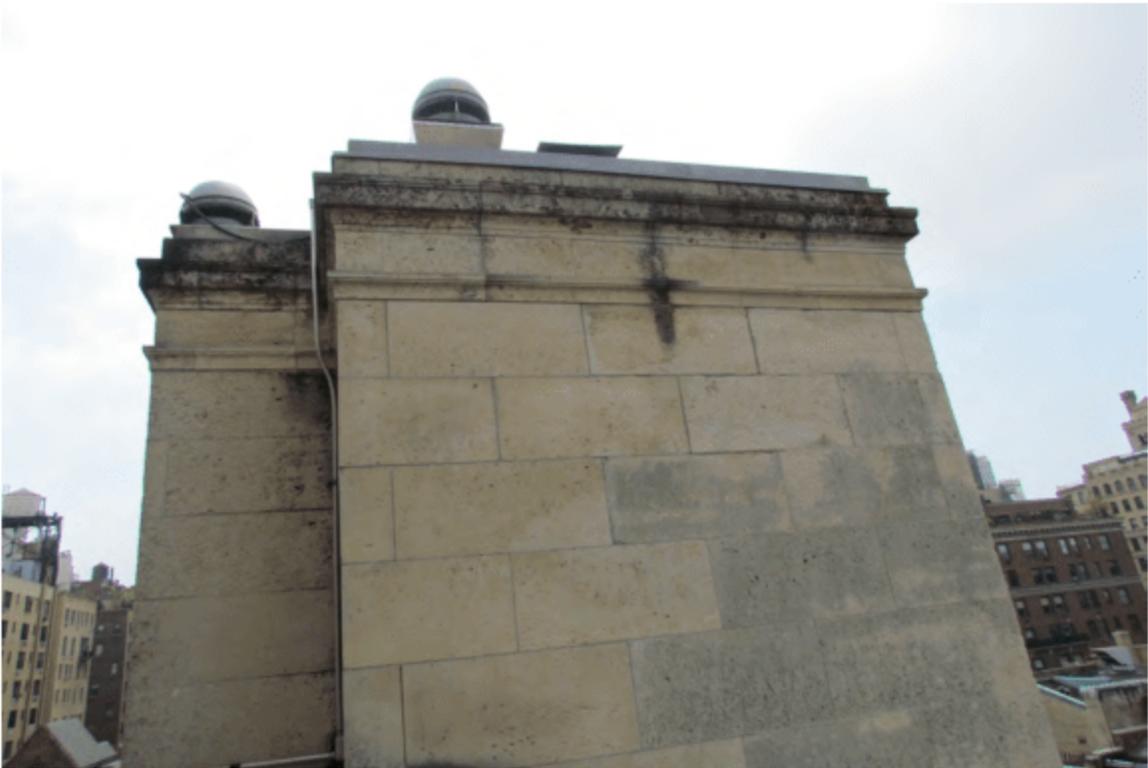
13. West face of southeast chimney.

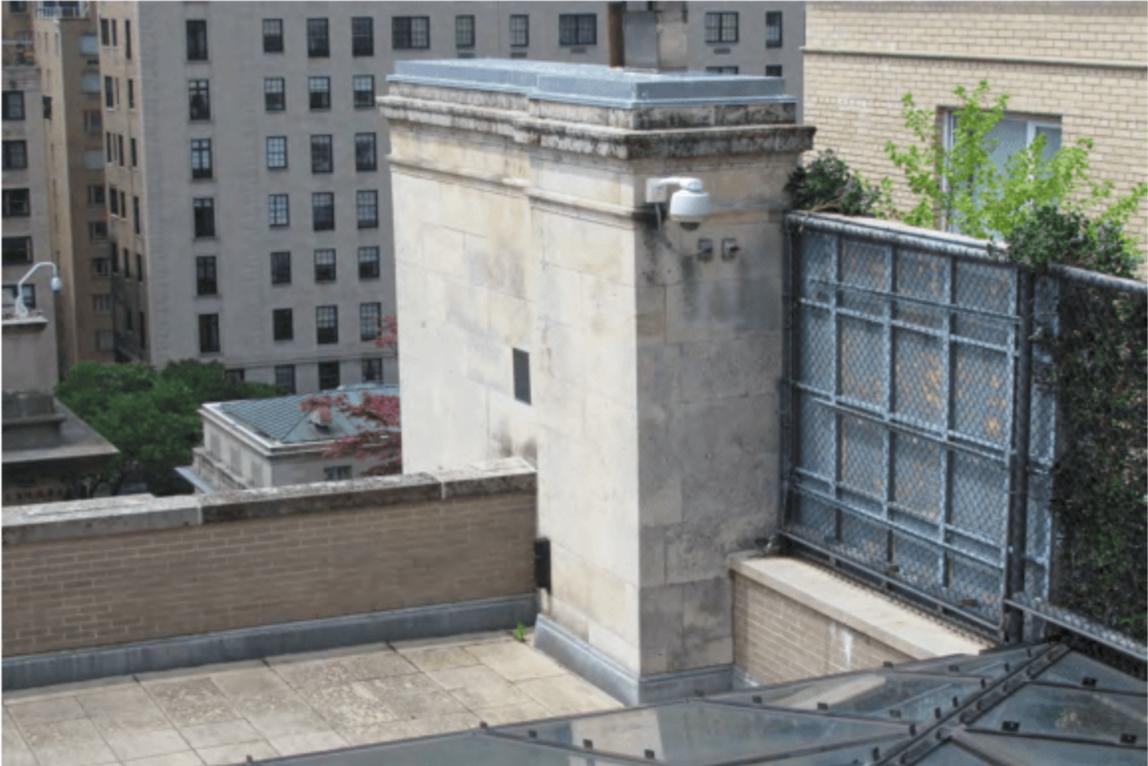
14. South view towards southwest chimney.

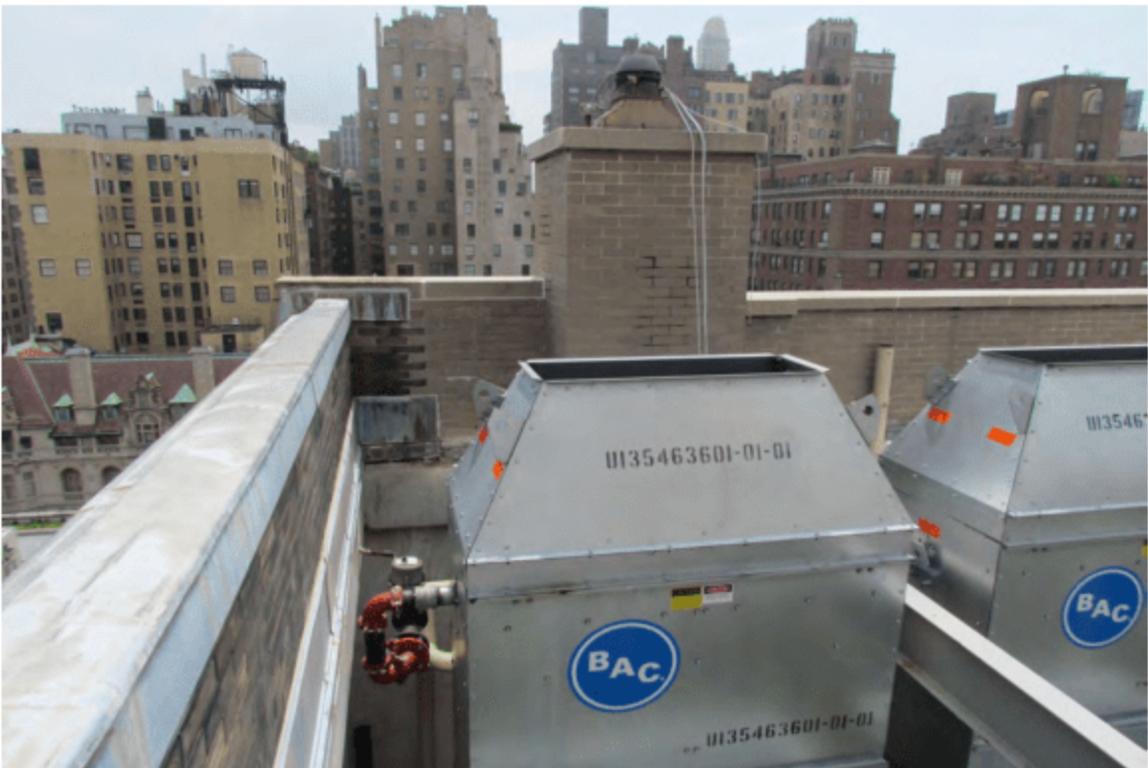
15. Main flue at northeast corner.

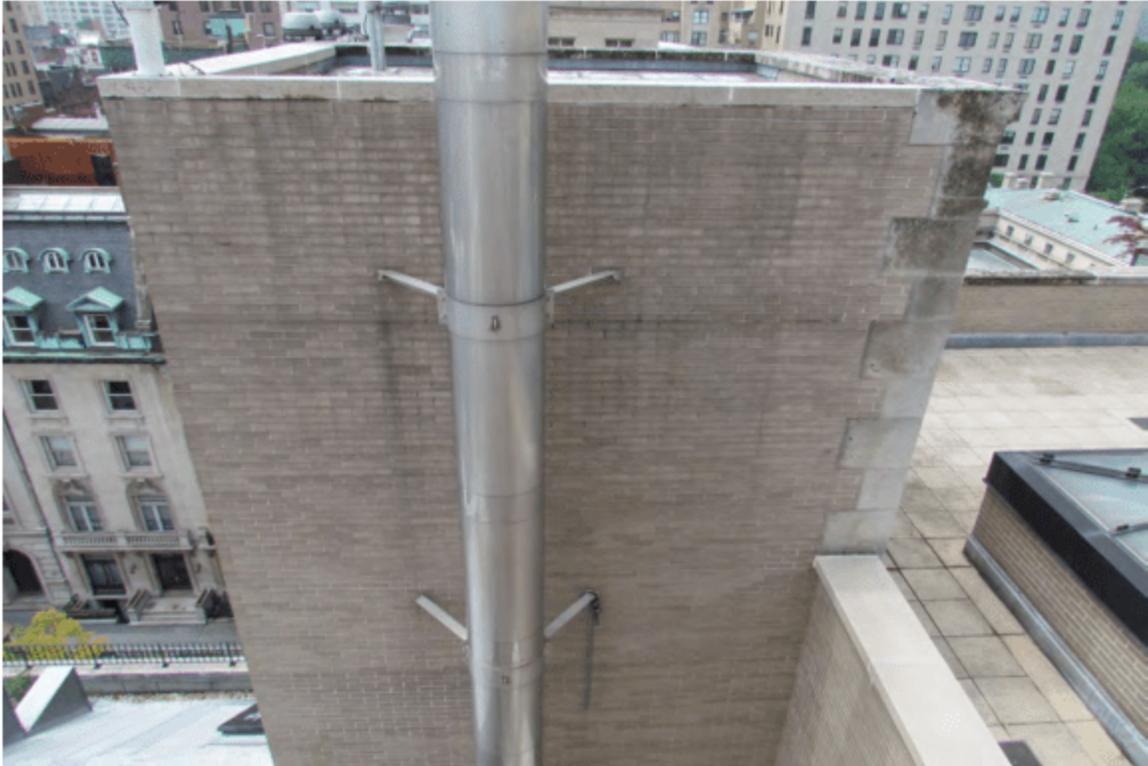
16. North face of elevator bulkhead with metal flue in good condition.

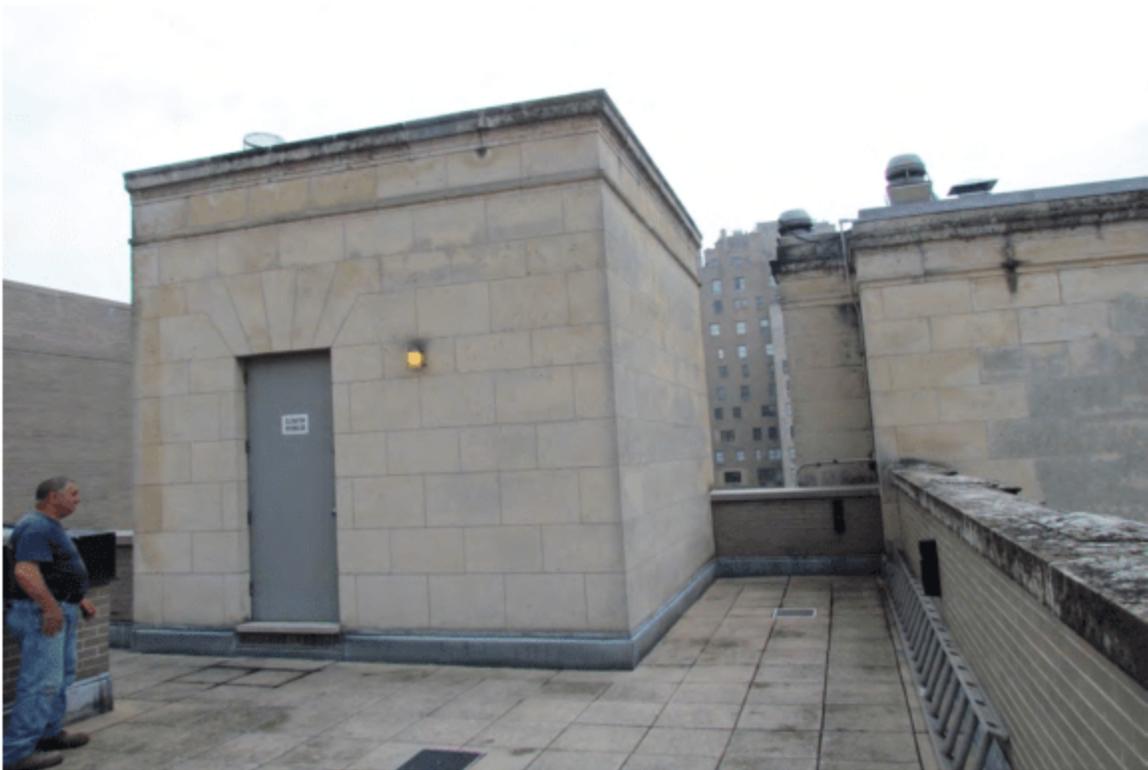
17. Southwest corner of Elevator Bulkhead.
