ASSESSMENT OF IMPACT OF FILL MATERIAL
PLACED OFF THE NORTHWESTERN POINT
OF THE ISLAND OF
LITTLE ST. JAMES

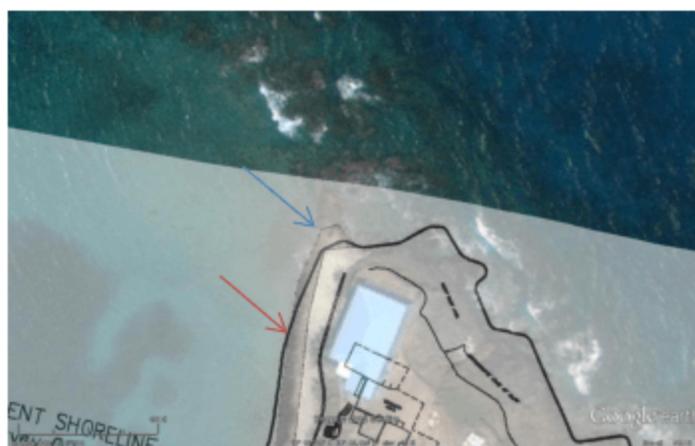
Figure 1. The August 18, 2009 survey conducted by Brian Moseley and Associates overlain the August 18, 2009. The blue arrow represents the 2009 shoreline the red arrow the 2003 shoreline as drawn from a 2003 aerial.

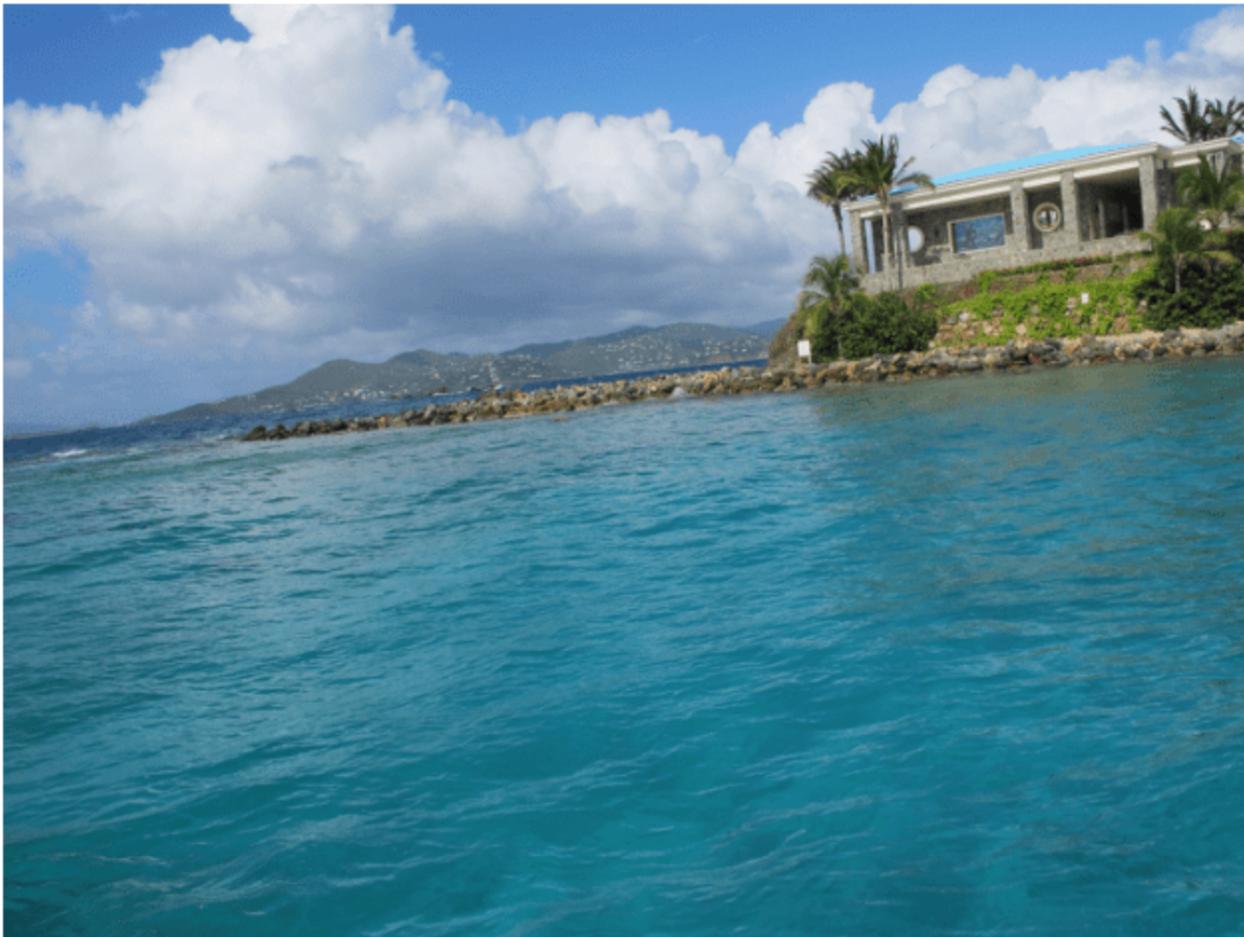
This photograph shows the extent of the fill extending offshore.

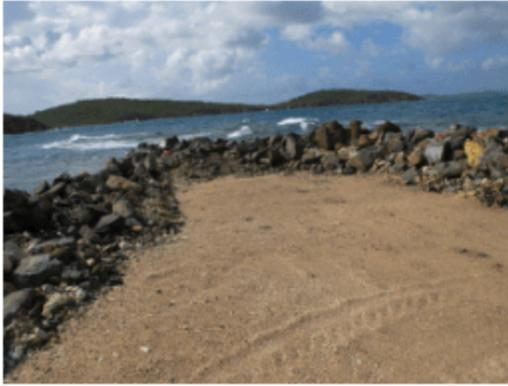
Sandy material extends part way out the created groin, which narrows to an all riprap. The northern slope of the riprap is much steeper than the southern and western slopes.

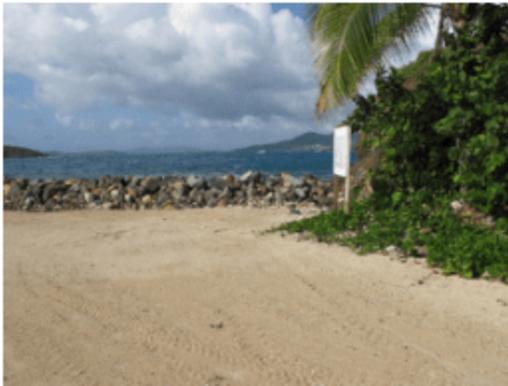
This sign is at the base of the slope and is approximately 10ft. from the base of the building. As shown in the large photograph above, the riprap now extends out 140ft. from the sign. GPS readings were taken with a Garmin Hand Held GPS at the sign and at the outer edge of the emergent riprap.

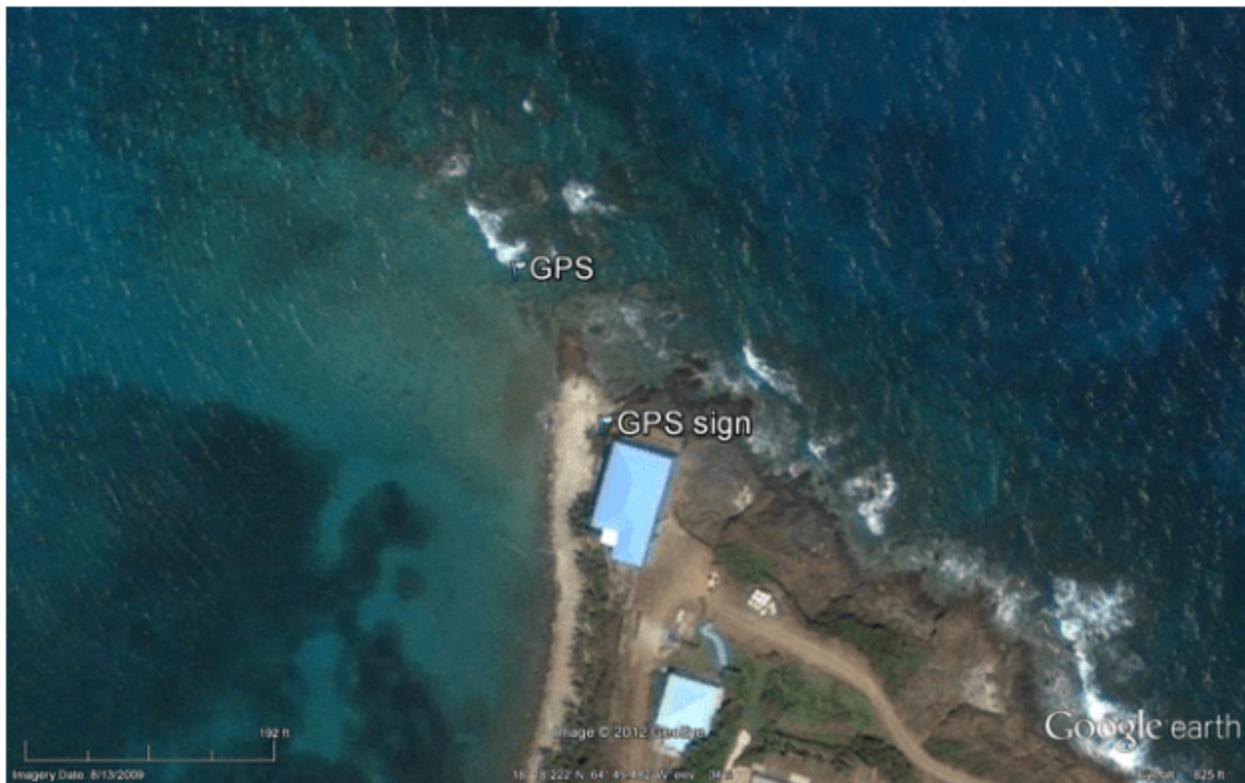
GPS readings taken at the site in May 2012. This places the outer edge of the riprap 80ft. from the 2009 shoreline. Because of the sea conditions and that the steepness of the northern riprap face the width of the groin was not accurately measured.

From the aerial showing the GPS points above it is apparent that additional material has been placed in the sea. It would appear that somewhere between 1000 and 1250 sq. ft. of benthic habitat was directly impacted by the placement of fill. It appears that the fill material impacted very shallow tidally areas out to a depth between 1' and 18" to the south and to the north the impacts go deeper to as much as a depth of 5ft. because of stones falling into the grotto which runs along the point along the point.

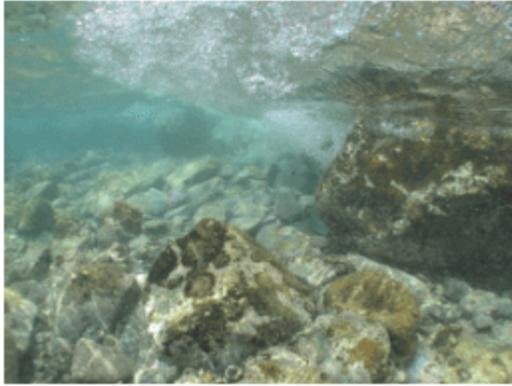
The older material along the areas where the new material was not deposited have encrusting algae and many of the rocks are worn smooth due to movement in the wave.

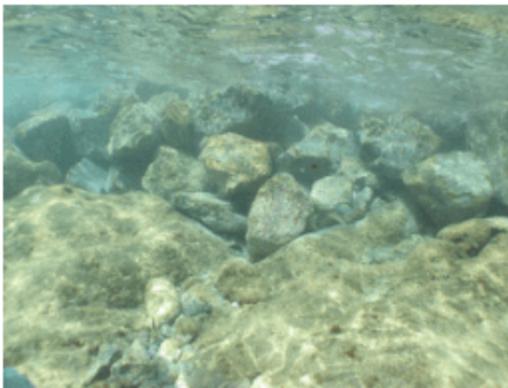
The new material looks very different, and has not yet become as colonized and has sharper edges.

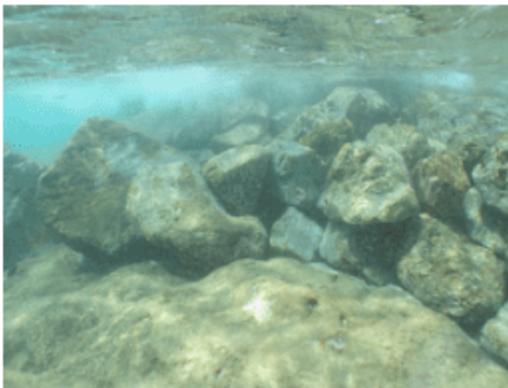
The fill material appears to have been carefully placed rather than dump, which limited the extent of the direct damages.

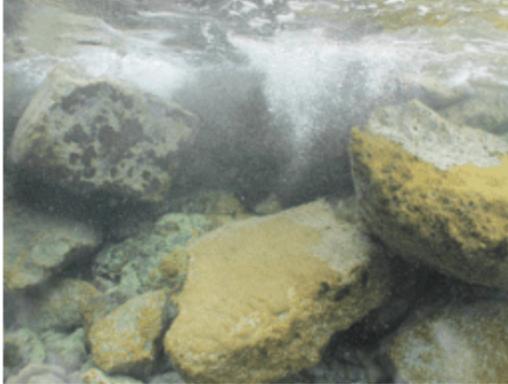
The *Porties* amid the boulder indicating that corals were present in this area of the hard bottom where the rocks and riprap were placed.

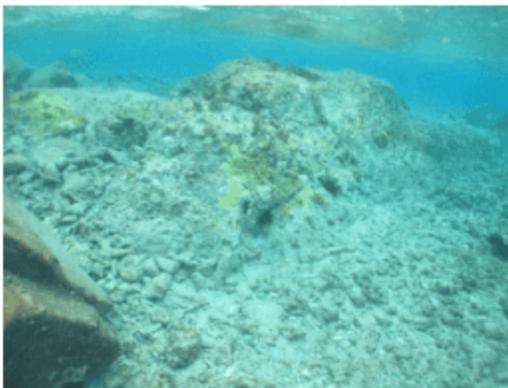
The hard bottom immediately off the end of the new riprap, the last piece of riprap is evident in the left hand corner of the picture. The area has urchins, fire coral and widely scattered corals. This is a good representation of the habitat that existed under the southern portion of the riprap.

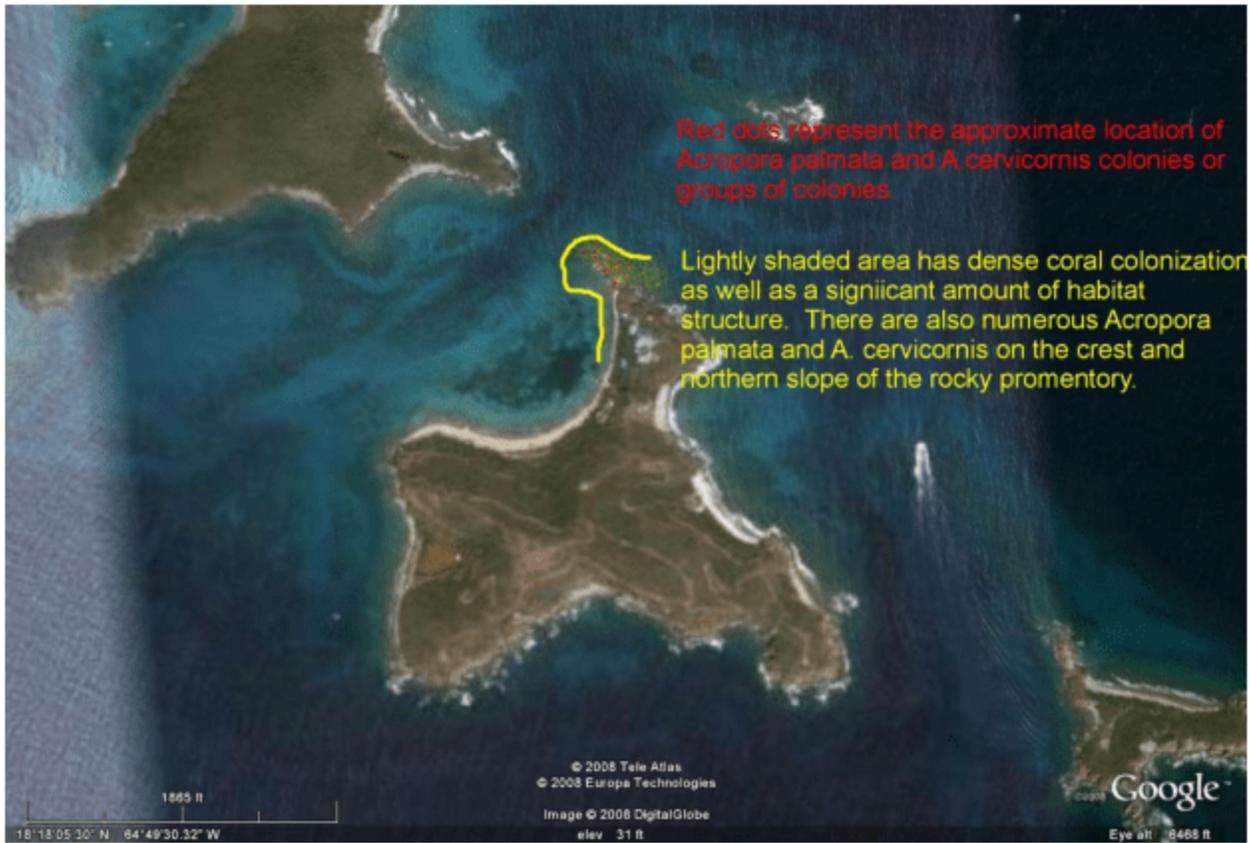
This figure shows the area of habitat as well as the approximate location of the *Acropora* colonies

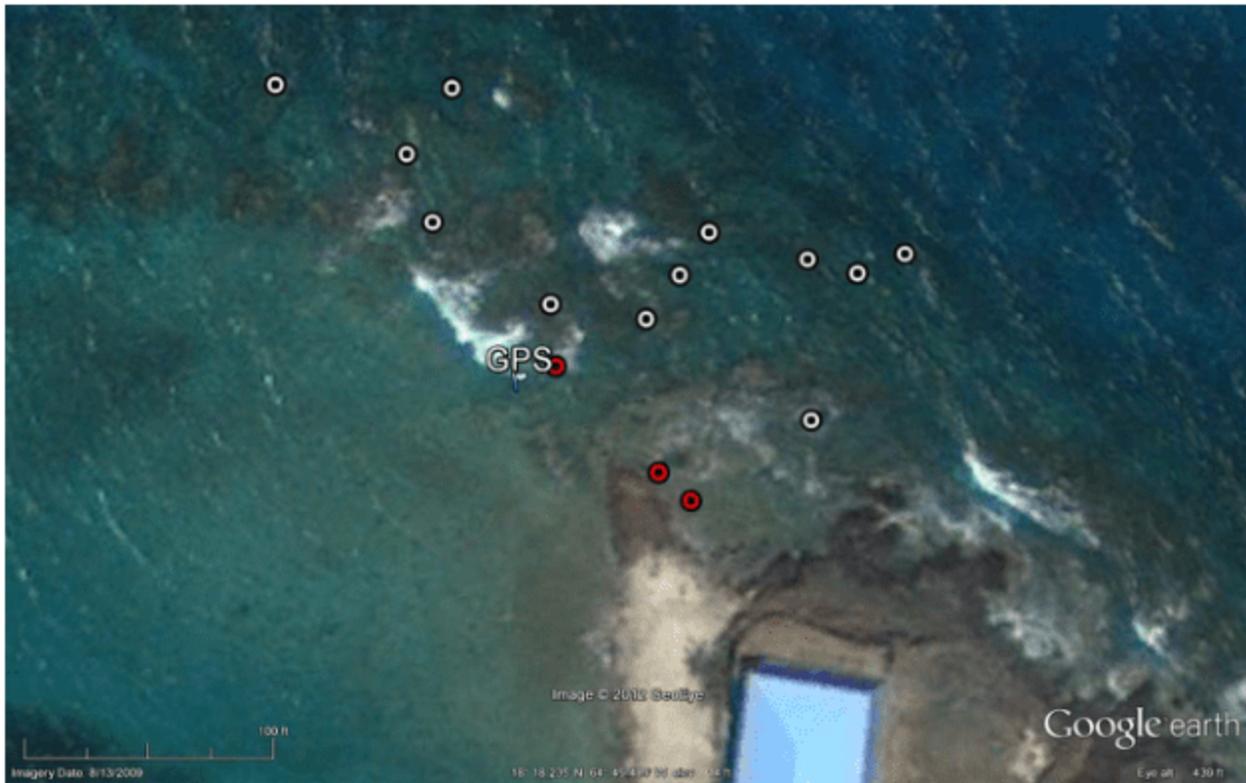
The locations of the *Acropora* overlain the current aerial and are of impact shows that 3 *Acropora* were directly impacted by the filling activity.

The *Acropora* which were impacted by the placement of fill are shown in red.

We would recommend that mitigation be off site, yet in-kind by protecting additional *Acropora* habitat. We recommend the placement of XX public mooring buoys protecting a total of 1250 sq. ft. of coral habitat placed in locations selected by DPNR to protect coral habitat and through the cleanup debris from areas where wrecked vessels have impacted the shallow water environment and the presents of this debris continues to pose a threat to nearby corals as it is moved in the waves. The proposed sites of cleanup are as follows and would protect XXXX sq. ft. of coral habitat.

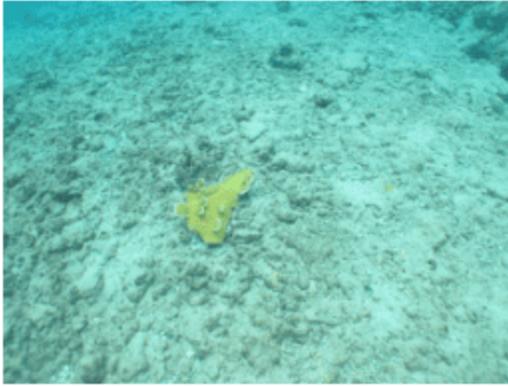
This broken branch of an *Acropora palmata* lies just off the end of the expanded groin. The branch is putting out new branches but is not attached to the seafloor and is subject to movement.

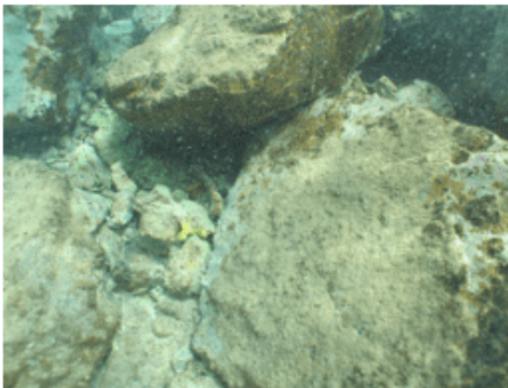
Another broken limb of *Acropora* at the edge of the new riprap, this fragment is not doing as well.

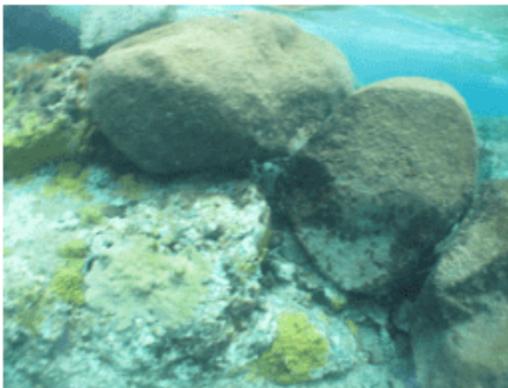
The boulders here are sitting on top of fire coral as well as a *Porites astreoides*.

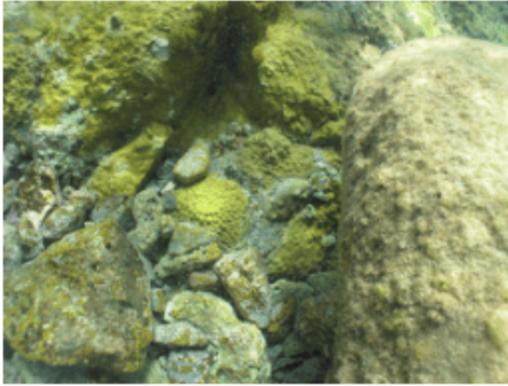
Corals extending out from under boulders and small stones along the northern edge of the groin.
