Little St. James Service Report:

Feb. 24th, 2014

February 18th, 2014 we started the contracted work at Little St. James Island (LSJ) of replacing the entire contents of the SWRO high voltage control panel that had received severe damage following an incident that sprayed high pressure seawater throughout the panel.

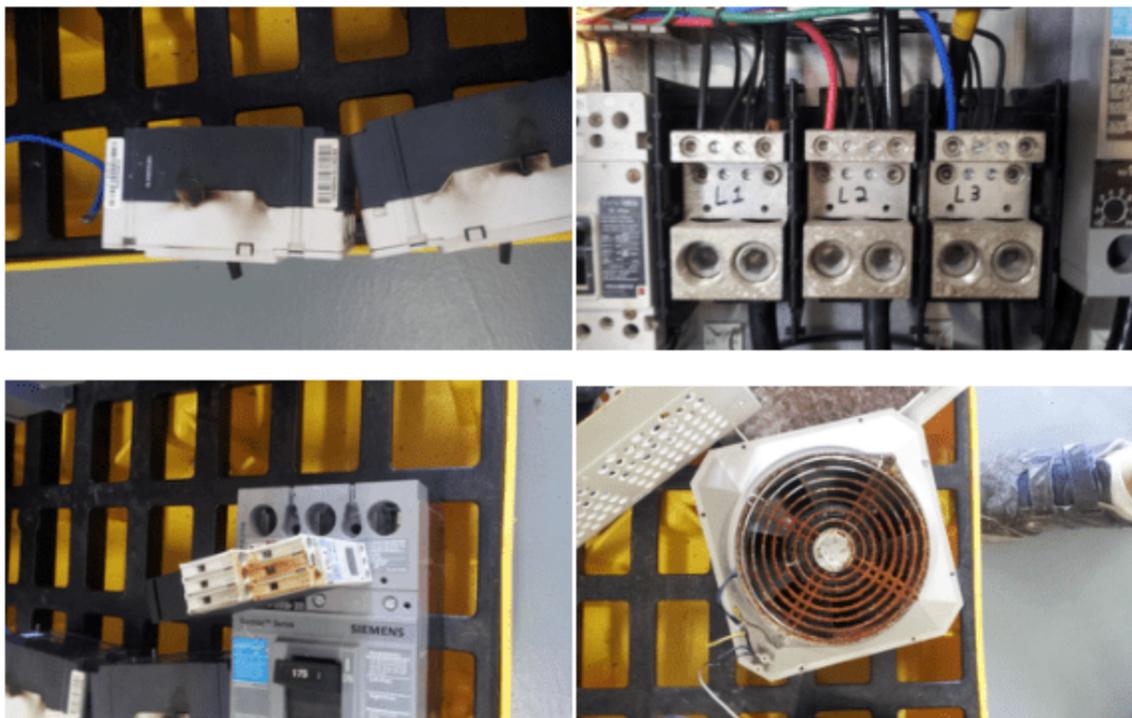
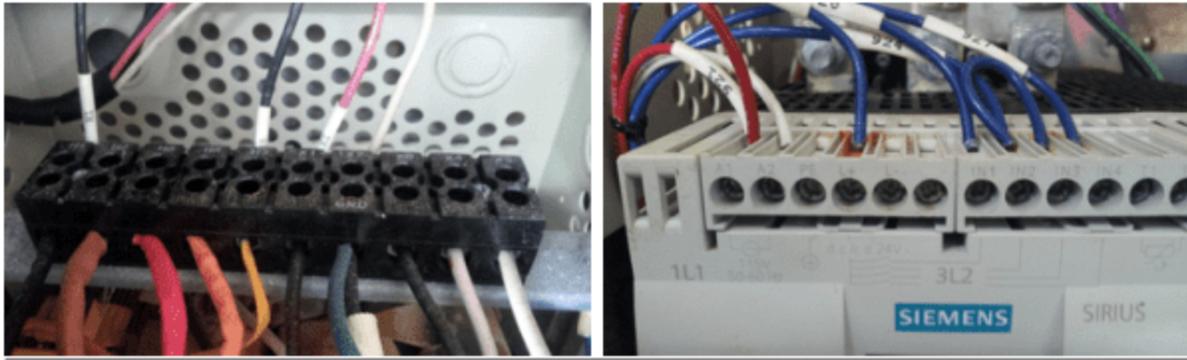
Upon entering the SWRO plant Tuesday 2/18/2014 there had been another pipe burst incident and seawater was all over the floor and on the skid of new replacement parts had been sprayed with seawater too. There were several burst tubing connections due to the SWRO plant being operated manually and allowed to run at 980psi. We checked the contents of the new parts and it was determined that the parts inside the wet cartons were not damaged by this latest incident, so we moved forward with replacing the components of the damaged control panel. Below are photos of the parts removed from the damaged control panel. NOTE: ALL components inside the panel were replaced.

There was a lot of salt and rust on the components inside the panel as noted above. Great care was taken to clean the panel completely before installing any new components. The finished product was a completely new high voltage control panel as is pictured below.

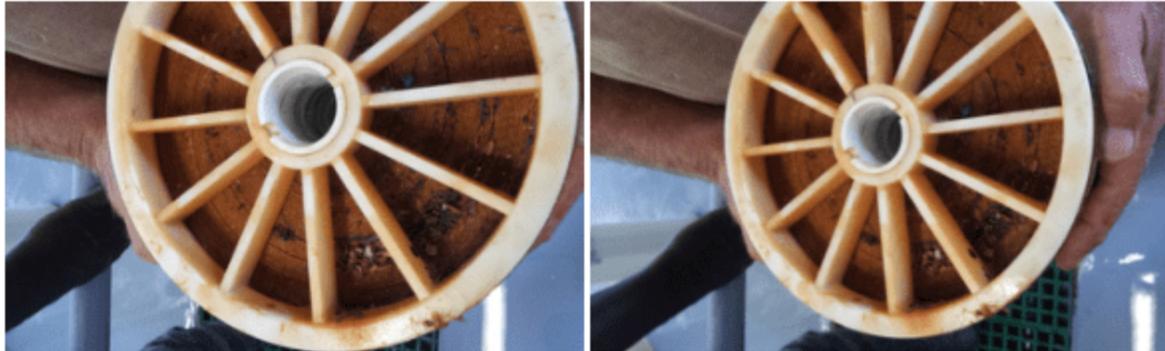
These two membranes show rocks, gravel, dirt, and debris that has passed through the cartridge filters and entered the membrane vessels.

It was determined that the best approach for getting the system back to acceptable operational membrane feed pressures was to replace the two lead membrane elements in all four tubes as they were the most severely fouled. Eight membranes were all that TSG had available, and it is suggested that the other 16 of the 24 total membranes be replaced in the LSJ SWRO plant as soon as is possible to bring the system back to its original design pressure parameters of 780-850 psi membrane feed pressure.

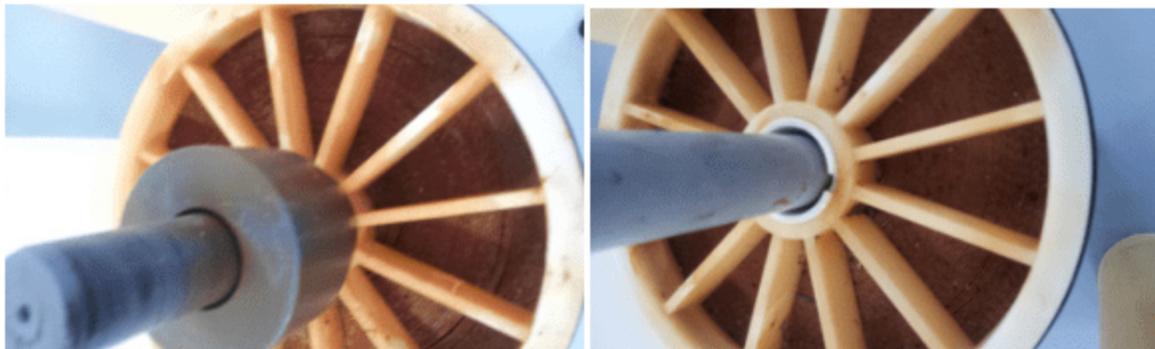
The membranes pictured below show severe fouling due to dirt and rust. The picture left shows mechanical damage noted by gaps in the membrane material

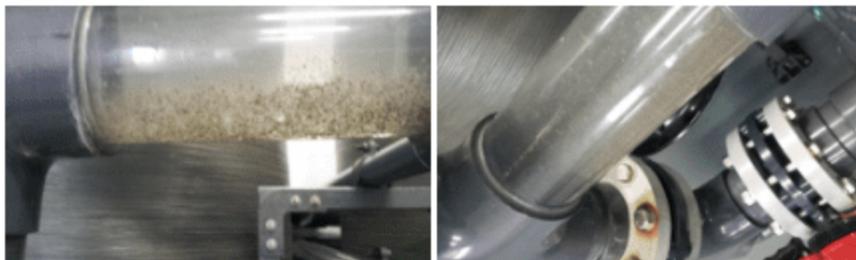
The picture below shows debris left in the Media filters after backwash. Filters backwashed using flow rates too high cause media to be backwashed out of the filter, into the piping and transferred to the Cartridge filters. I explained to Smiley how to watch and balance MMF Backwashing.

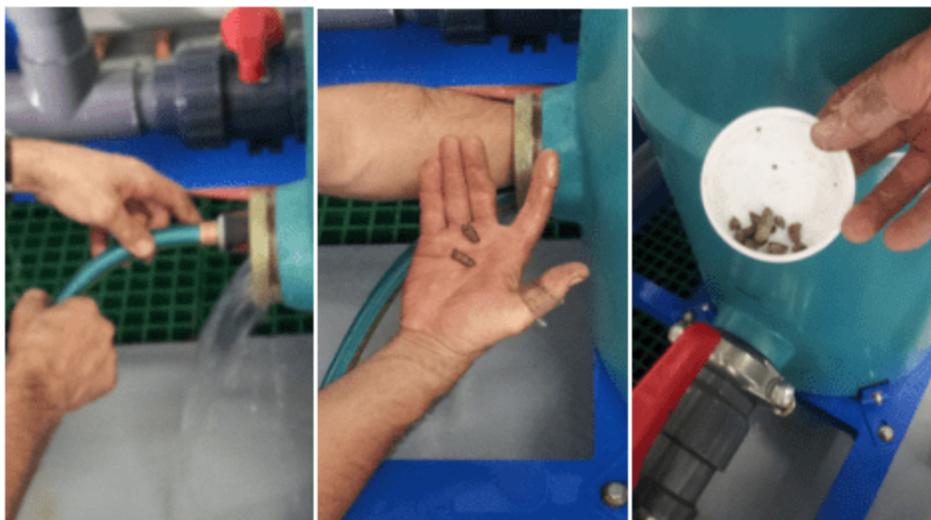
We then focused our attention on the Cartridge Filter Housing. Filters were removed, the spool piece connection was removed and the housing was thoroughly cleaned out. Dirt, sand and rocks were removed from the housing. Pictures are below.

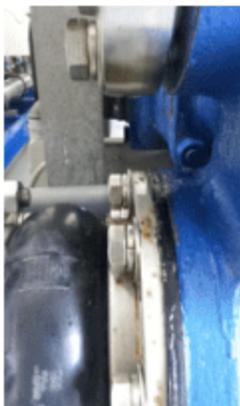
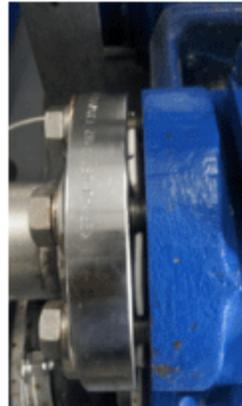
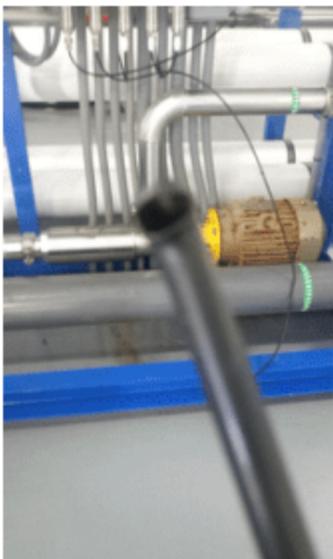
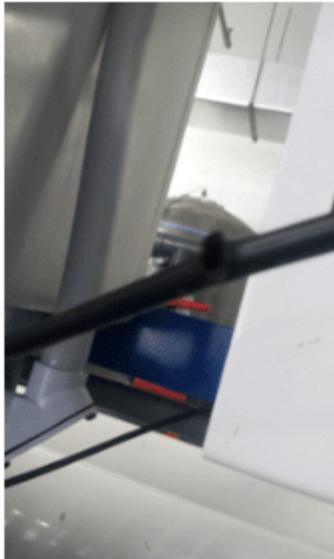
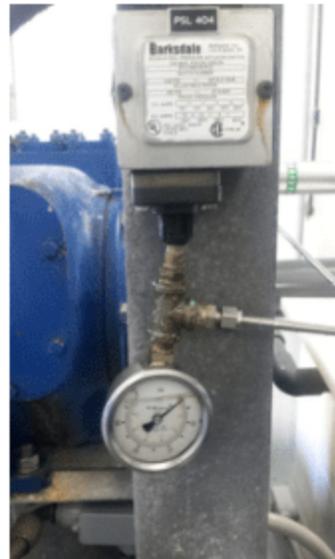
2/20/2014. We arrived with TSG's Virtual Machine Computer. Power was restored to the SWRO plant, electrical connections were checked, and the PLC program was gone through, checked, and tested by our controls engineer in Gainesville, Fl. By mid-morning, we were ready to start the plant only to have issues with low feed water pressure and several more leaks. We had to backwash the MMF's, change out all of the high pressure tubing on the systems instrumentation connections, Repair the HP Pump oil pressure gauge, and replace the high pressure flange gasket on the high pressure pump.

NOTE: There were NO gaskets or fittings onsite, and we had to get a LSJ boat to take one TSG engineer from LSJ Island to Red Hook to pick up parts brought to us by another TSG employee. See pictures below:

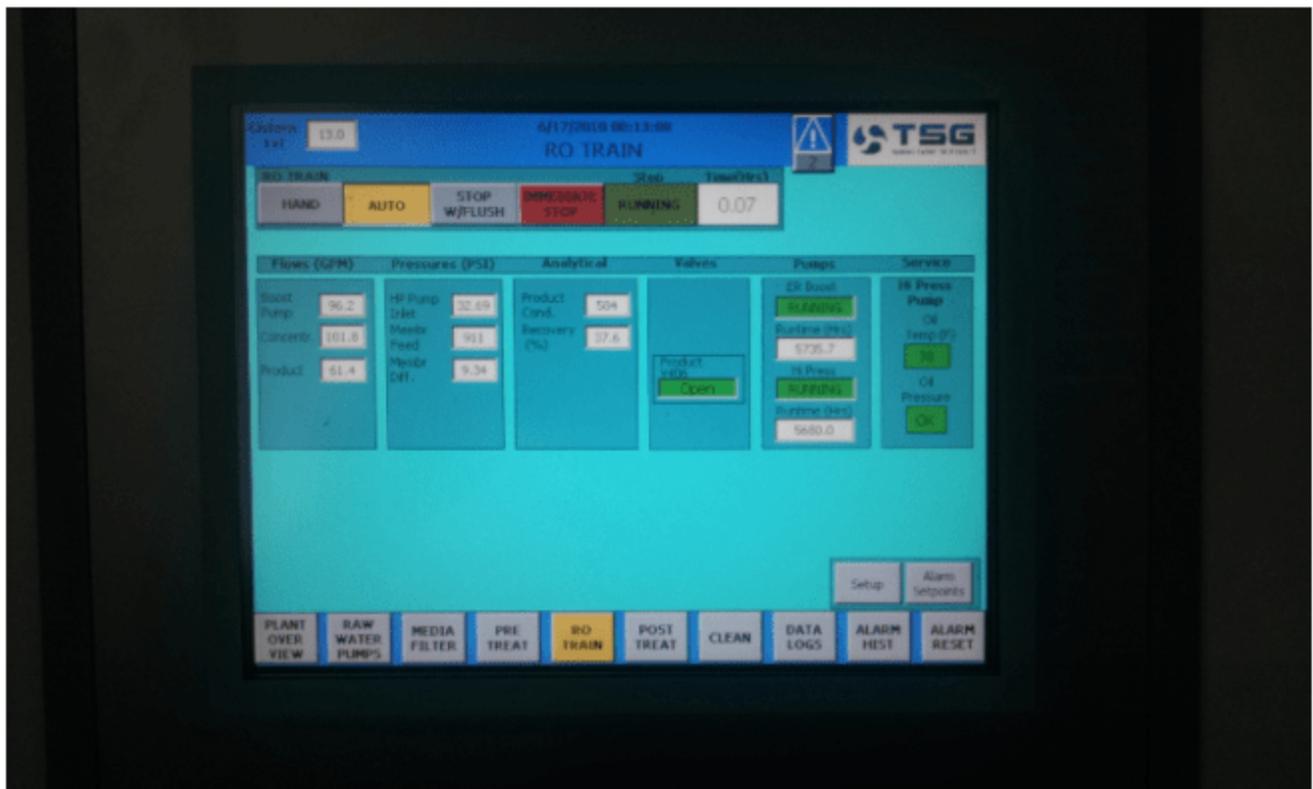
It was noticed during the initial service run that the Membrane Feed Pressure was still higher than normal and shows that there has been irreversible damage done to more of the membranes than was initially replaced. We were able to get the pressures down to just above 900 PSI after increasing the SWRO plants brine discharge and Boost Pump flow. The screen shot below shows run parameters.

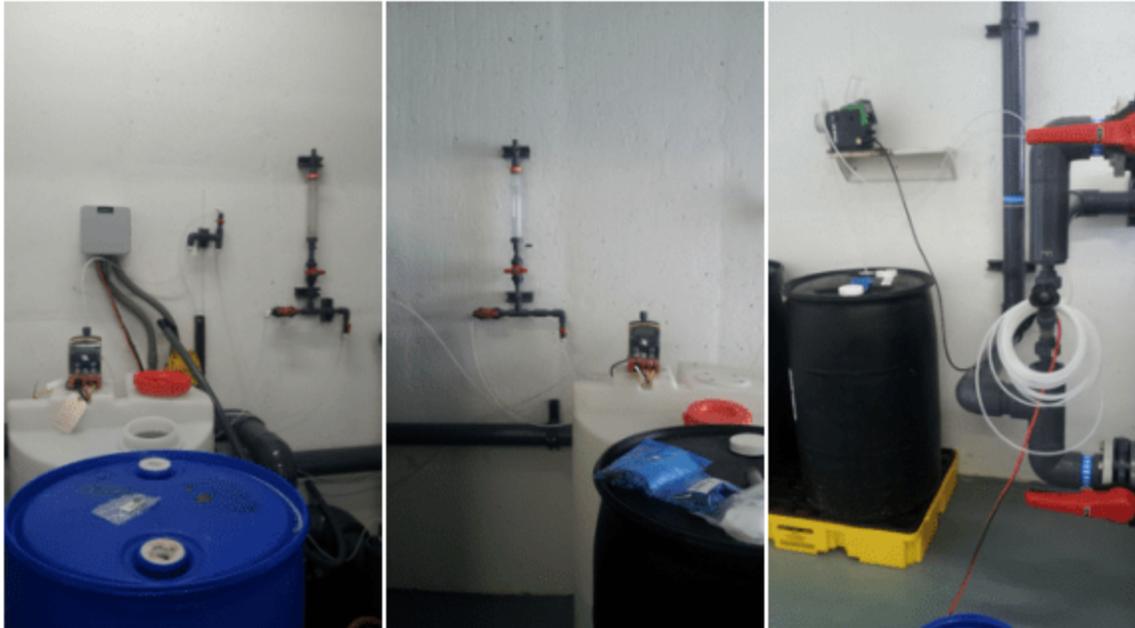
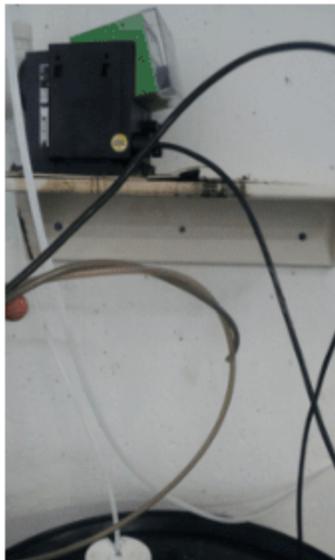
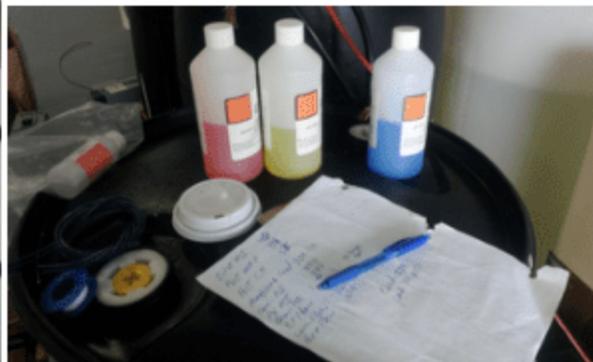
We then set about the task of calibrating instrumentation, batching pre-treatment chemicals, replacing the tubing on the Sulfuric Acid Chemical feed pump, priming and adjusting all chemical feed pumps using the chemical calibration columns that were provided to LSJ during the initial installation and commissioning of the SWRO Plant. Pictures are below.
