## Little St. James Service Report:

Feb. 22<sup>th</sup>, 2015

On February 12 and 13, TSG technical staff traveled to the island to perform a service on the LSJ 90 K RO plant's high pressure positive displacement pump. The high pressure pump is somewhat similar to a car engine in that it contains 5 cylinders, 10 valves and 5 plungers (pistons in a car engine) that allow filtered sea water to enter the pump on the low pressure side at about 40 psi and leave the pump on the high pressure side at 800-900 psi to force the seawater through the membranes and achieve salt separation and desalination. It is composed of two stainless steel sides, a "power end" that transmits the motive power from the electric motor to the crankshaft and a "fluid end" that allows the water to be pressurized via valves and plungers. Unlike air, water is incompressible and a positive displacement pump will raise the water pressure to the high pressures needed for desalination. Because of the corrosive nature of seawater and the high pressures involved, regular service of this equipment is vital.

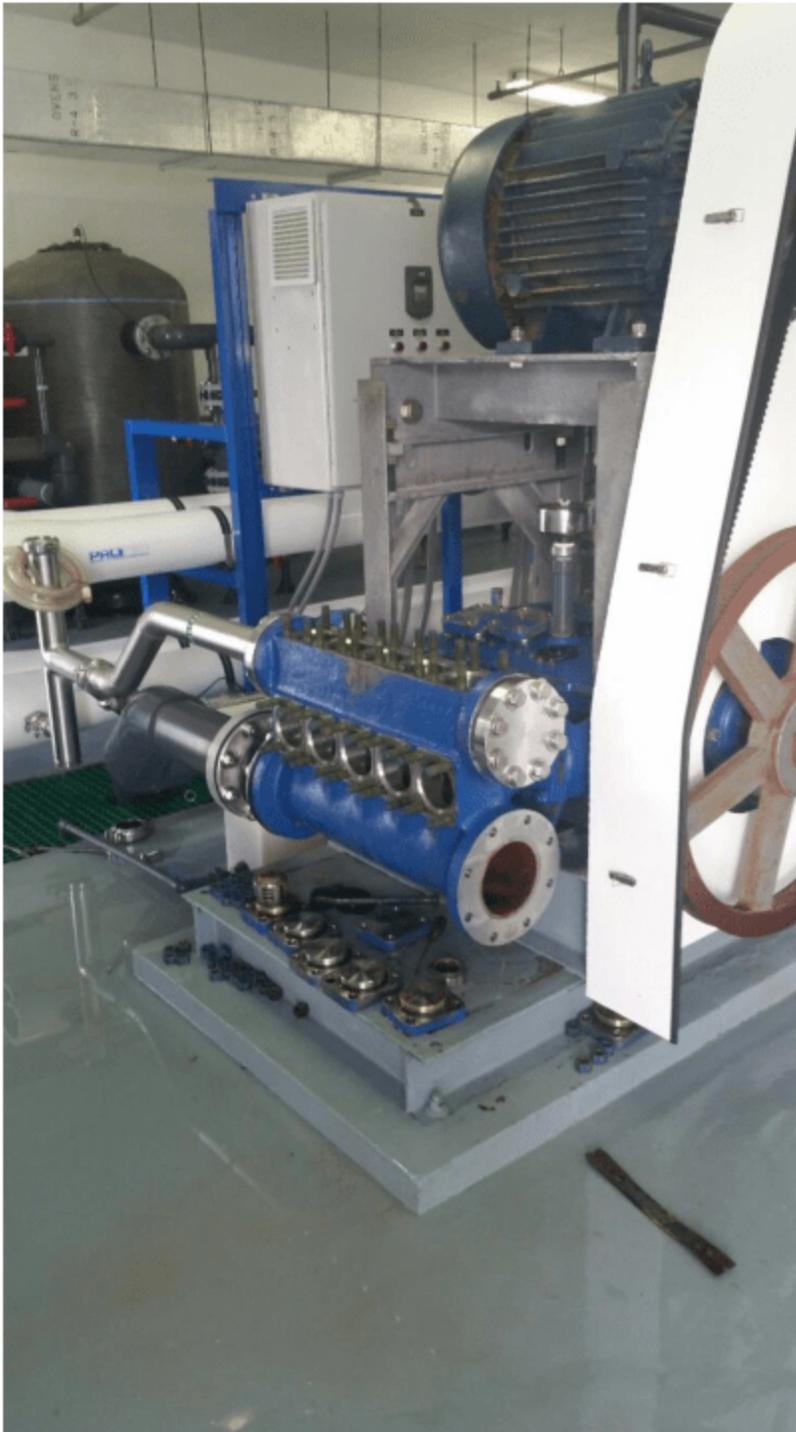
*Figure 1- Disassembled Fluid end of high pressure pump, power end is directly beneath the electric motor.*

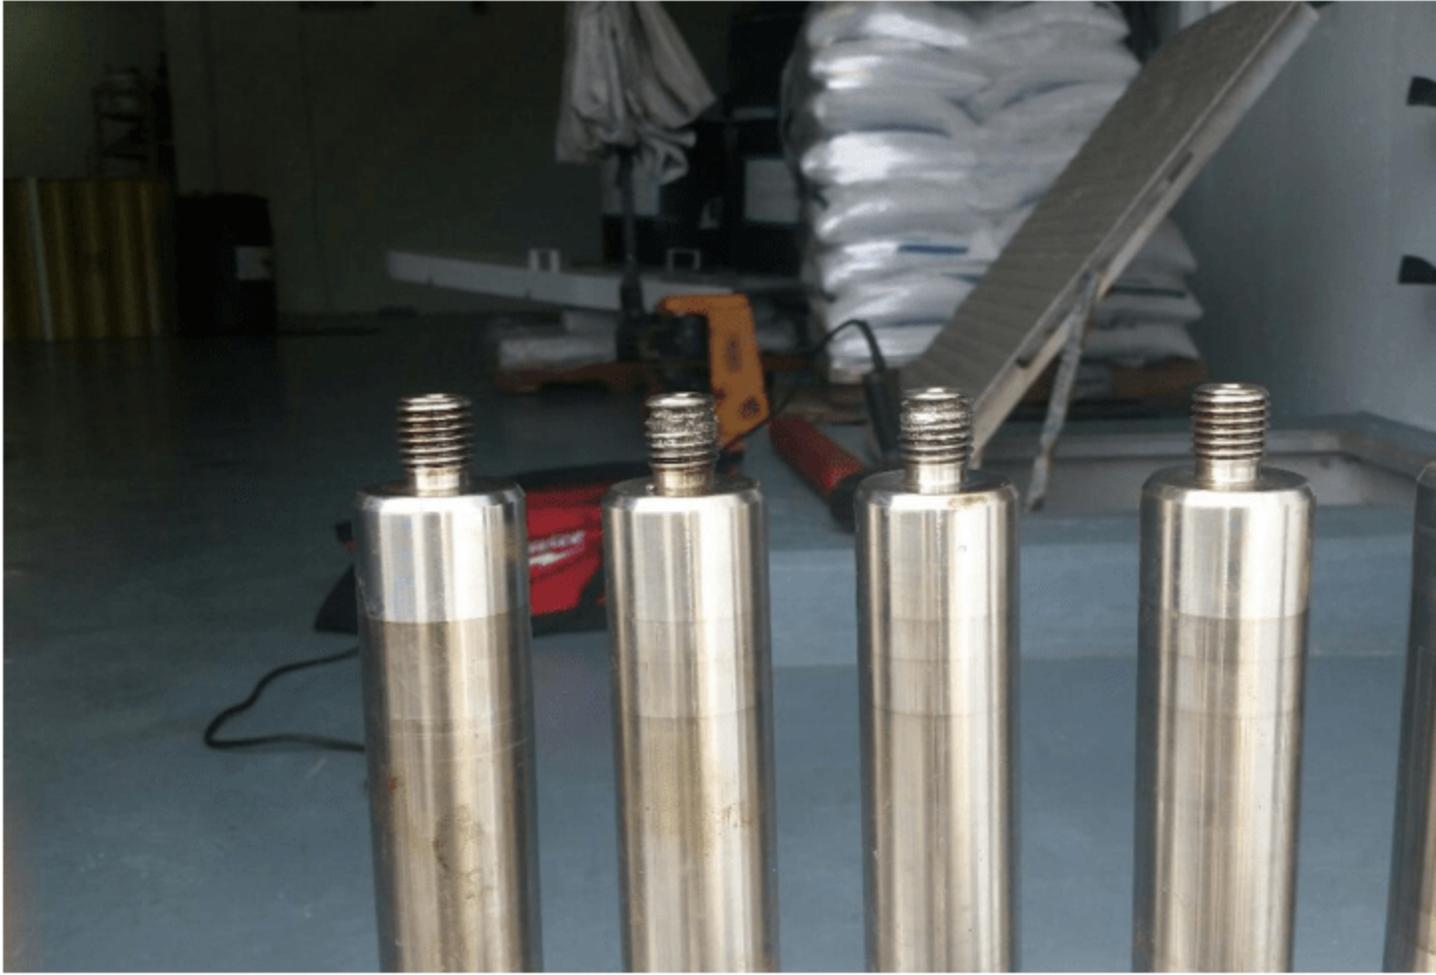
Task 2-Upon disassembly of the fluid end to check the plungers, it was discovered that one of the plungers had broken loose from the corresponding power end cross head and was not moving at all. Its threaded portion had broken off in the crosshead and the broken plunger had

been impacting the cross head for an undetermined duration. Two more plungers were discovered to have damaged threads, due to having come loose. Of the five plungers and cross heads, three had sustained damage. It took the better part of a day to remove the broken piece of the plunger from the crosshead. It was necessary to return a second day with a tap to chase the damaged threads in the three power end casing cross heads. It should be noted that the power end crosshead-plunger interface on three of the five crossheads have been compromised and should be carefully monitored to ensure that they remain tight or future damage will occur.

*Figure 2- Removal of Five plungers showing thread damage and broken threaded end*

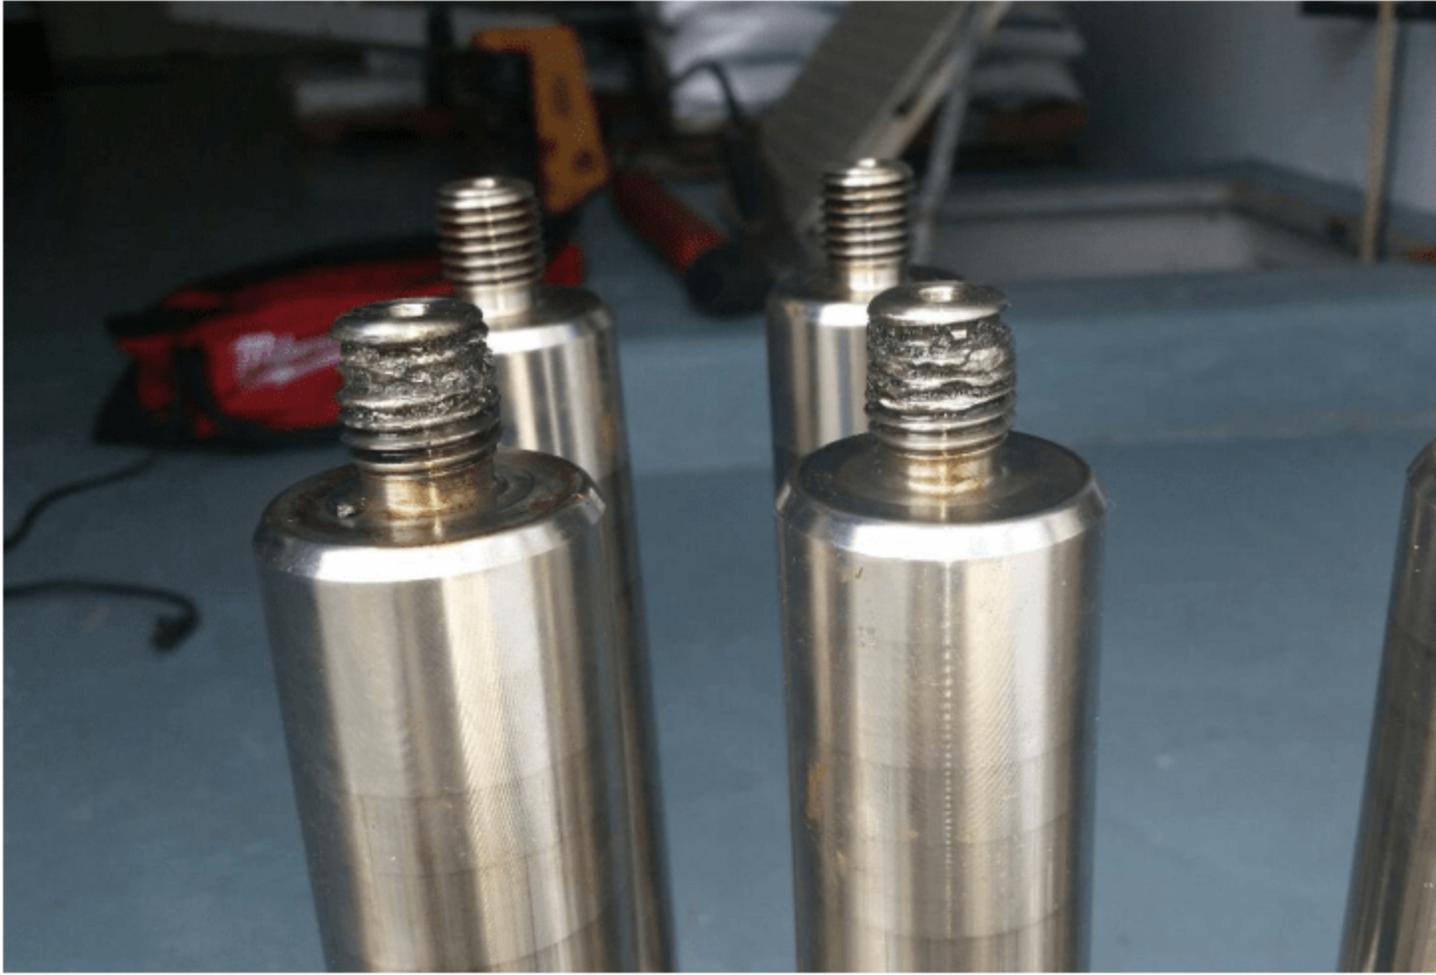
*Figure 3- Close up of plunger thread damage and broken end*

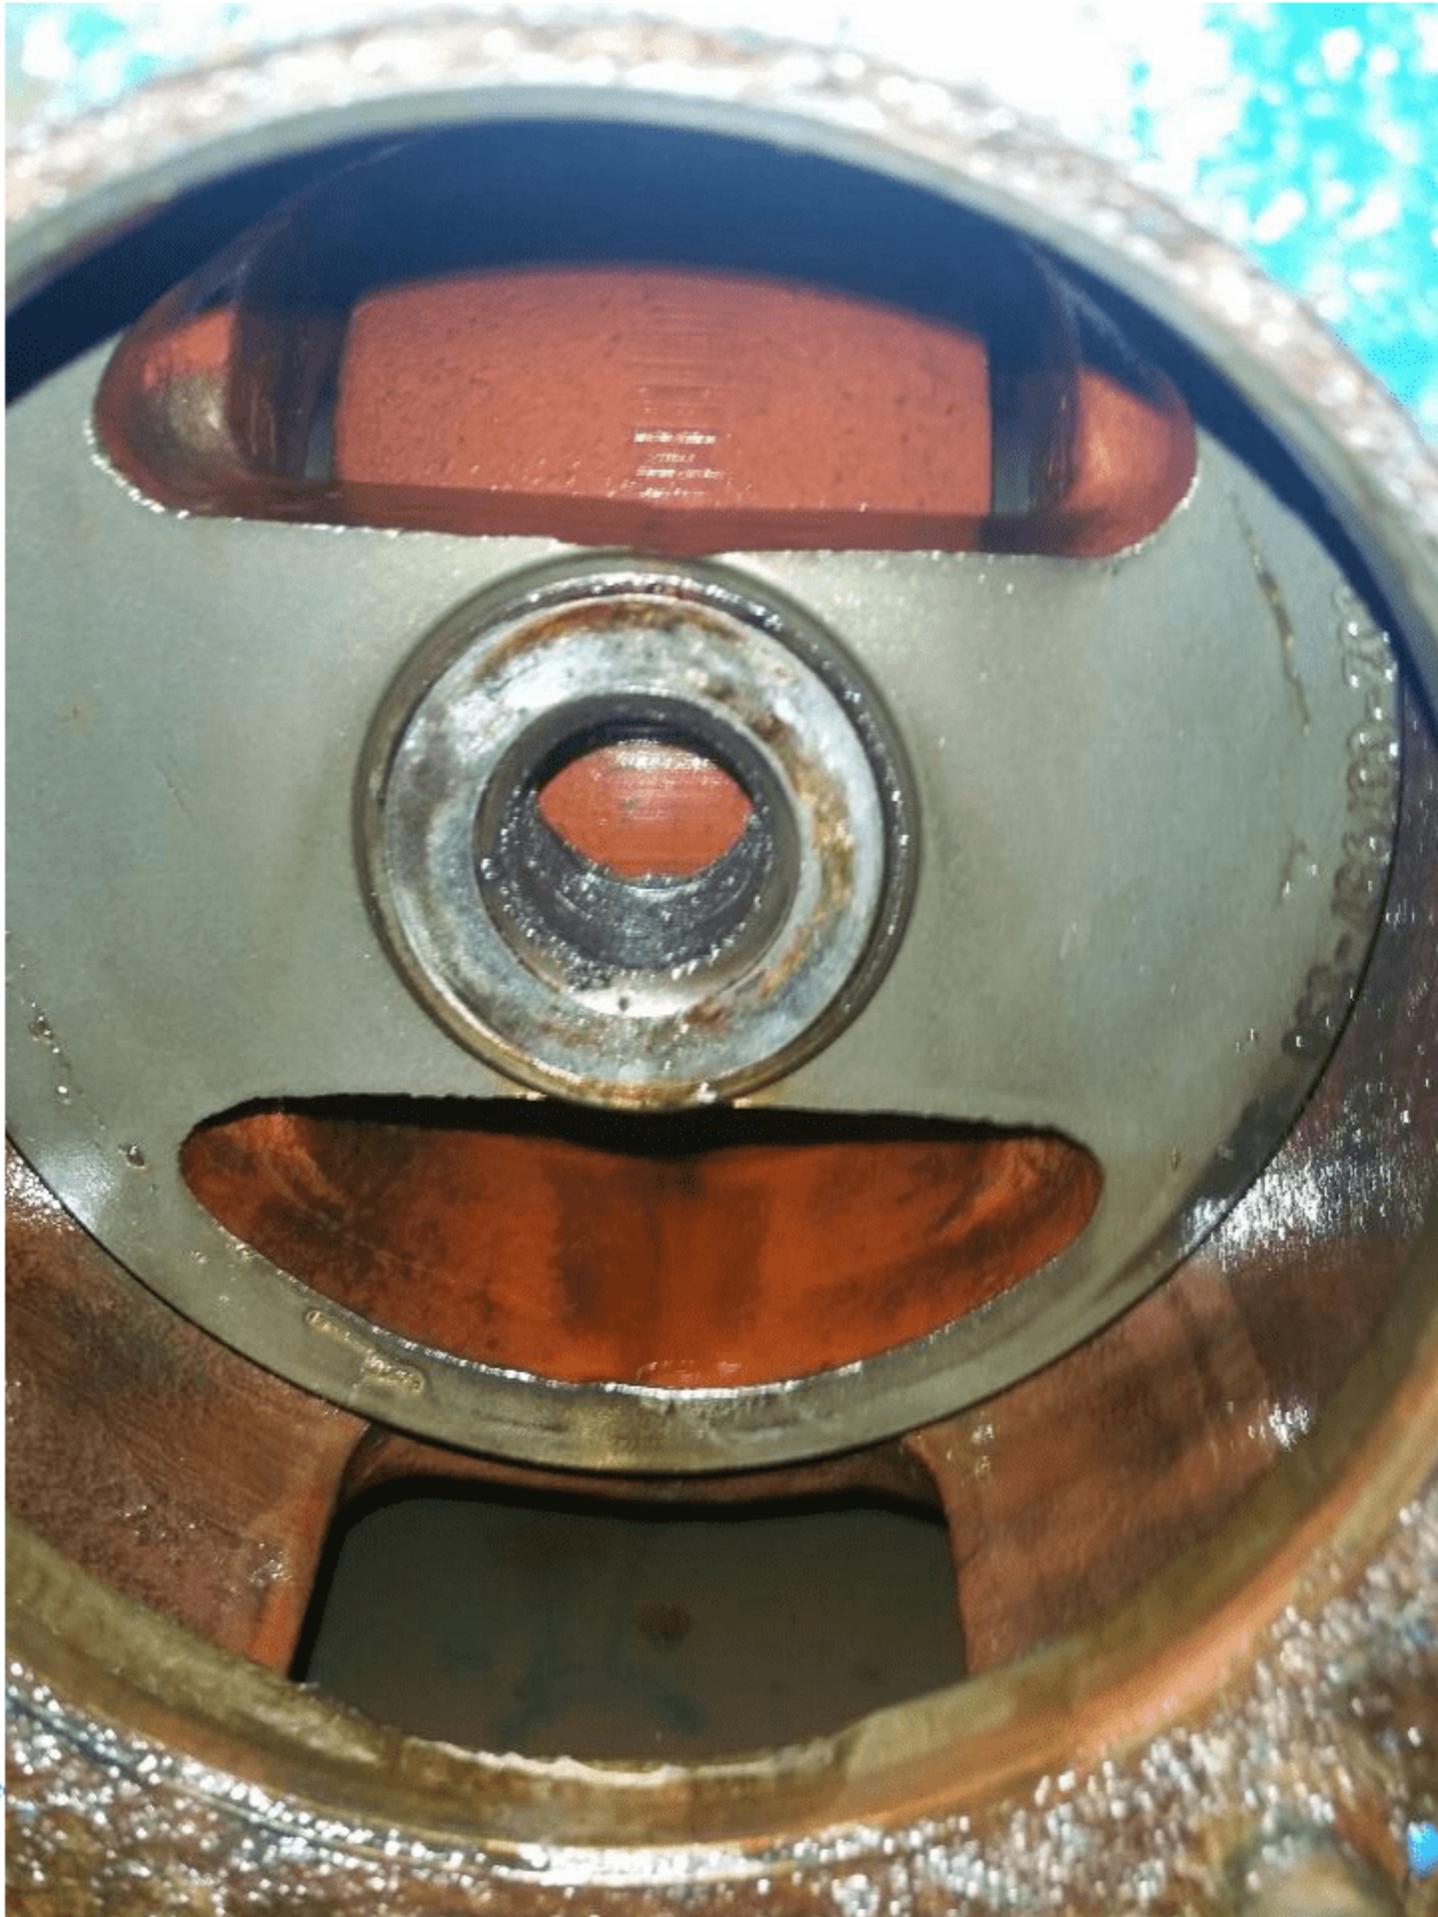
*Figure 4- Close up of Crosshead thread damage*

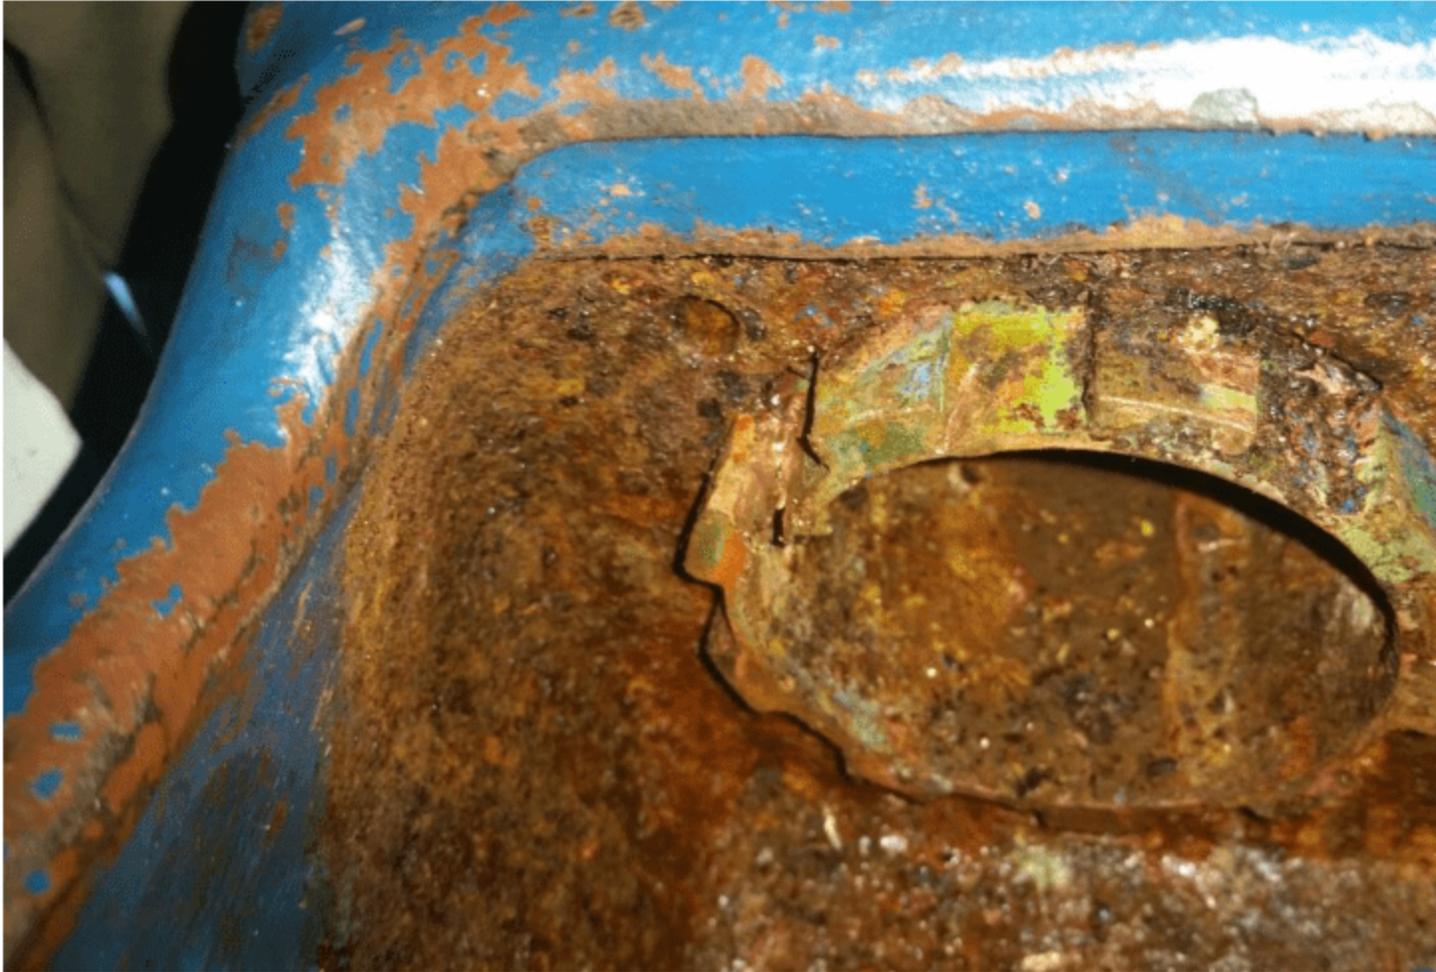
The gland nuts that hold the packings into the fluid end were severely corroded and completely fused into the fluid end and were not able to be removed, nor were the packings changed out.

*Figure 5- Fused Gland nut in Fluid End*

TSG recommends that funds be budgeted to replace the entire stainless steel fluid end assembly of the high pressure pump with stainless steel body, new plungers, gland nuts, packings, etc. This is a costly item with a lead time of 12-18 months. Price available upon request. Another option to consider is to replace the Wheatley pump & motor entire with an axial piston pump/motor manufactured by Danfoss. This technology direct couples the motor to the pump, uses no drive belt, no oil and needs no adjustment. The pump is lubricated by the water itself. Price available upon request.

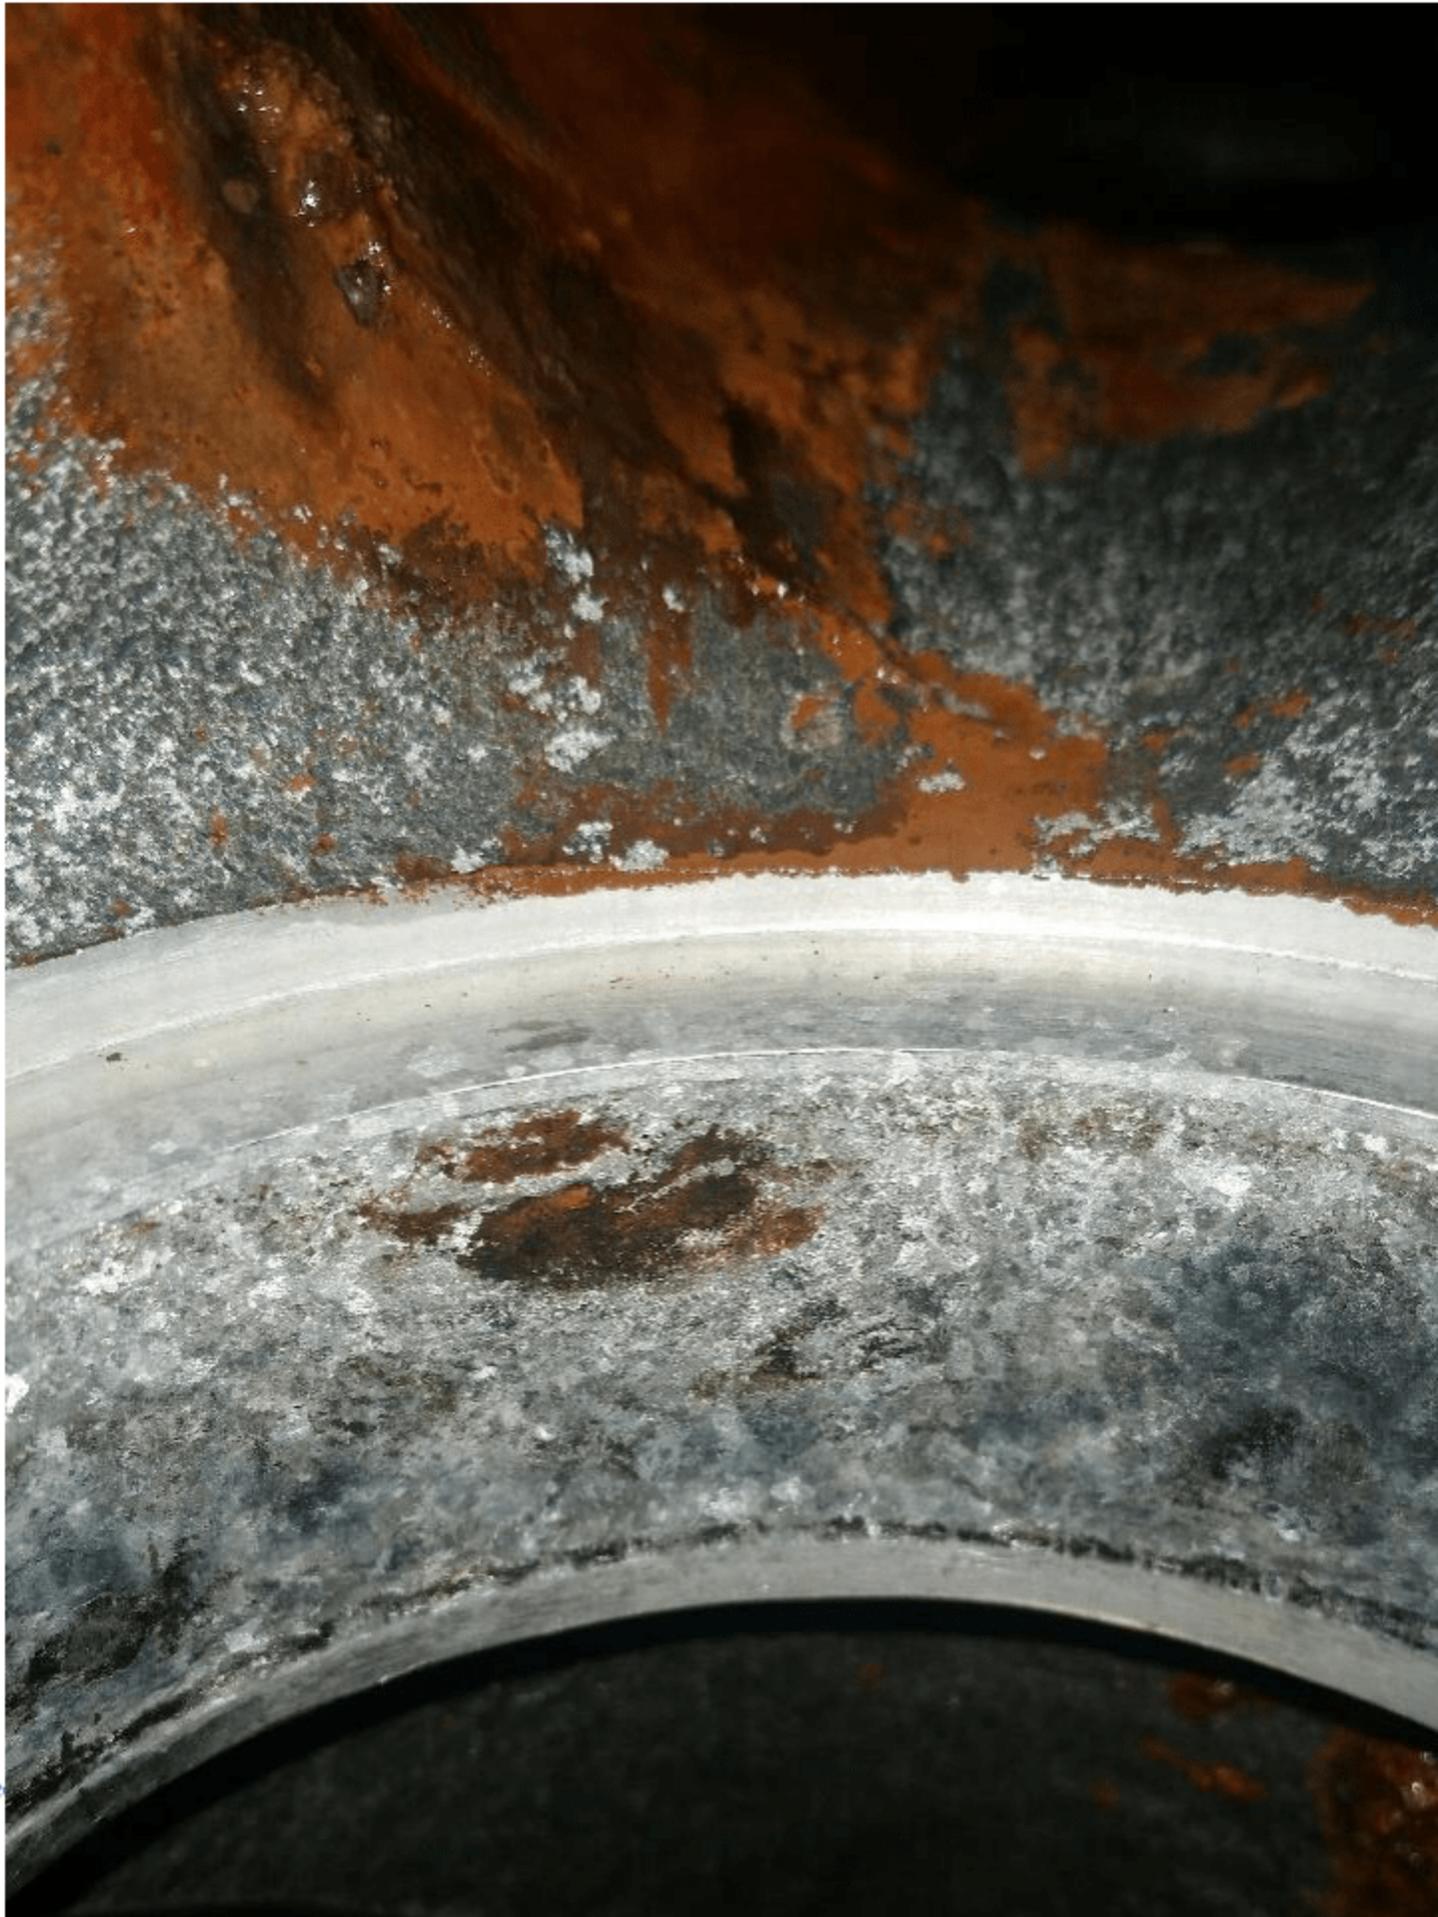
Task 3- Advanced pitting was observed in the valve recesses of the fluid end, which has compromised the valves' ability to seat and seal during each pump revolution and accounts for the pulsation observed on the analog pressure monitoring gauge. This pulsation is caused by high pressure escaping from around the compromised and pitted valve recesses into the pressure side of the pump. All ten of the spherical valves were replaced as seven out of the ten original valves showed advanced corrosion. Five valves had to be supplied from TSG inventory to complete this task. The pulsation condition is unfavorable and prompt attention by replacement of the fluid end assembly.

*Figure 6- Pitted valve recess in Fluid end*

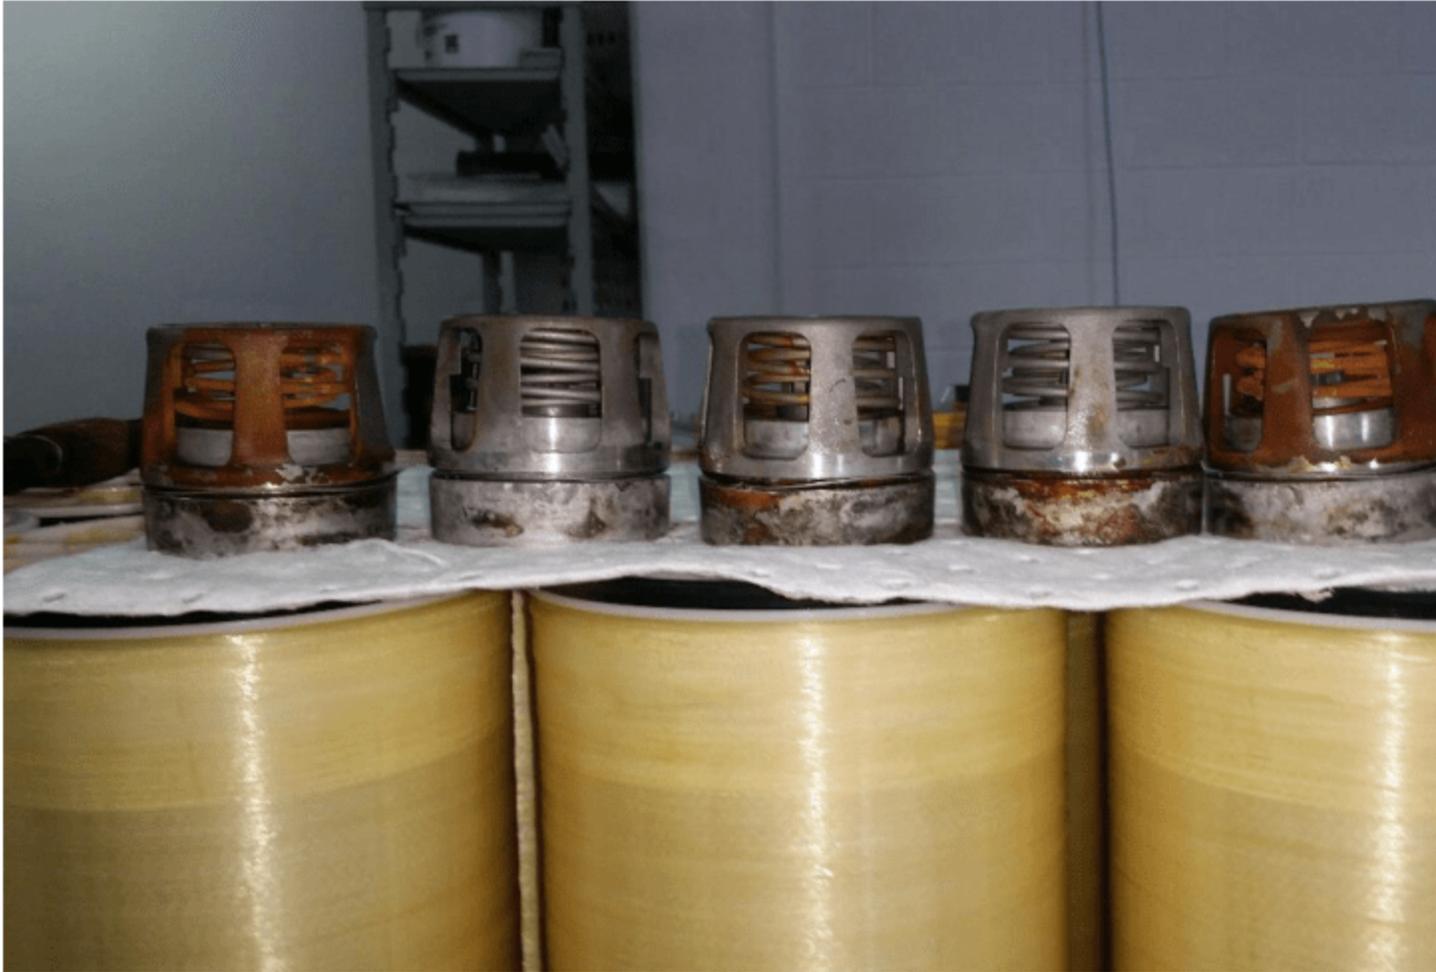
*Figure 7- Condition of valves in Fluid end- all were replaced*

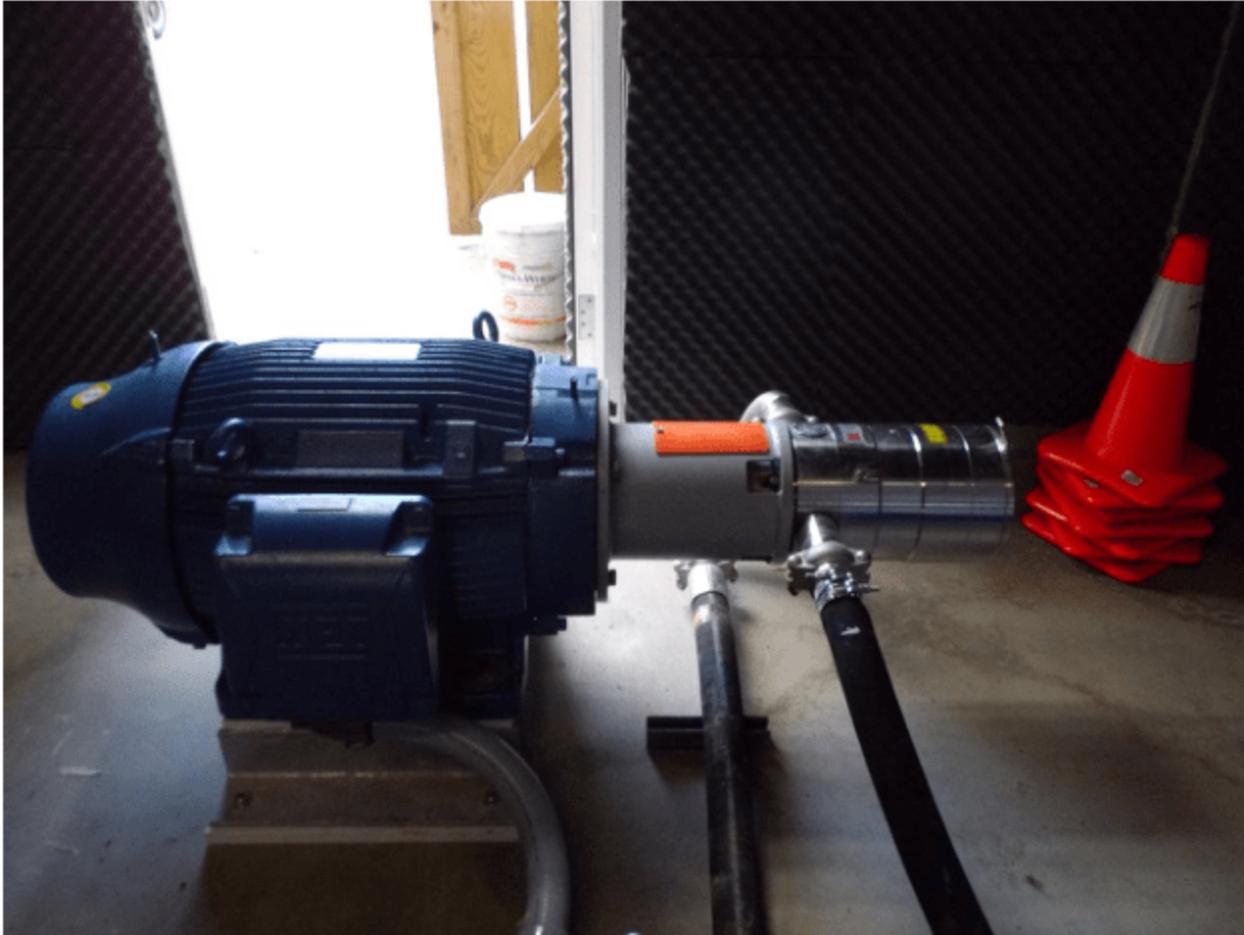
*Figure 8- Danfoss Axial Piston Pump/Motor installed by TSG at Frenchman's Cove*
