October 2, 2013

**Gulfstream IV, Serial No. 1085, Registration No. N212JE**

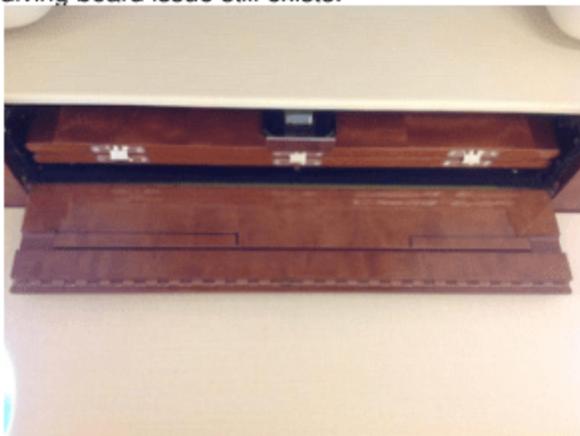
**Tables-**

JE noted difficulty in the deployment / stowing of the side ledge tables in flight (trim / adjust). Extend the amount of material routed out in the table lids(see photo) to allow easier access for passengers and paint as existing. Table arms need to be supported after deployment so that there is no space to allow for "spring board" type action. Clear rubber/Felt micro pads for tray tables halves, when stowing table the two wood surfaces meet. VIP tray tables still rattles. When tray tables are open, the mechanism that holds table top firm rests on fabric side panel, it was discussed to fabricate Titanium or stainless steel (waterfall decorative type of cap to this area would allow the tray table to rest on this surface firming table top, diving board issue still exists.
