CONDITION AND VALUATION SURVEY REPORT

M.V. SEA EAGLE

January 28, 2014
File No. 01281-S-14

SURVEY REPORT

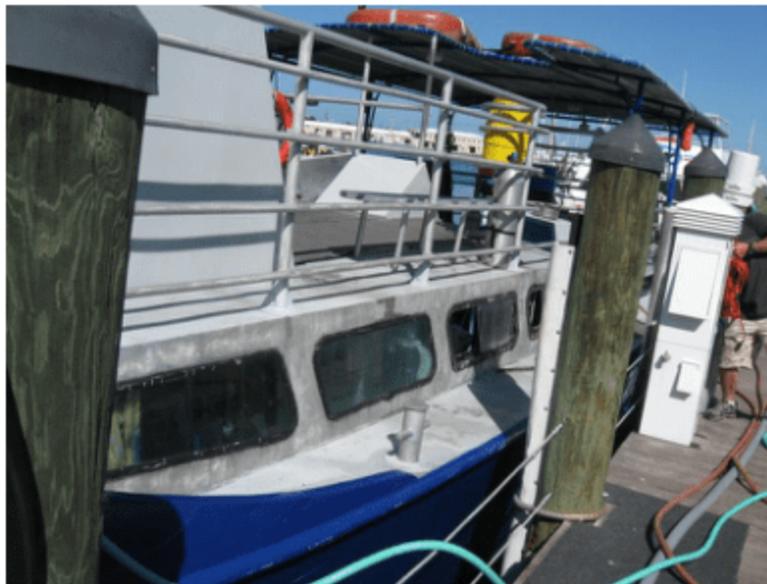
COSMETIC/ COATING REQUIREMENTS

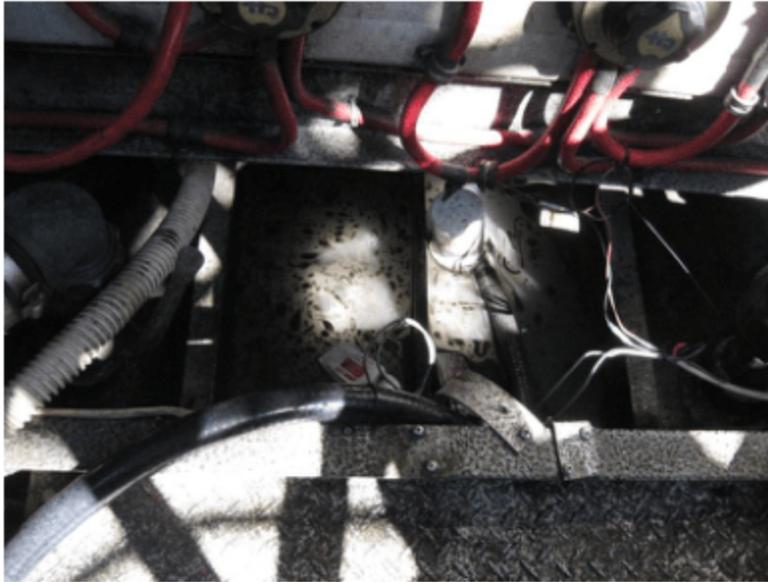
OILS IN BILGE/REMOVE

1. Protect port side battery cables from chafe-see photo.
2. Clean engine room bilge and provided new oil zorbant materials in bilge.
3. Clean battery tops.
4. Clean stbd engine inboard air intake-see photo.
5. Replace inboard stbd engine exhaust riser insulating material-see photo.
6. Cleans stbd engine inboard air intake box.

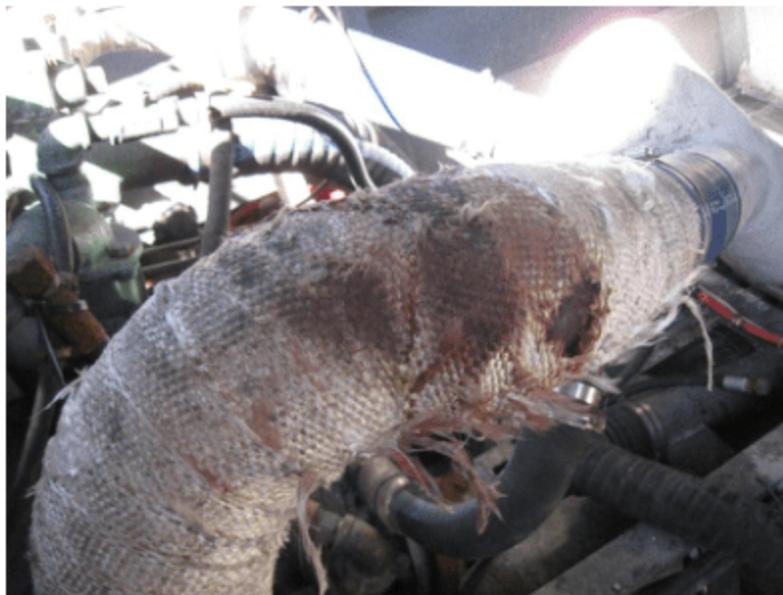
STBD INBOARD RISER-REPLACE INSULATING MATERIAL

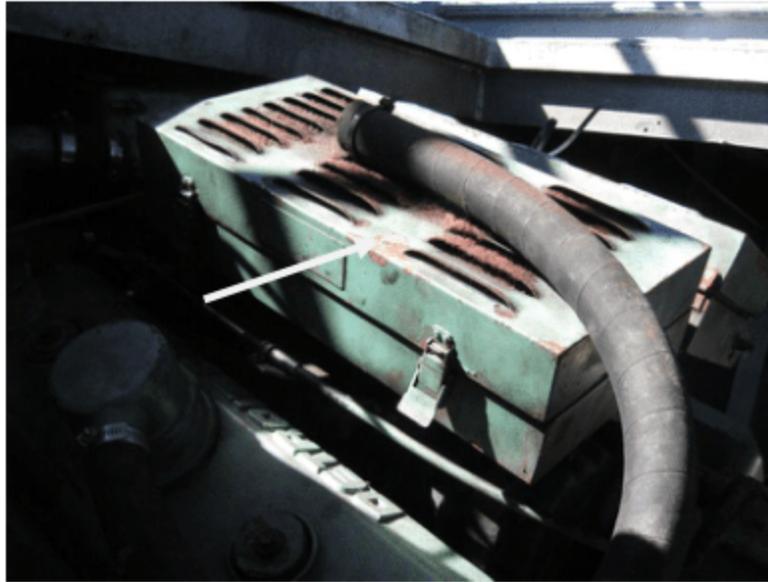
CLEAN STBD ENGINE INBOARD AIR BOX

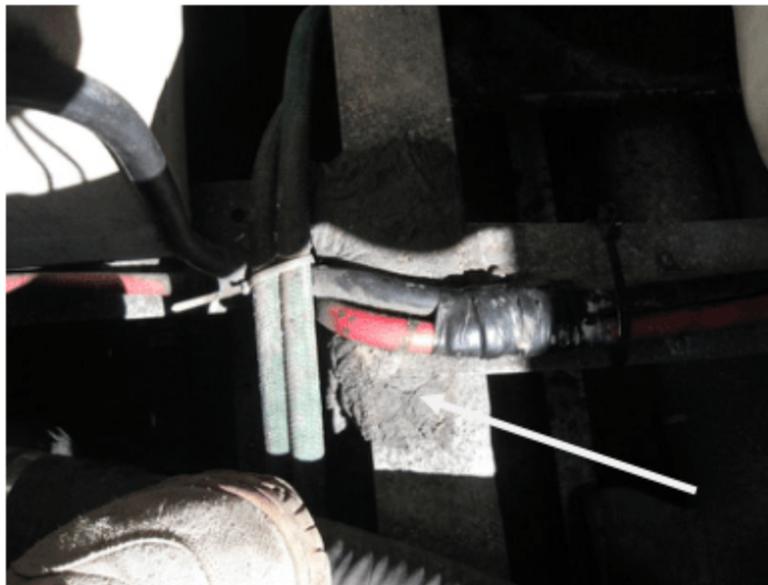
USE BETTER MATERIAL TO ISOLATE PORT SIDE BATTERY CABLES

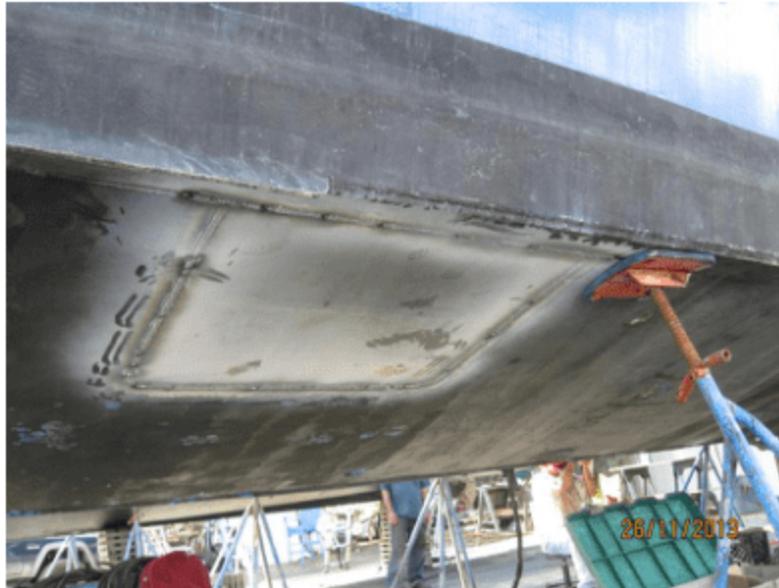
NOTE: On November 27, 2013 I attended the vessel for the purpose of regular C&V survey. Upon arrival I was notified that the vessel had been inspected out of the water and numerous structural (hull plating) issues were observed. USCG required certified repairs prior to continuance of the vessels current COI (expires 2017). The value of the SEA EAGLE at that time was significantly affected by these findings and the survey was postponed until this date. The value of the MV SEA EAGLE at that time, considering the damage discovered, prior to repairs required and condition of machinery and appointments was, in my opinion, \$ 90,000.00. The repairs were undertaken and completed at an approximate cost of \$ 50,000.00.

NEW INSET PLATING-NOVEMBER 26, 2013

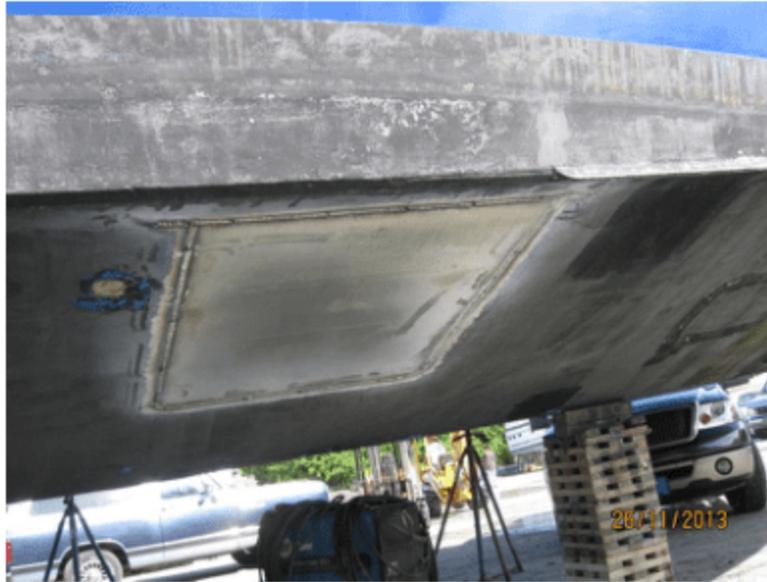
INSET PLATING-RENEWED NOVEMBER 26, 2013

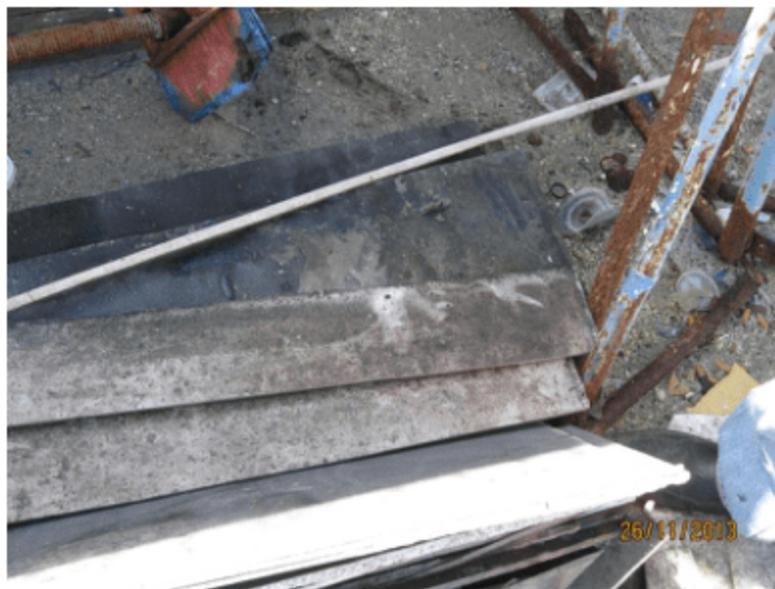
CORRODED CUT-OUT PLATING

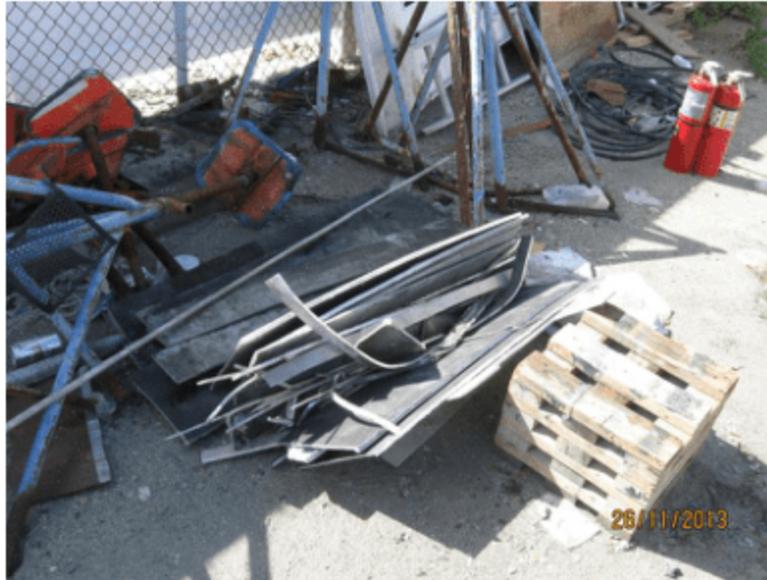
CUT OUT PLATING

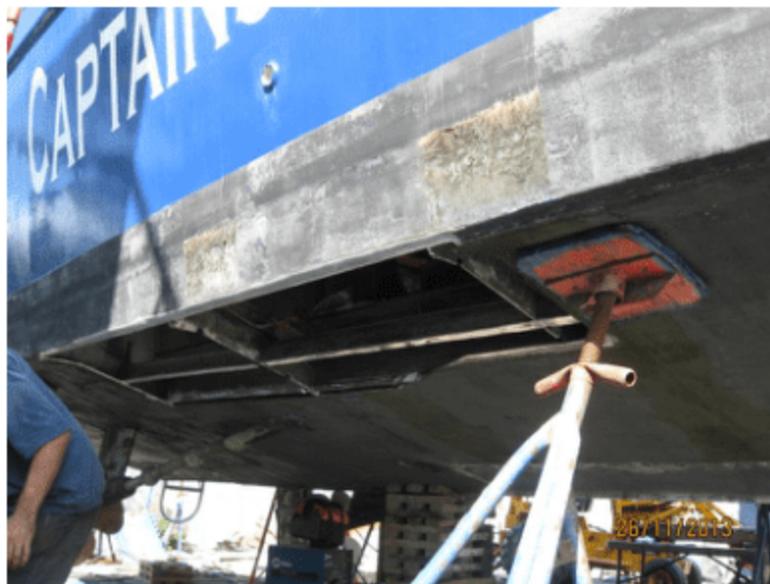
TYPICAL INSET REPAIR
