Little St. James

SWRO Plant Engineering Report

Michael Malo, PE
TSG Technologies
2401 NE 18th Terrace, Suite B
Gainesville, FL 32609

December 4, 2014

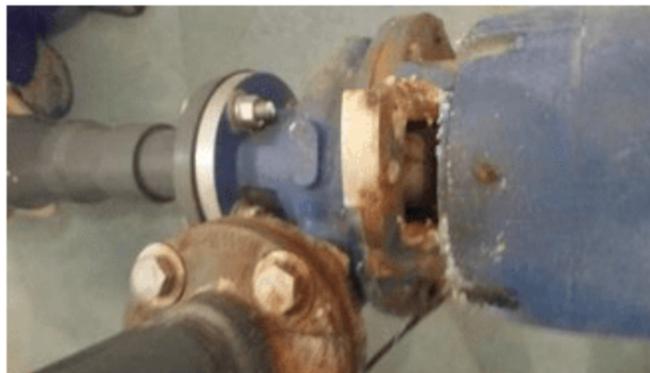
Figure 1: Corrosion on Intake Pump

During our visit, it was noted that the entire pumping and priming system has fallen into disrepair. The plant currently operates on Pumps A and D. Pump D has a leaking seal. Pump B is not operational at all and seems to have been disassembled. The suction piping for Pump B has also been removed. It is not clear if Pump C operates. Corrosion is apparent on all of the pumps and all of the motor grease fittings. The priming system was started in hand and worked, although the priming pump has corrosion issues as well. The intake control panel appears to be in good condition, but it was not communicating with the RO plant's PLC (programmable logic controller) located in the main control panel on the RO skid during this visit. Since that time, the Profibus repeater and adapter card have been installed by TSG and have fixed the communication problem.

- Replace Pumps B and C and reinstall suction piping for Pump B.
- Replace seal on Pump D.
- Provide shelf spare of priming pump and at least one intake pump.

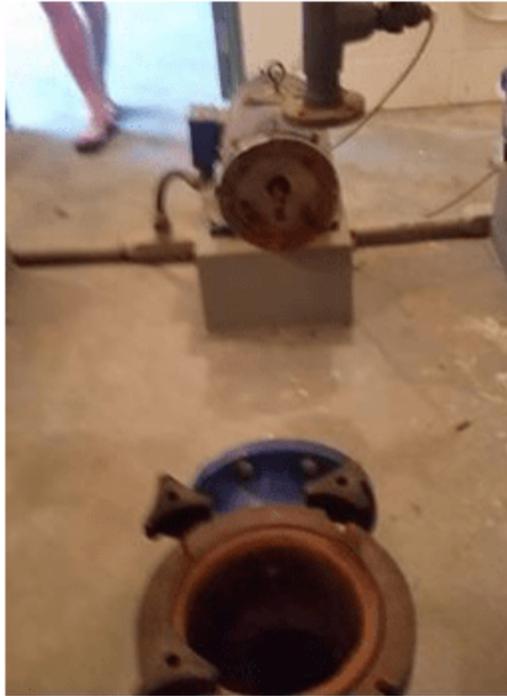
Figure 2: Dismantled Intake Pump and Piping

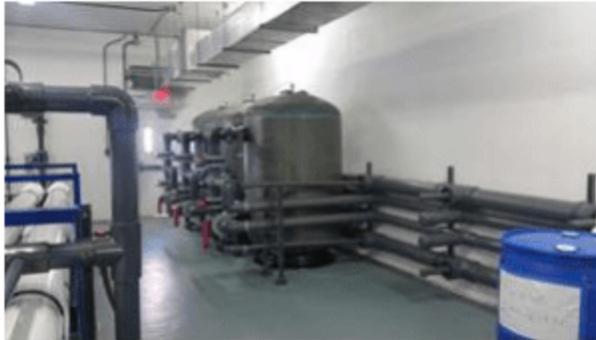
Figure 3: Media Filters

The plant's pre-filtration system consists of three 48-inch diameter mixed media filter vessels that provide removal of fine particulates from the raw seawater. These filters must be monitored and backwashed manually on a regular basis – at least weekly, if the plant sees regular use. At the time of our visit, this system appeared to be well maintained and clean. However, there were no logs of the use of this system. Regular backwashing logs need to be kept with pressure data recorded before and after every backwashing event.

- From a previous visit in February, we reported that the media filter sight glass had debris left in it after a backwashing event. The debris appeared to be media from the filter. Media was also found in the cartridge filters. If the top layers of media have indeed been removed, then they need to be replaced. The media filters need to be drained and checked for proper media levels.

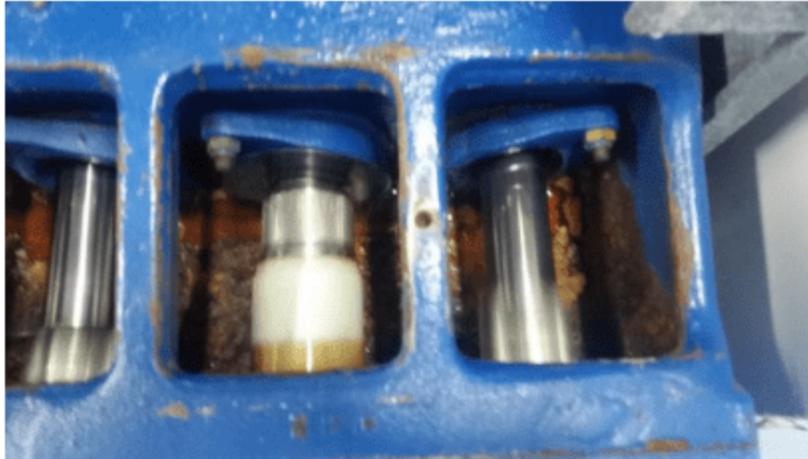
Figure 4: HP Pump Gallery

The high pressure pump is the “heart” of any RO plant as it raises the seawater feed pressure to approximately 850 psi to allow membrane separation to occur and convert seawater to fresh water. The system consists of a Wheatley 110Q-3L oil-filled positive displacement pump, driven by a 75 hp high efficiency motor. The drive belt was examined and found to be in acceptable condition. Front bearing noise was observed from the motor. The pulsation dampener connection has an apparent leak. Minor leaks and salt buildup were observed in the pump gallery indicating that seals were worn and may need to be replaced. Oil change records were not available. The oil/water separator was full and needed to be cleaned. There is a warranty issue with the HP Pump soft start and that is already in process.

- Perform annual service on Wheatley pump.
- Check and replace bad valves or seals.
- Clean out salt buildup in pump gallery.
- Change oil and clean out oil/water separator.

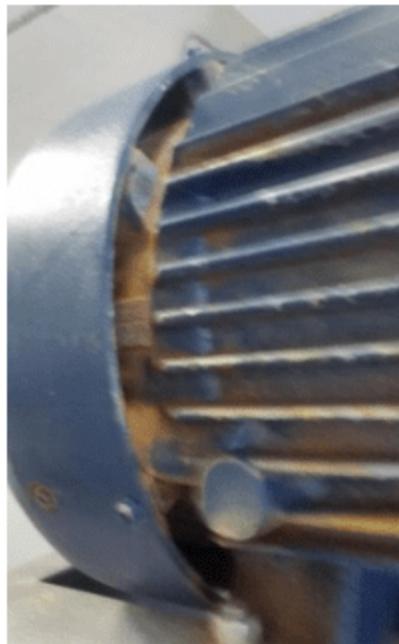
Figure 5: HP Pump Motor
