Date: June 25, 2015

Job #AC-15-076  
A/V-15-077

Subject: **A/C 1085 Cabin Vibration Investigation**

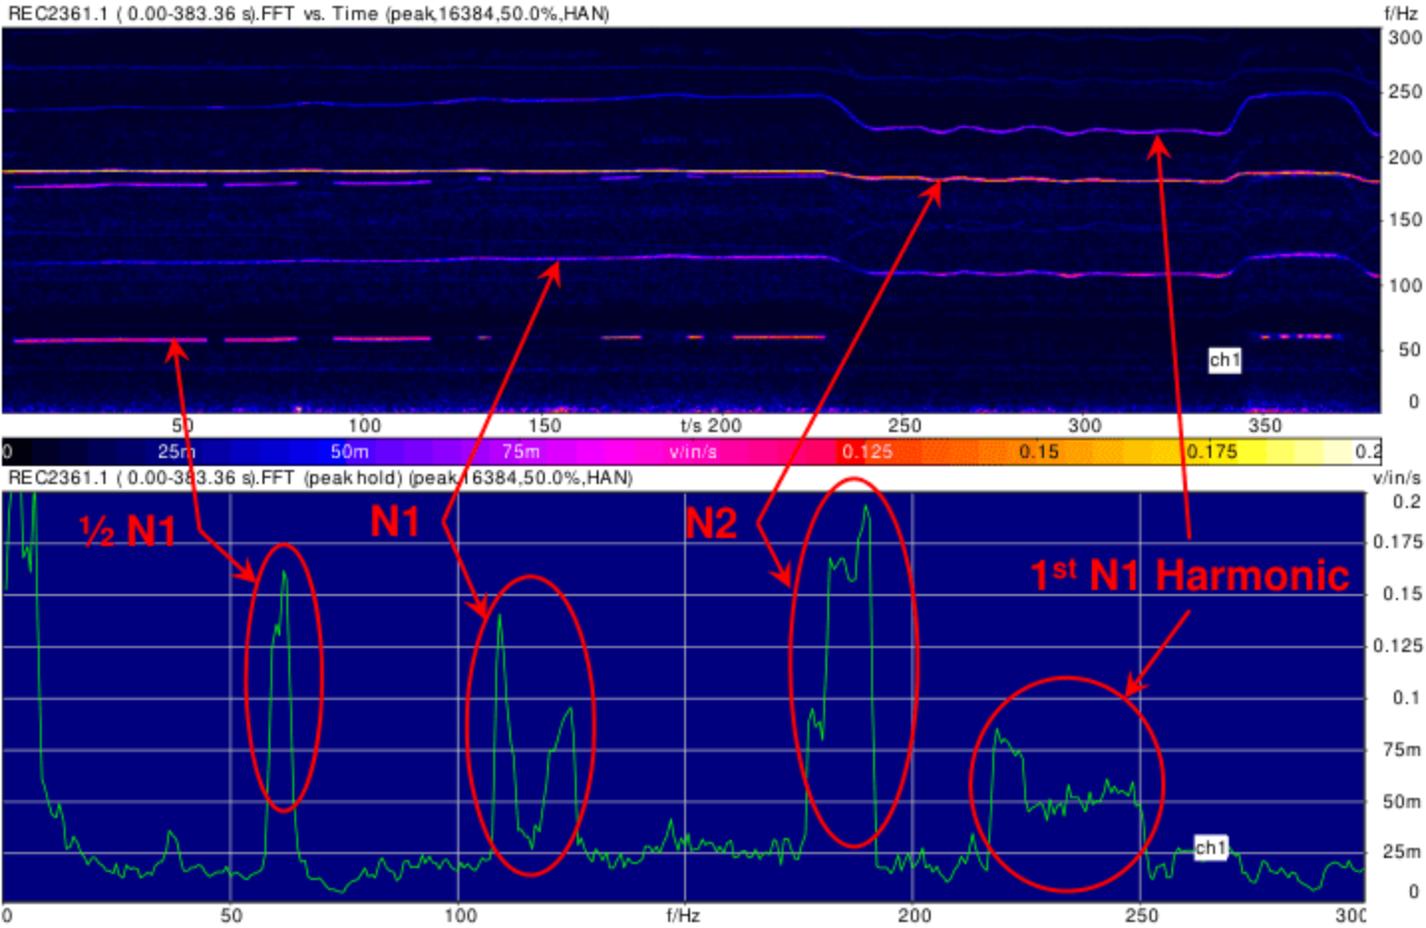
Figure 1

Analysis of the recorded data showed a 1/2 harmonic on the left engine's N1 spool during climb through 36000 feet. The frequency of the 1/2 harmonic was 61.7 Hz with a vibration level of 0.16 in/s and a sound pressure level of 71.9 dB (Figures 1 & 2). The vibration was also measured on the Window 2 left and right outboard seat tracks (Figure 3). When the left engine was decelerated to idle, the 1/2 N1 harmonic went away. During climb, the left engine's N1 vibration levels were as high as 0.14 in/s and the right engine's N1 vibration levels were as high as 0.20 in/s.

# Left Engine Vibration During Climb Up To 45000 feet

To mitigate the felt vibration during climb to 45000 feet, it is recommended to perform a 180° clocking of the left engine fan followed by a fan trim-balance on both engines. The fan trim-balance should achieve N1 vibration levels no greater than 0.10 in/s from MCT to idle on both engines.

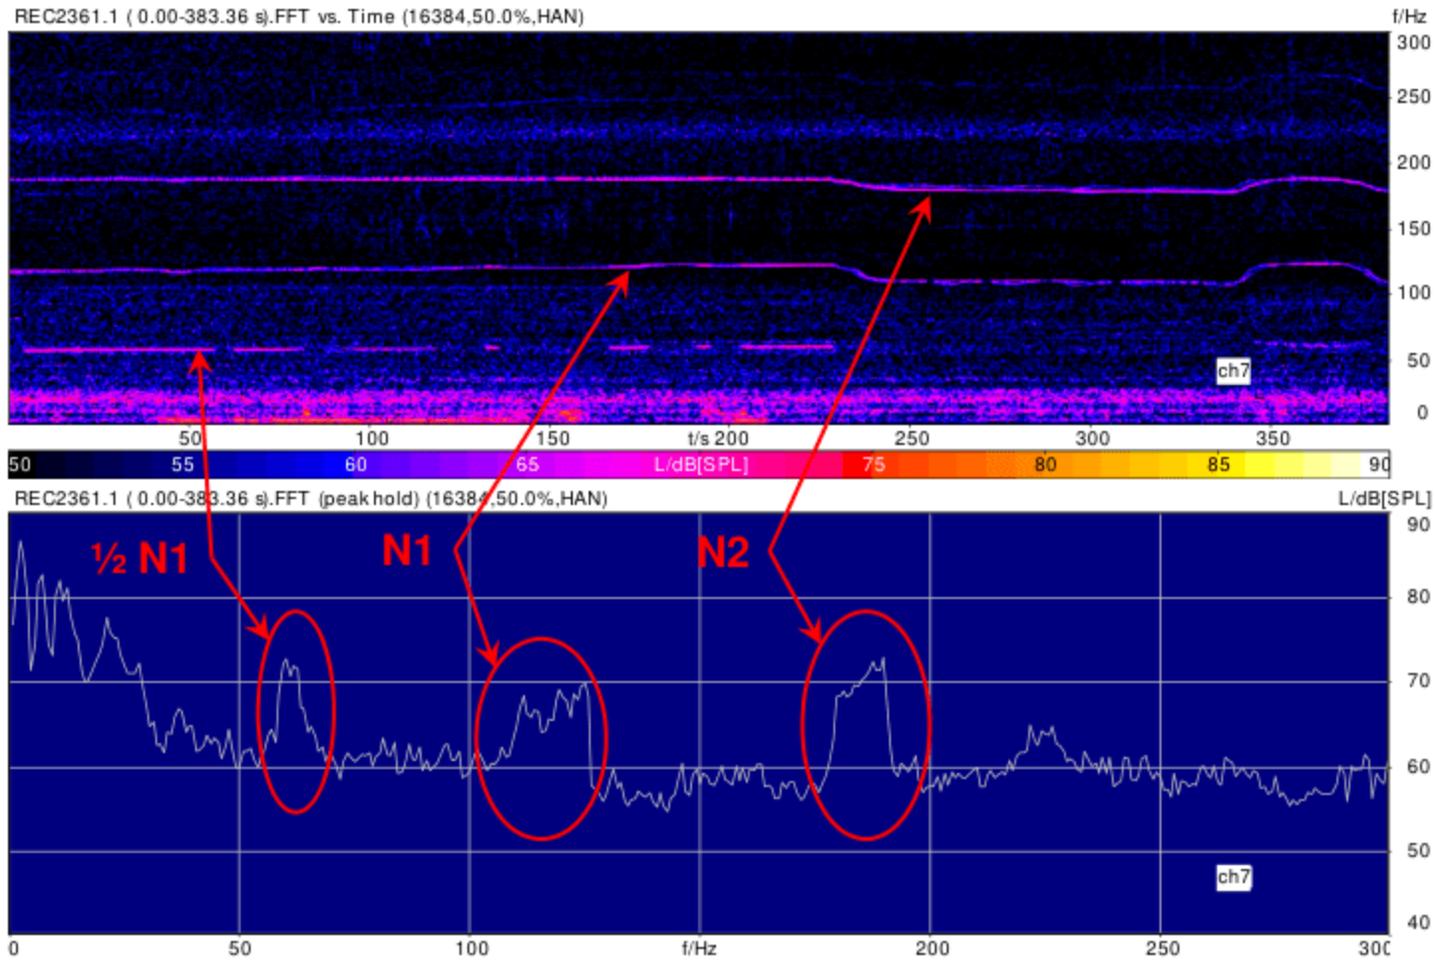
Figure 2

# Sound Pressure Level at Window 2 Center

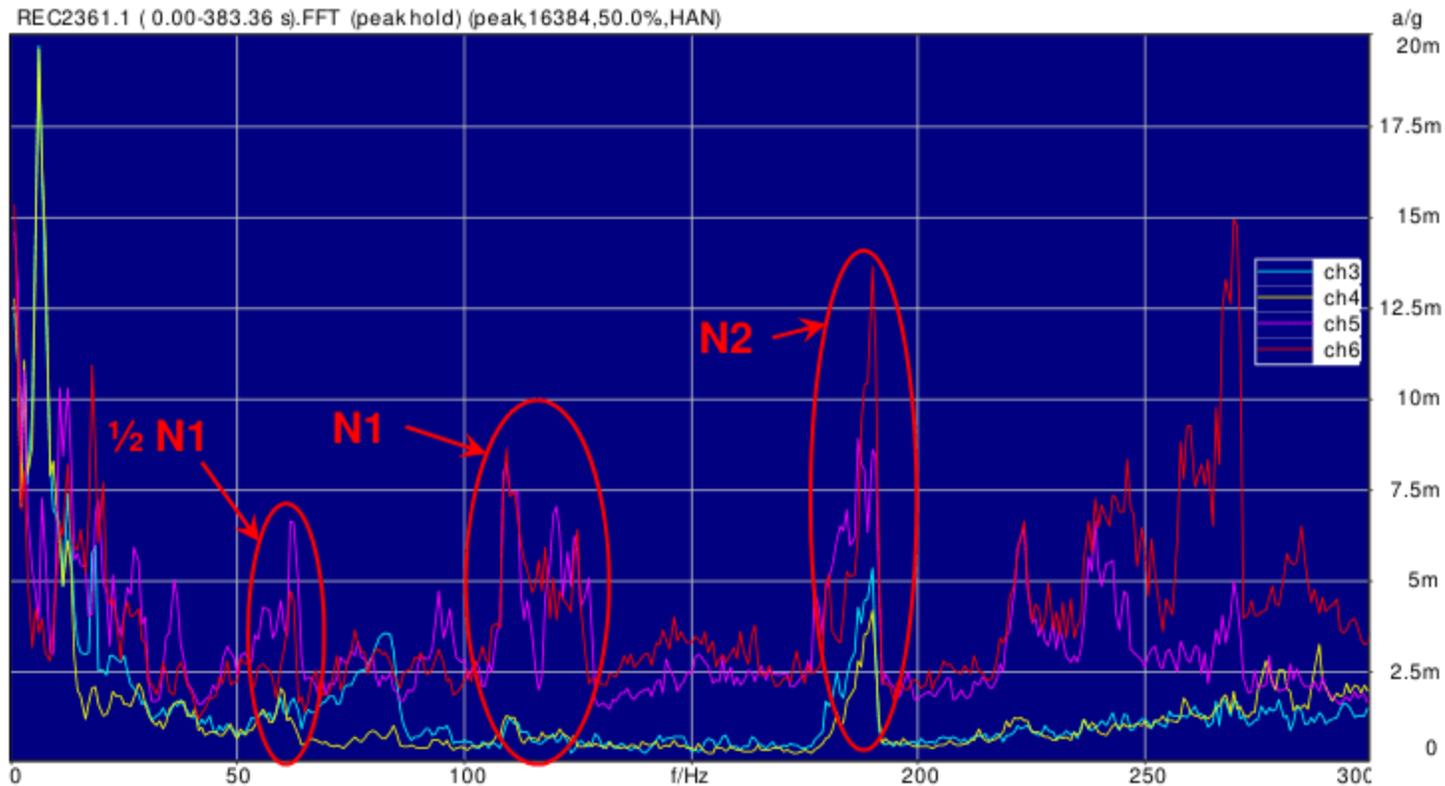
Figure 3

# Vibration Measured on Seat Tracks
