MARINE RESOURCES

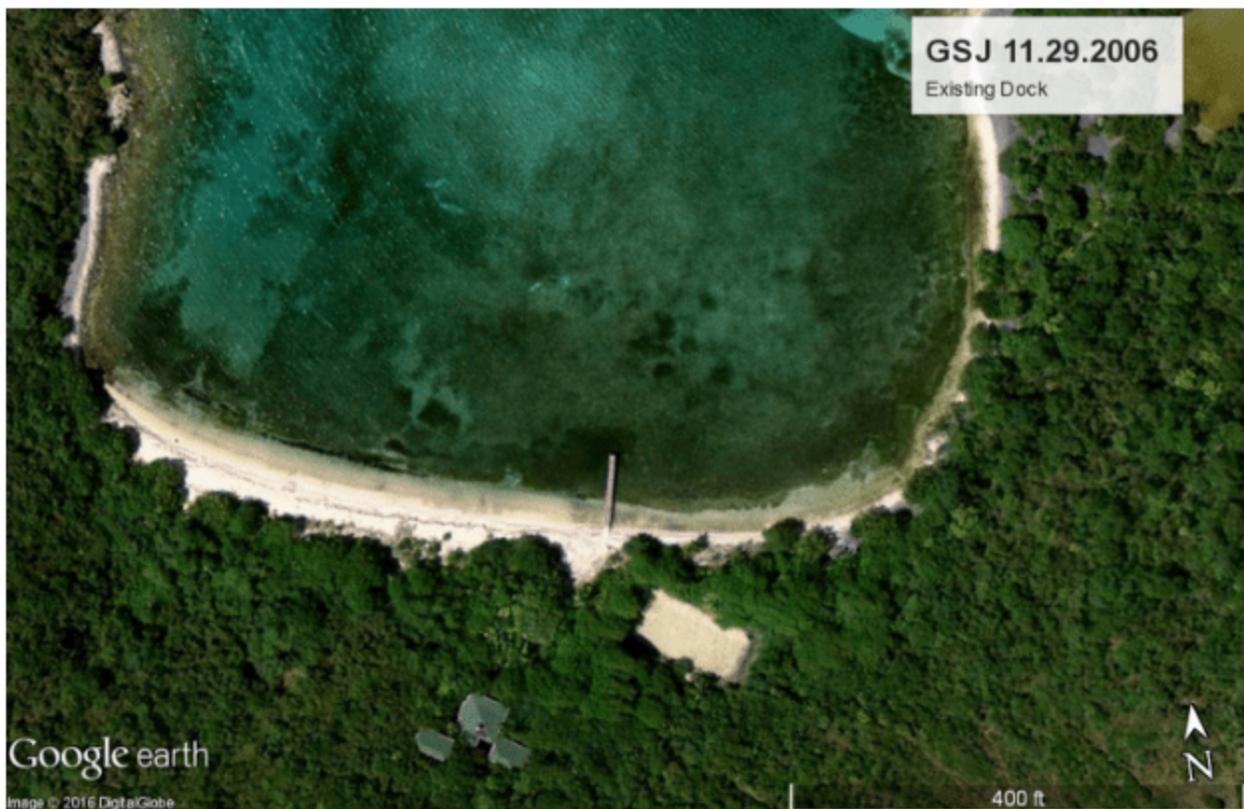
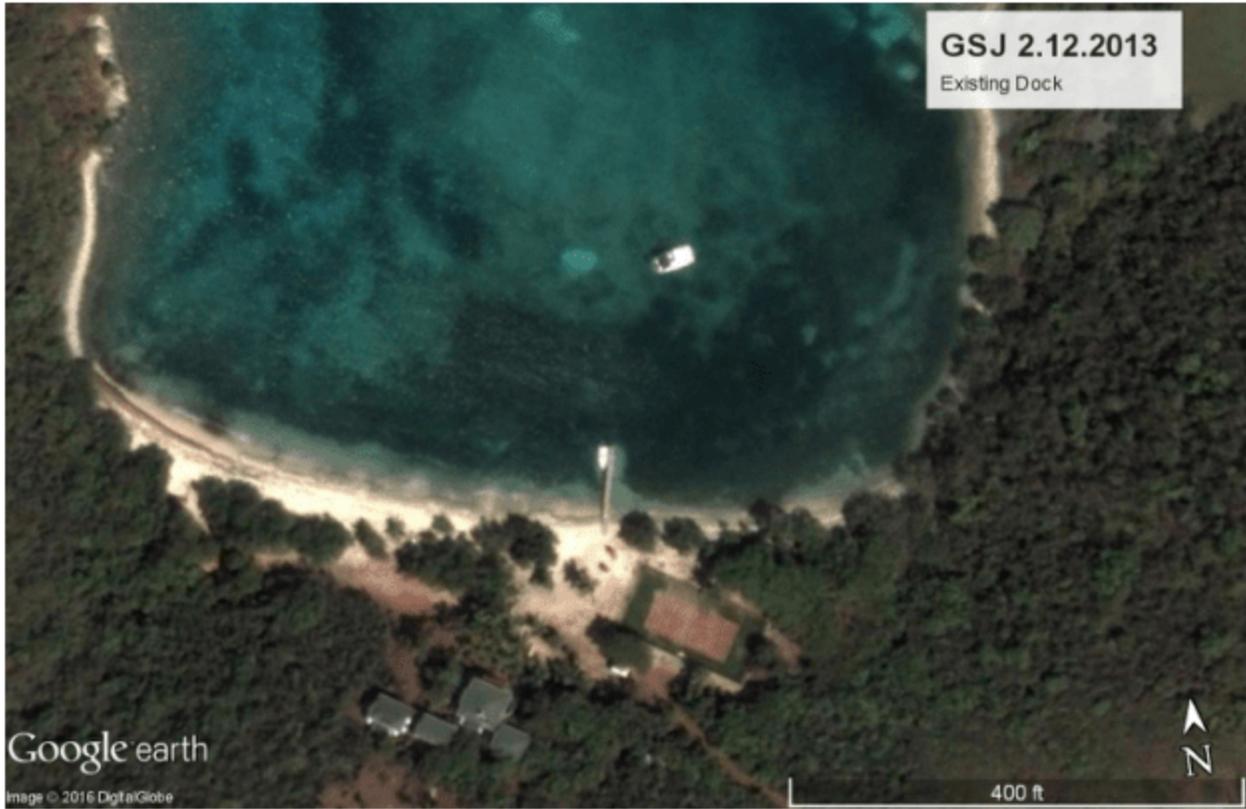
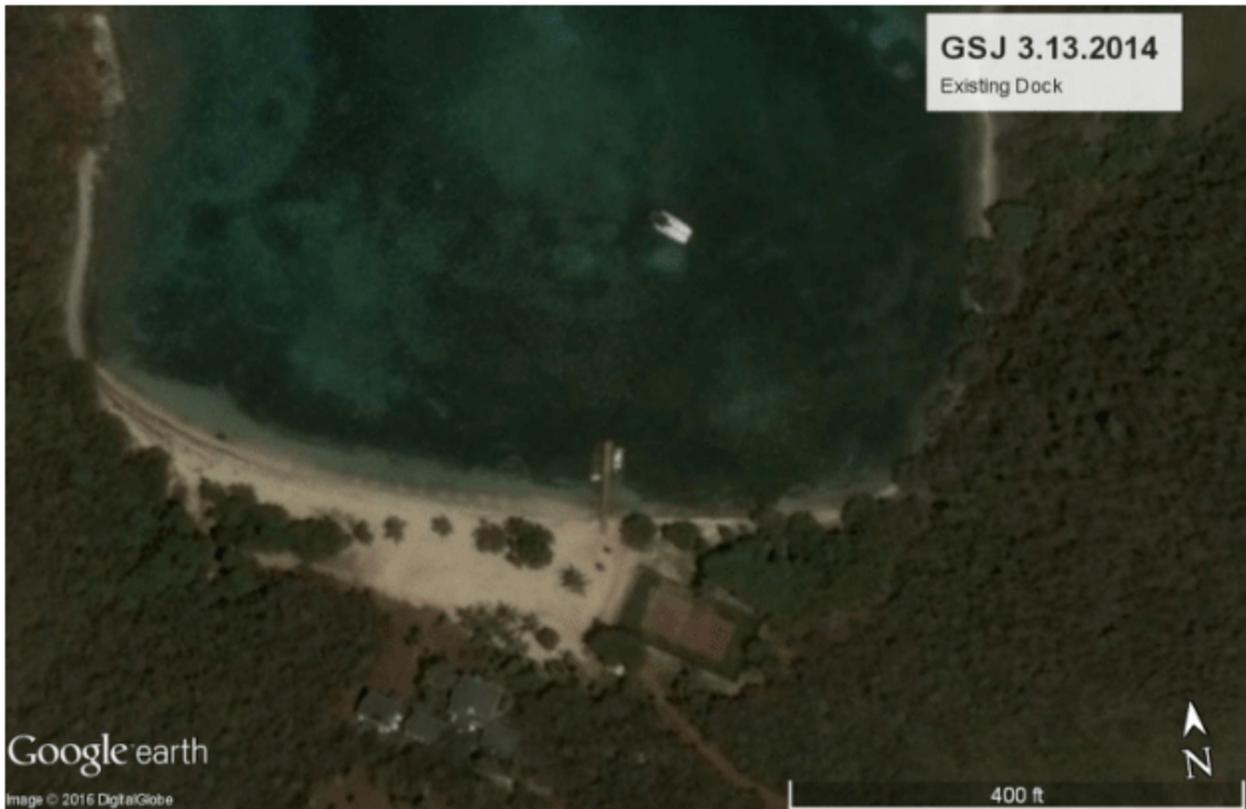
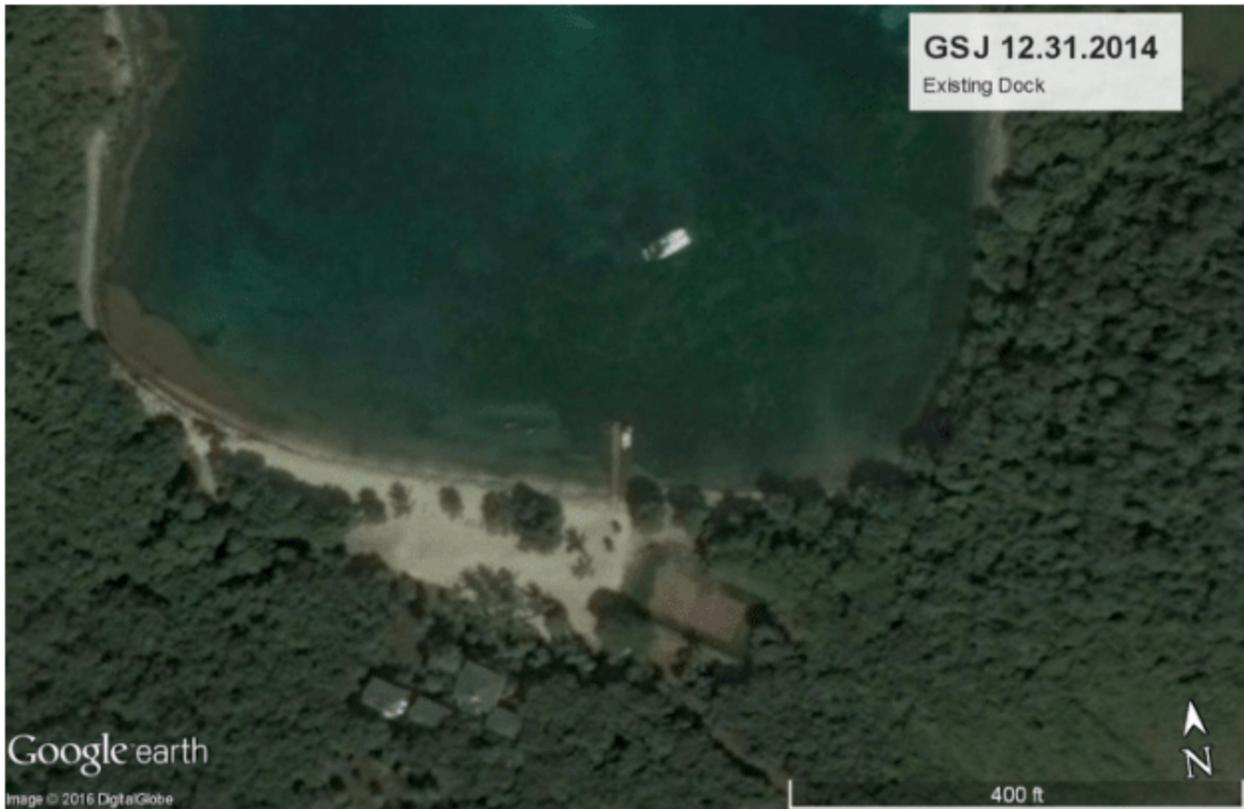
When surveys of the bay were done in 2006 the seagrass extended under the dock. In 2016 there are now large depressions around the dock as much as 9' in depth off the end of the dock and there are large blowouts in the beds along the shoreline to the north. This appears to have been happening over time as documented by the Google aerial photographs.

The blowouts are now far worse than what is shown in the latest photograph.

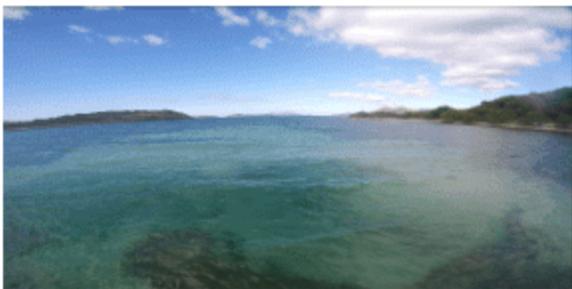
Beds now from end of dock

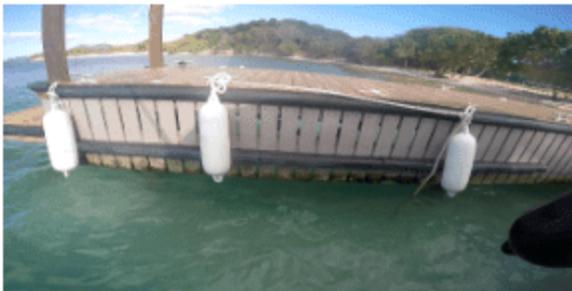
Existing dock, note poor water quality

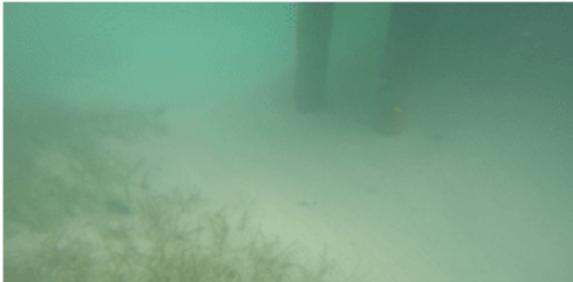
There were dense Thalassia beds under the dock in 2006.

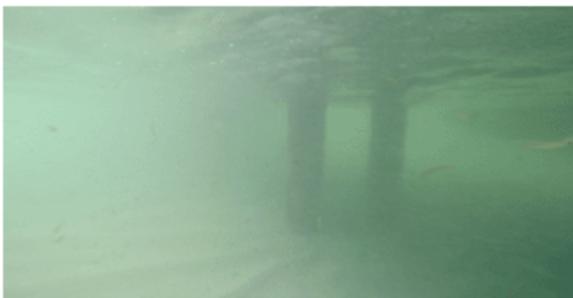
There is no longer any seagrass immediately around the dock.

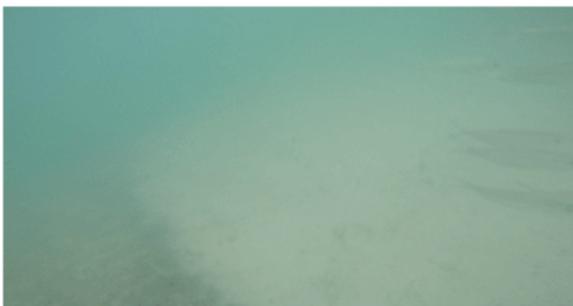
There is loose seagrass detritus rolling in the surf along the beach.
