## **Little St. James SWRO Service Report:**

**March 21, 2017**

On March 15<sup>th</sup> through March 18<sup>th</sup> 2017, Jamaal Hodge conducted an onsite service visit at the seawater RO system on Little St. James Island. The goal of this service visit was to perform the necessary work to resolve the following issues;

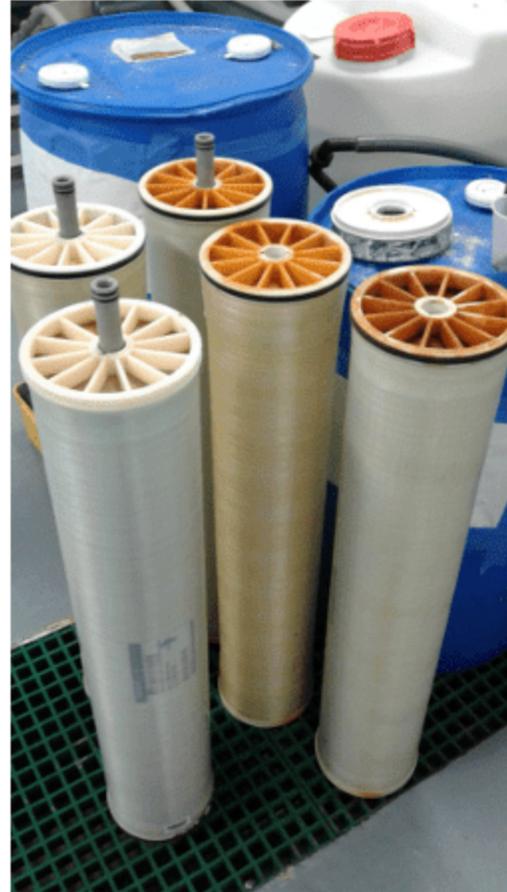
**Photos:**

Upon arrival, the plant was operating at a membrane feed water pressure of 890 PSI with a concentrate pressure of 910 PSI. Please note that Maximum Operating Pressure of the membrane housings is 1,000 PSI. Jamaal changed out two of the lead membranes that were found to have FOD and mechanical damage cause by the FOD and installed new membranes into the final position of the vessels so as to insure the new membranes would not be overflowing permeate known as "Over Flux" when combining new membranes with older ones. This resulted in an overall pressure drop of 100 psi overall with membrane feed pressures now being 790 psi and concentrate pressure of 810 psi. This small change also resulted in permeate (product water) conductivity being lowered from 583 to 483. The photos below document the FOD, new membranes being installed, and the pressure and conductivity differences.

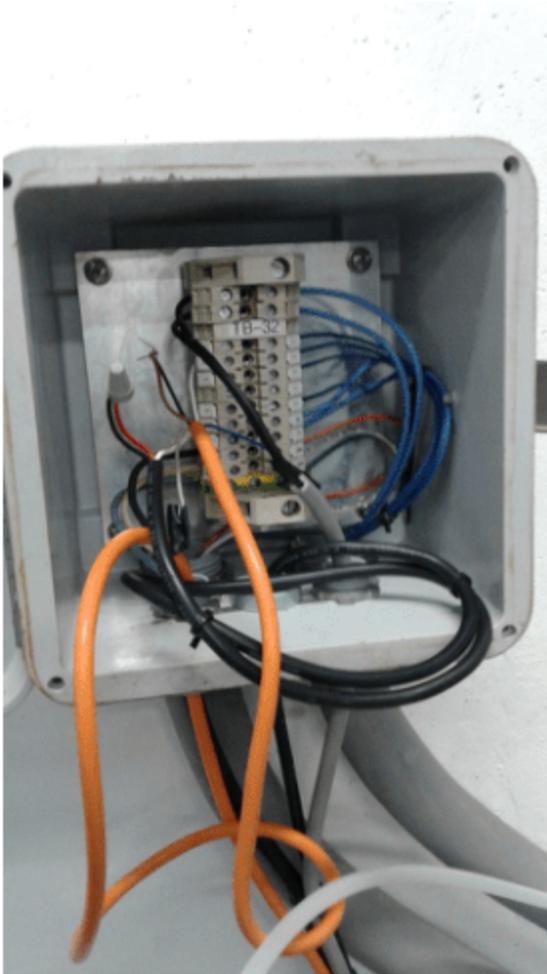
Pre-treat Elec Box:

Injecting proper amounts of Avista Vitec 5100 pre-treatment chemical is necessary to obtain maximum life from the SWRO membranes. The systems PLC controller insures that proper chemical dosages are delivered as well as turning on and off the chemical pump as the SWRO plant starts and stops. Jamaal found that the electrical box for the pre-treatment had been tampered with and the wiring had been changed to where the pre-treatment chemical pump will no longer operate in this fashion and must now be operated manually. Due to the fact that

this was an unknown issue prior to Jamaal's arrival, we did not have the necessary electrical drawings available to remedy this issue. It also needs to be noted that Danny told Jamaal that he was responsible for changing the electrical and that he would restore the electrical box back to its original configuration at a later date.

Given these circumstances, Jamaal had no choice but to install the newly purchased chemical pump, set it for manual operations, perform chemical drawdowns to insure proper chemical dosing, and leave the system running manually. I highly suggest that the electrical issues with the Pre-Treatment Chemical Station be remedied as soon as possible. Please see photo Documentation below:

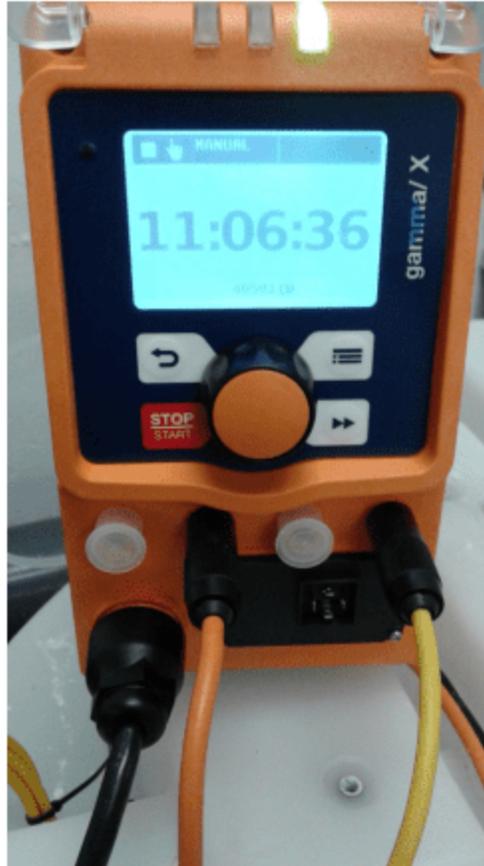
New Chem pump in manual mode:

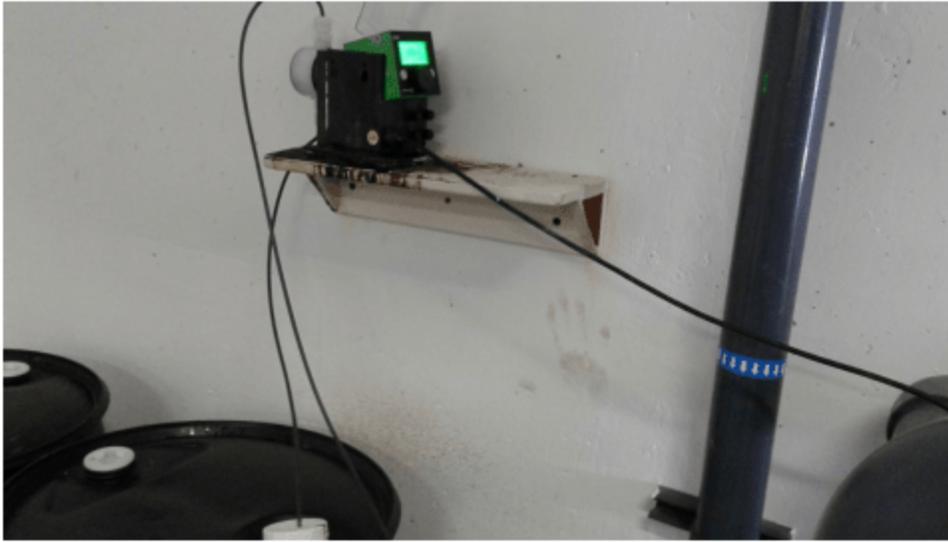
Post treatment Chemical Pump:

Jamaal worked on the post treatment portion of the plant on Saturday and found the chemical injection pump dosing over twice what it should be dosing which will cause an excessive amount of calcium carbonate to be consumed as well as poor water quality being delivered into the cistern. He also found the calcium carbonate reactor valve itself in the closed position probably due to the fact that with improper chemical dosing, the final product water was very high in calcium carbonate or hardness, so someone just figure that it would be best just to shut it off rather than properly adjusting the chemical feed. Unfortunately, this allowed for very low Ph water to be fed into the cistern which when one considers that the cisterns on LSJ are of concrete design, will cause damage through attrition of the cistern itself as well as cause a rise in hardness and conductivity of the treated water.

The first step in setting up the post treatment for Jamaal was to adjust the chemical feed pump with the calcium carbonate reactor in the by passed position until a Ph of 6 to 6.5 is achieved. Next he opened both inlet (bottom valve) and outlet (top valve) of the reactor and over the course of three hours slowly closed down the reactor by pass valve until an overall Ph at the post treatment sample port of 7.2 to 7.8 is reached. Then he checked the overall calcium carbonate level and found it to be 20 requiring only 2 drops of buffering solution to change the red solution to blue. We ordinarily look for 40 ppm of calcium in the post treatment water but because of the high amount of calcium currently in the cistern water, we opted to leave the level at 20 ppm.

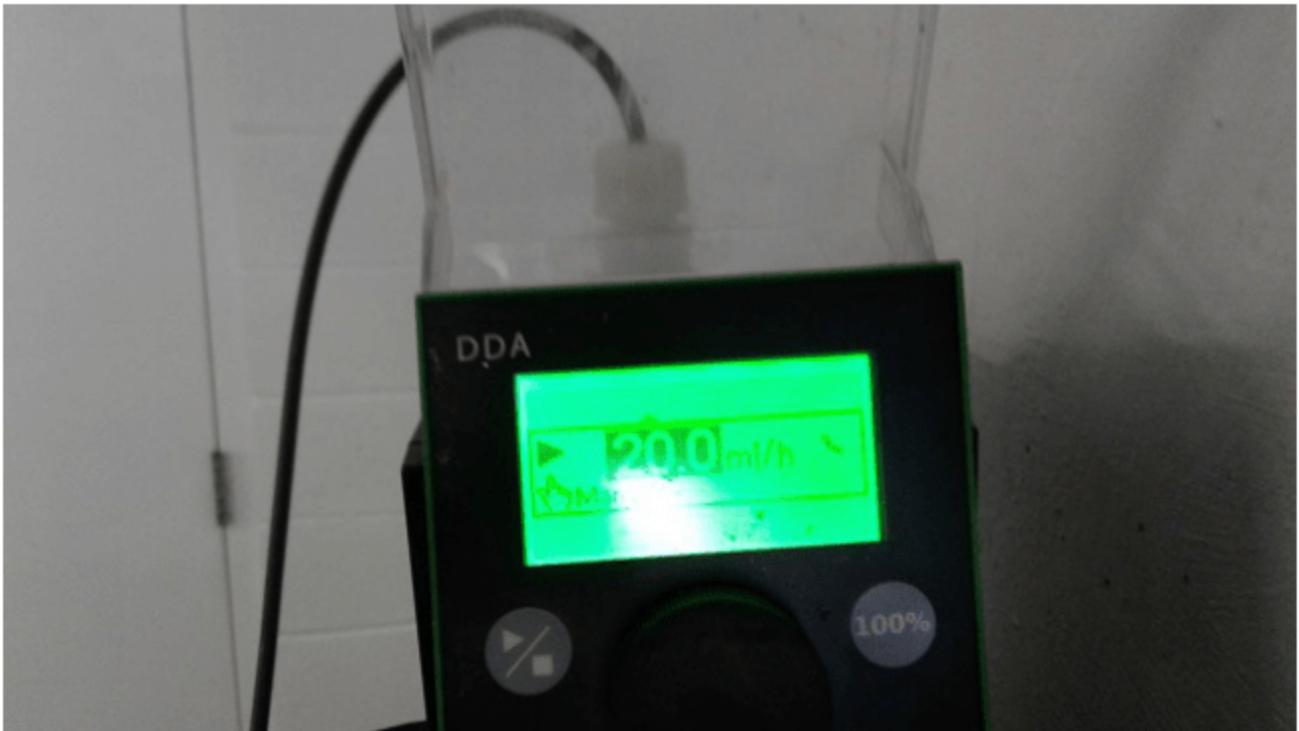
Post treatment chemical Pump at minimal setting:

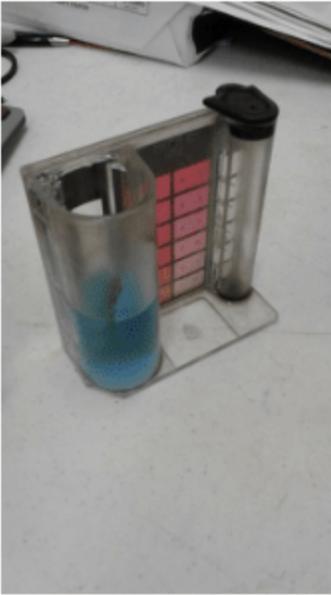
Calcium test step 3: two drops = 20ppm as CaCO<sub>3</sub>.
