**REVISED MANAGEMENT SUMMARY FOR
PHASE II ARCHAEOLOGICAL TESTING AND EVALUATION
PERFORMED FOR
GREAT ST. JAMES HISTORIC VILLAGE SITE
GREAT ST JAMES, U.S. VIRGIN ISLANDS**

February 1, 2007

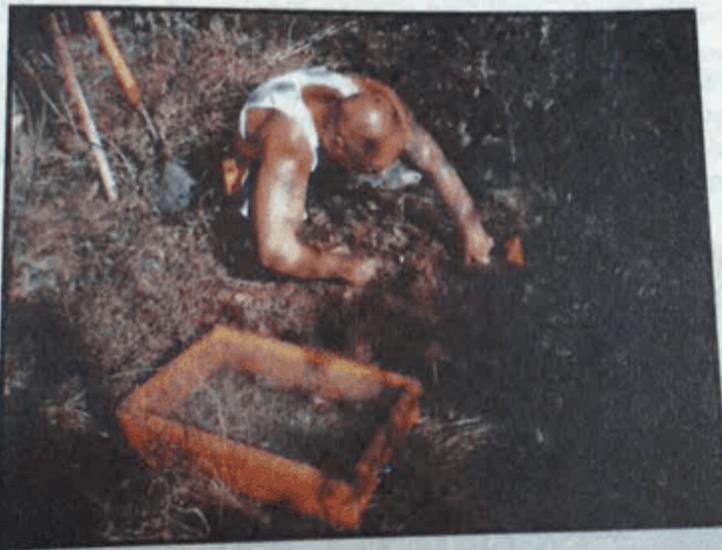
Figure 2: Controlled surface collection activities in progress

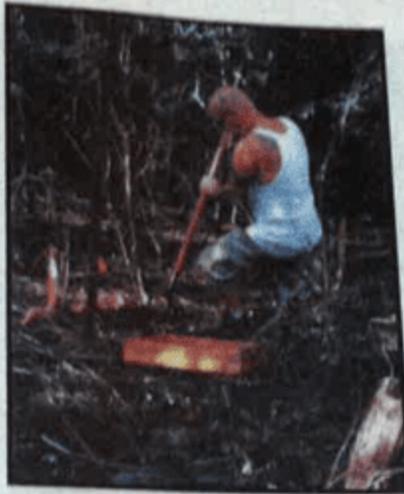
Shovel testing was performed at 10 meter intervals to define the horizontal and vertical limits of the site. Each test measured 30 by 30 centimeters and was excavated to artifactually sterile depths; all excavated soils were screened through ¼ inch mesh hardware.

Figure 3: Photograph of shovel testing activities in progress

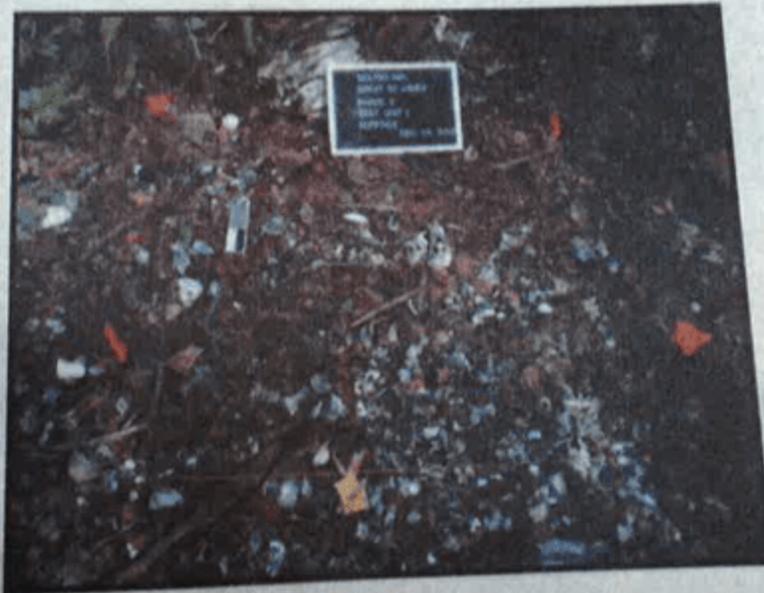
Five one by one meter units were excavated to test select areas of the site. The areas selected included thick midden deposits (Figure 4), general site contexts, discrete concentrations of artifacts and one area in the central part of the site that appeared to be devoid of materials. In addition to the test units, large areas were cleared of vegetation, rubble and colluvium to expose and record architectural features (Figure 6).

Figure 4: Surface of Test Unit 1. Note shell and artifacts

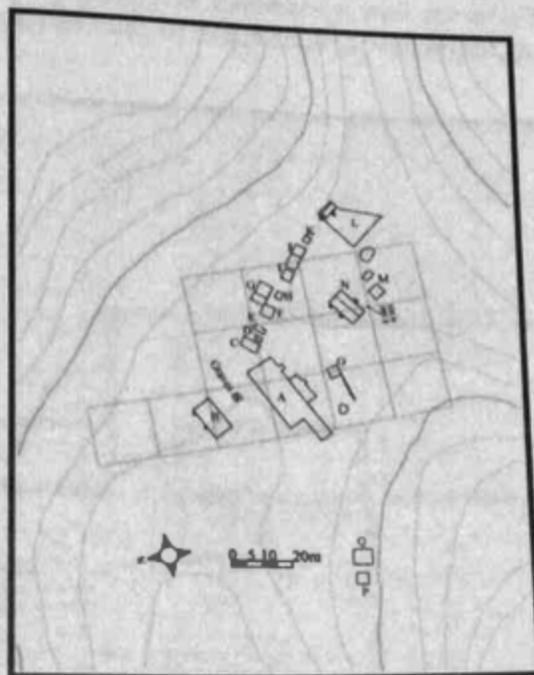
The Phase II Archaeological Testing and Evaluation performed for the Great St. James Historic Village resulted in the identification of 17 structures of varying forms and likely function within the historic village. We note that this number of structures is six less than reported by Righter in 2005. The village proper exhibits a symmetrical plan that is rectilinear in form (Figure 7) with what are likely to be small domestic structures and associated features aligned along the north edge of the saddle. The larger structures are located on the west side of the village and generally trend along a north to south axis. Two small structures are located to the west of the village core area (P and Q); these two structures may represent earlier construction or perhaps specific function buildings separated from the core village area. Additional possible associated features include a number of cart paths, a well at Christmas Cove to the west of the village, and constructed features to the northeast of the village, including one that was considered by Righter (2005) to represent a grave.

Figure 7: Map depicting the location of the Great St. James Historic Village Structures

The proposed road alignment to the west of the core of the ruins complex (Figure 18) will cut through midden deposits. Soltec will make specific recommendations for mitigating adverse impacts in the final report of investigations.

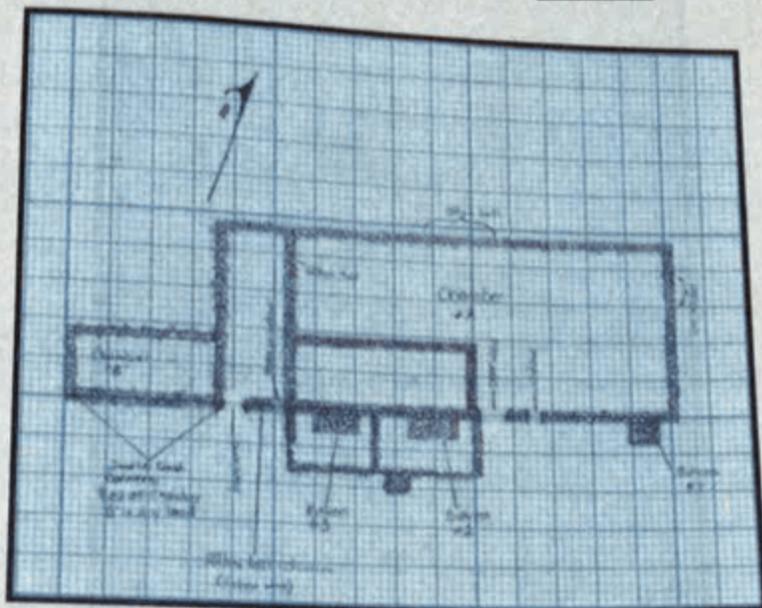
The remains of seventeen readily definable structures were located and recorded by measured drawings and photography, examples of the level of documentation is shown in Figures 8-10. We note that 23 structures were recorded by Righter; the discrepancy between our findings and Righter's may be in part attributable to the level of exposure made for each structure; we suspect that because of the thick vegetation and considerable disarticulation of building materials, some structures may have been considered by Righter to represent more than one structure.

The buildings are generally poorly to moderately well preserved, the surviving walls contain numerous diagonal fissures or disarticulated wall [redacted]. However, their plan is readily discernable.

Figure 8: Example of plan view for Structure A

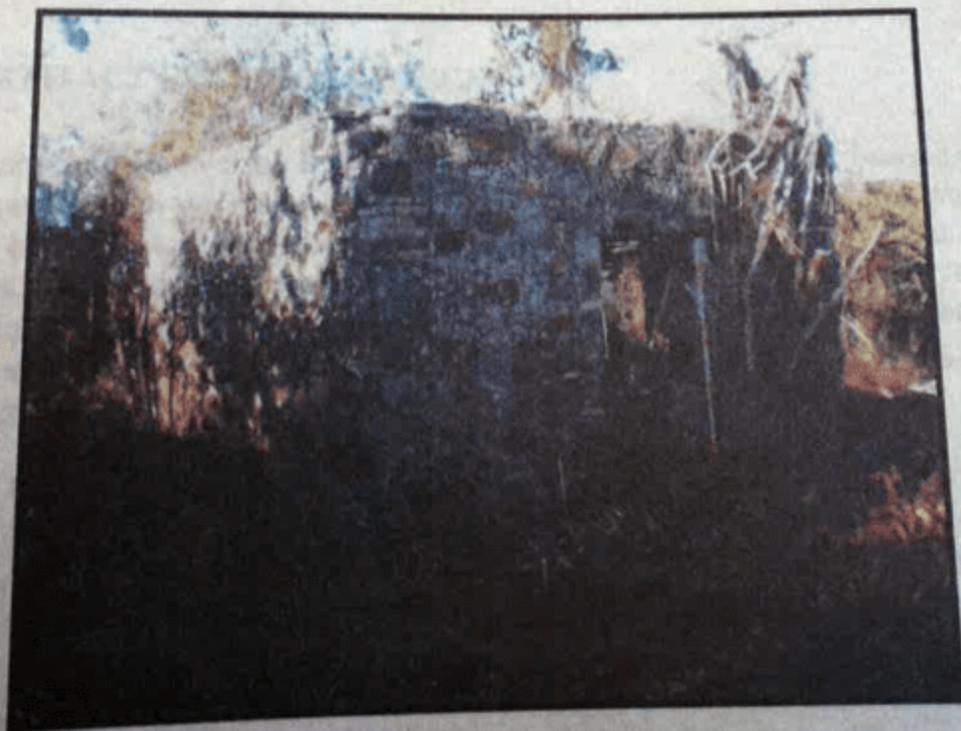
The domestic and store buildings are represented by rubble masonry foundation walls that supported timber superstructures. An exception to this pattern is a small building (M) that contained a full elevation of stone. Interestingly, no evidence for the use of wattle and lime plaster was noted at the site. Significant amount of the recycling of building materials appears to have been made in the late 19th-century as evidenced by ground level foundation walls, an absence of surrounding rubble and artifact scatters in the building's interiors. Other structures include a large rectangular cistern with a vaulted roof and catchment basin (Figure 10), other cisterns, bathhouse and a water trough.

Figure 9: Photograph of Structure M

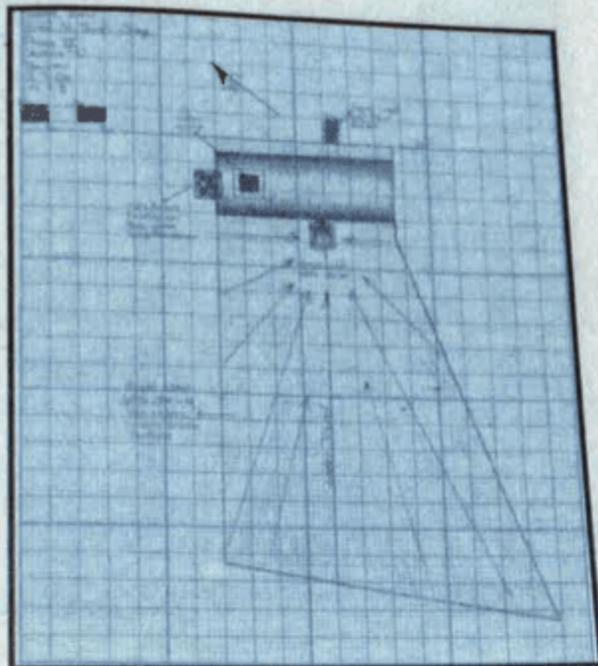
Figure 10: Plan View of Structure L, cistern and catchment basin

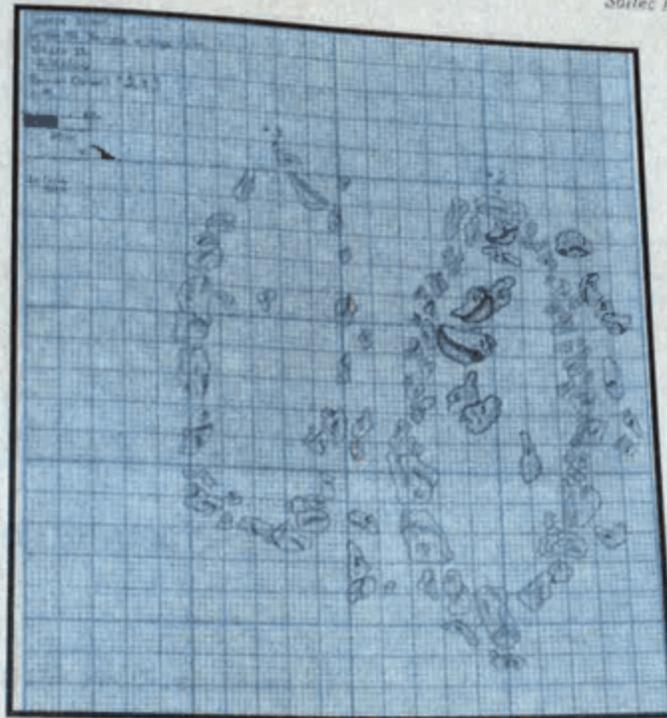
Two graves were found present in between Structures A and B (Figure 7); both graves are defined by arrangements of rocks and conch shells.

Figure 11: Plan view of graves recorded between Structures A and B

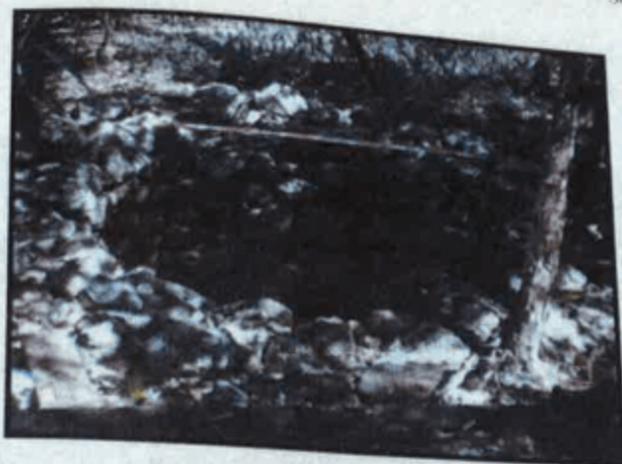
The well at Christmas Cove contains a dry laid rubble casing that is well preserved. The well was constructed at a location where it intercepts a small gut descending from the slopes above the well.

Figure 12: Well at Christmas Cove

The Christmas Cove features of concern include a well and a trough which appears to be of later construction. The well is most likely associated with the historic settlement and as Righter suggests, possibly also provided mariners with a water supply.

The well and trough located on Christmas Cove should be preserved *in situ* and incorporated into the overall landscape design for the development. We recommend that the location of the Christmas Cove features be mapped by a Virgin Islands licensed Surveyor. Additionally, we recommend that a grate be placed over the well opening as a safety measure.

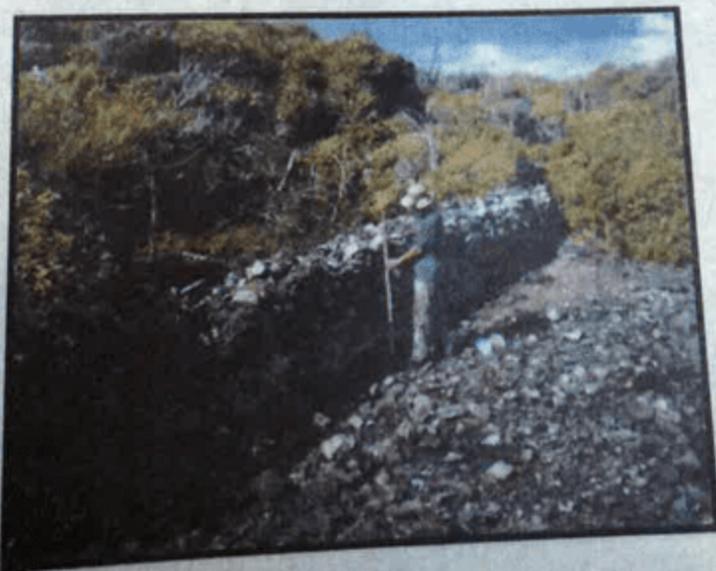
The features to the northeast of the village are in, or in close proximity to, the large salt pond located on the extreme north part of the island. These features include a dry laid rubble wall constructed with rock and coral was identified by Righter in 2005. The purpose of this wall remains undetermined. Similar additional walls are reported by Righter in this same general area.

Figure 13: Dry laid coral and rock wall

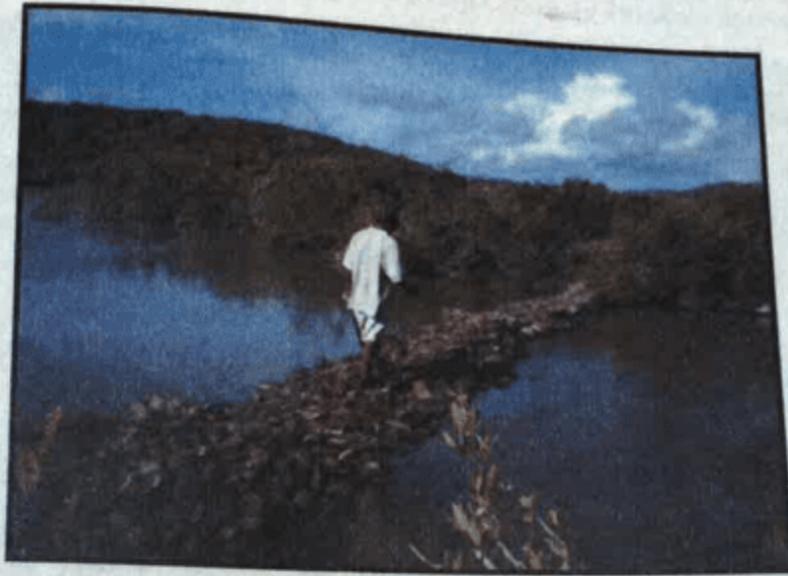
A causeway of loose rock and coral crosses the eastern end of a salt pond on the northern part of the island. The rock alignment (in the form of a stone lined path) continues on the slopes above, to a location that remains undetermined.

Figure 14: Photograph of causeway

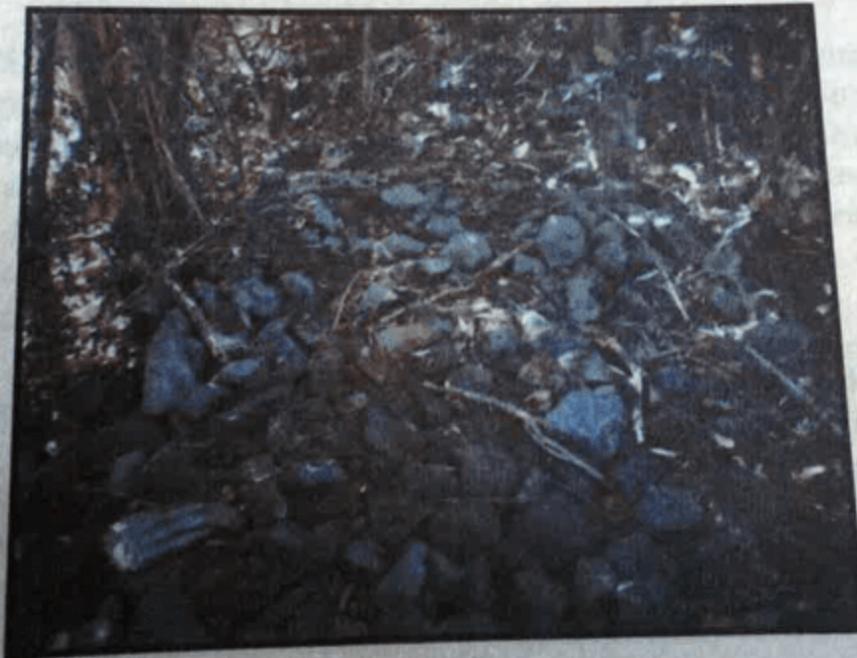
Figure 15: Stone lined path (continuation of causeway)

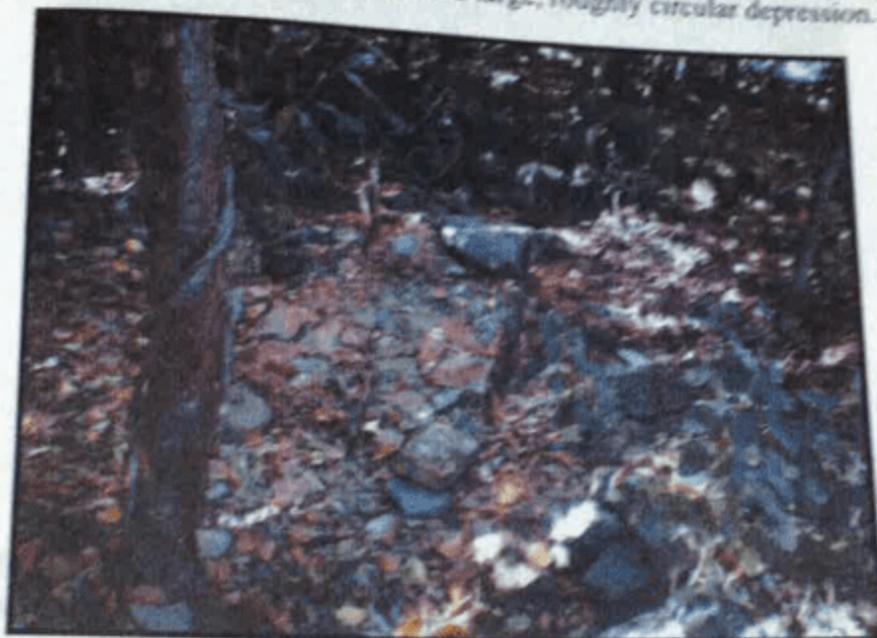
The grave site defined by Righter is interesting in that it appears to be a constructed feature that has been partially disarticulated (Figure 16). [REDACTED] larger faceted coral and stone blocks are found scattered in an area measuring approximately 10 meters in diameter and along the edges of a large, roughly circular depression.

Figure 16: Grave platform identified by Righter (2005:44)

[REDACTED] Righter (2005:43 and 44) suggests that the disarticulated coral and stone represents the remains of a monument that was set on top of the grave and the depression to be a robbed grave. We are not entirely convinced that this is a grave site, as the amount of worked rock and coral appears to be far greater than necessary for a monument (s), and the depression is far larger than necessary to rob a grave. Additionally, neither Righter nor our team reports seeing loose skeletal remains that are characteristic of robbed grave contexts (although we did not screen the soils).

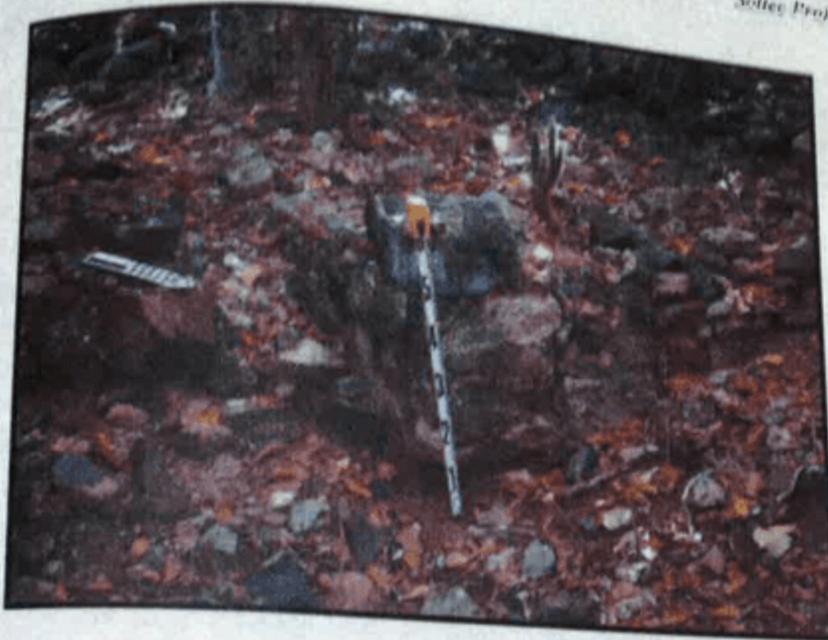
We did however, note an additional constructed feature to the south of the grave platform described by Righter (Figure 17). Additionally, a number of leveled areas and the features described above (dry laid walls, causeway, stone lined path) were noted by Righter and us in close proximity to the putative grave.

Figure 17: Photograph showing relationship of grave platform and additional constructed feature (north arrow sits on top of additional constructed feature)
