RMS CLAIM REQUEST/PROPERTY CAPTION REPORT

Insured Name: Jeffrey Epstein
Visit Address: Little St. James No. 6B, USVI 00801

Cat Loss – Hurricane Earl: The property had sustained mostly damage to trees and shrubbery. Erosion was noted along the beach. Damage was also sustained on a few of the outbuildings.

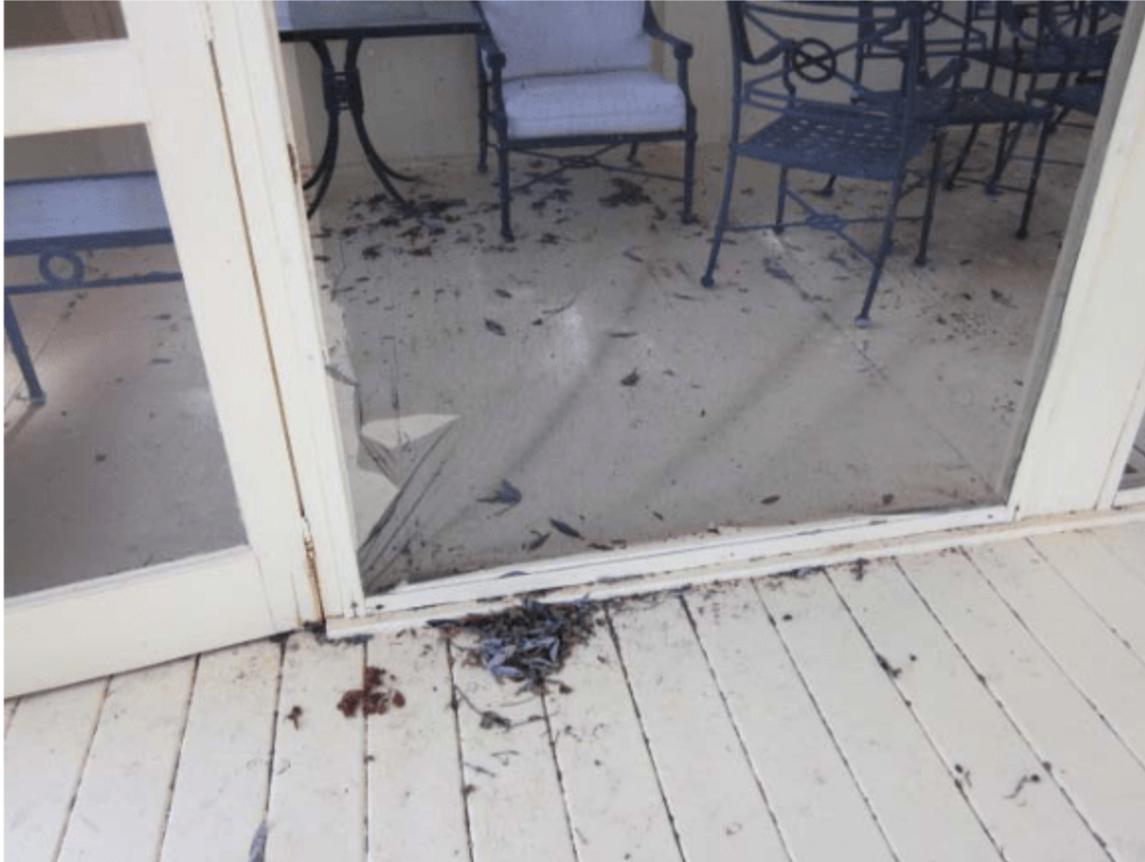
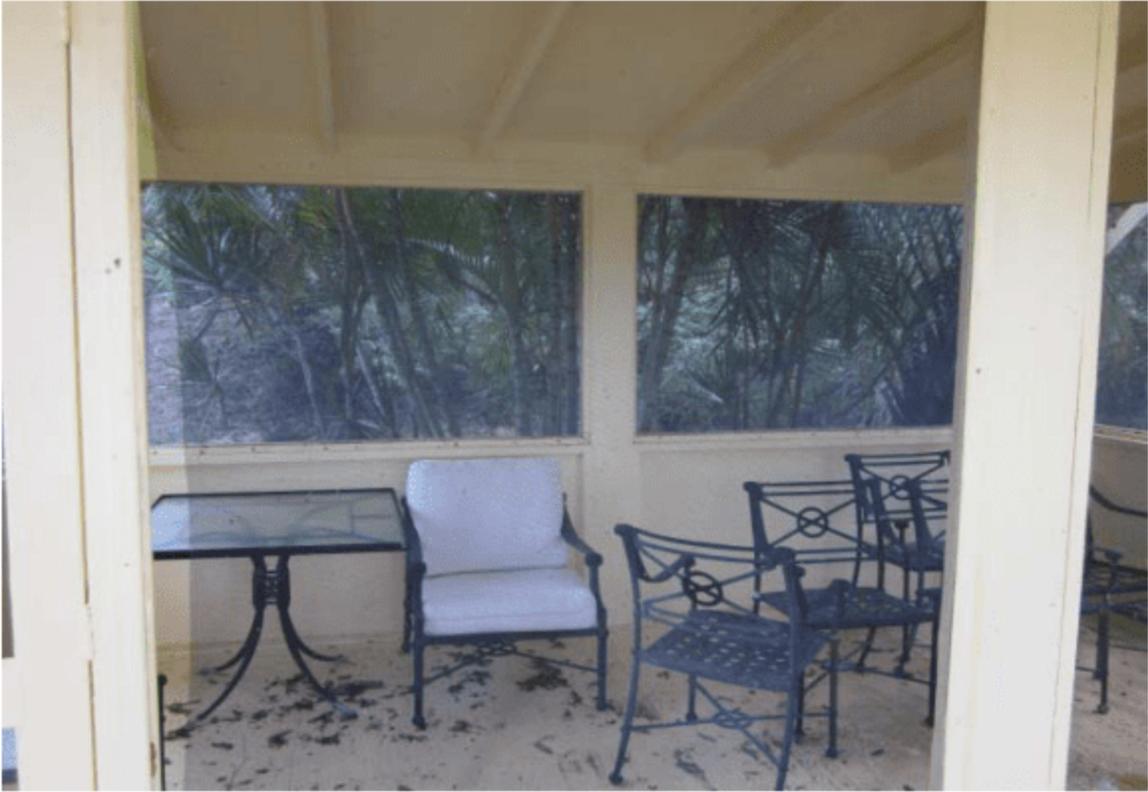
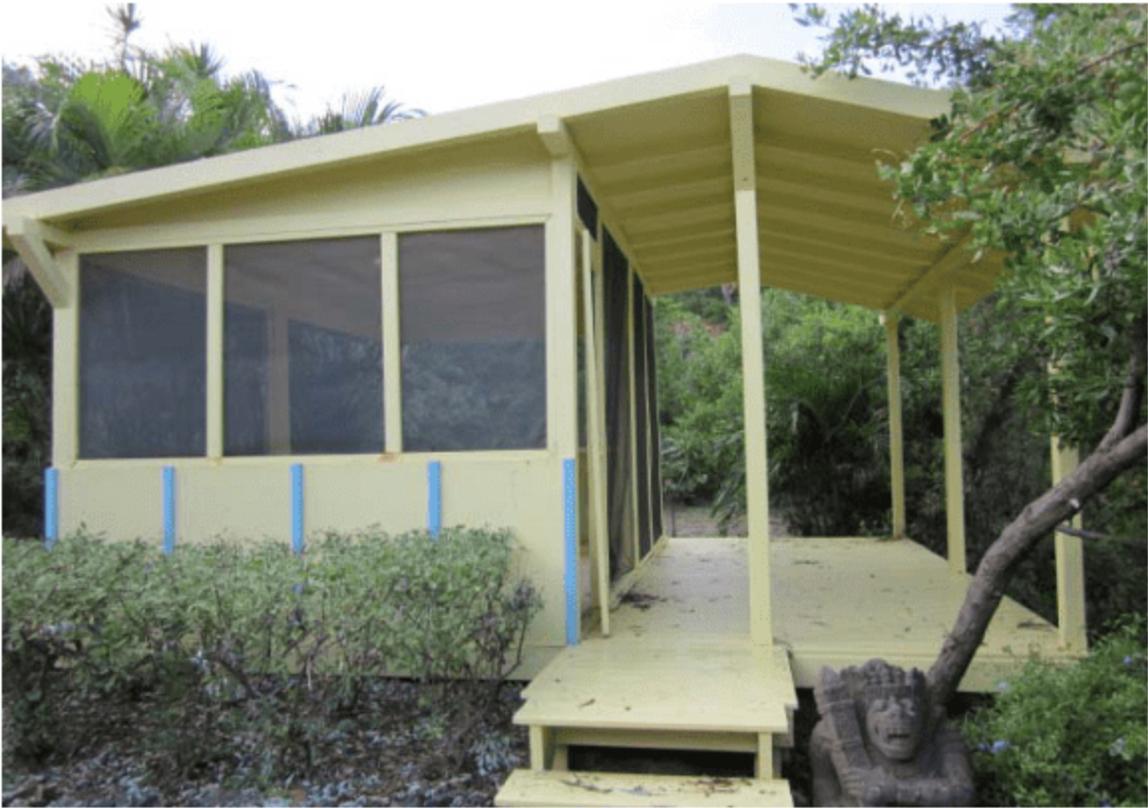
Salt Pond Cabin – Frame structure with screened openings. Current replacement cost for this building is \$24,000. Screened area is approximately 150 sf and covered porch is 90 sf. Areas of the screen are ripped from the framing. The covered porch portion has no damage.

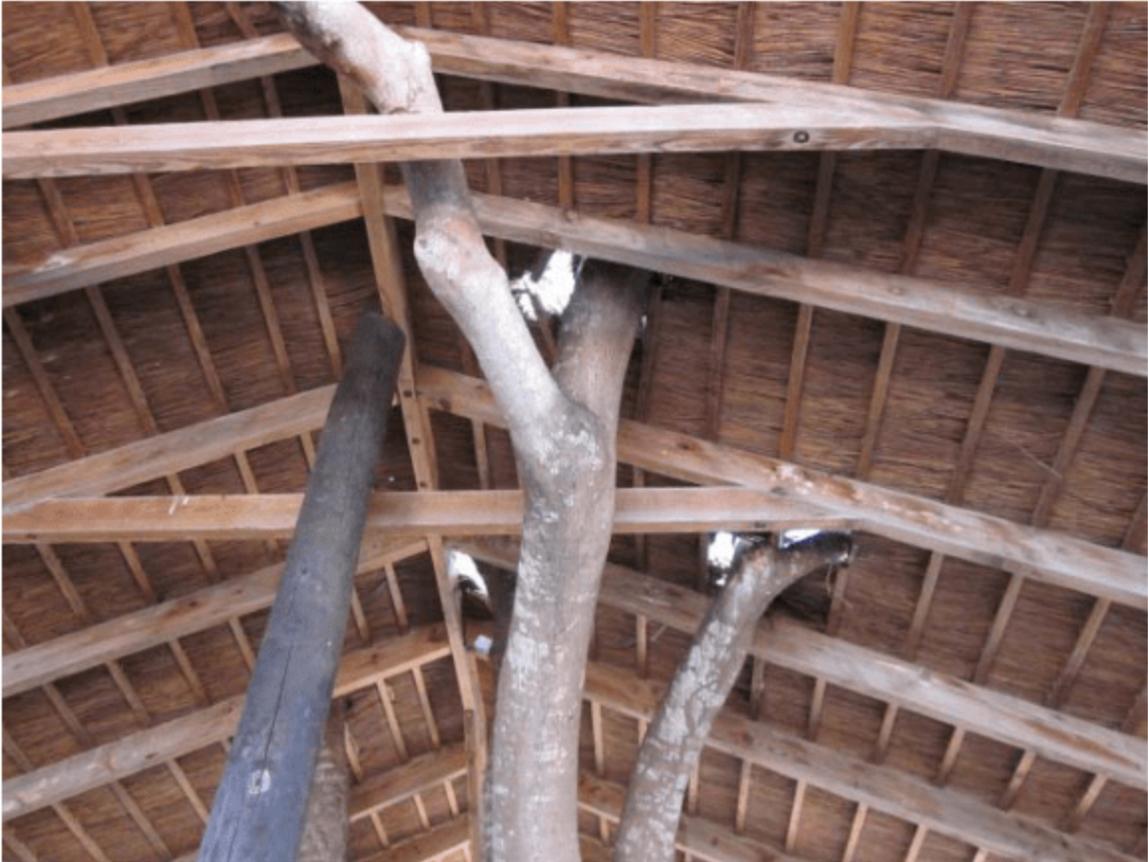
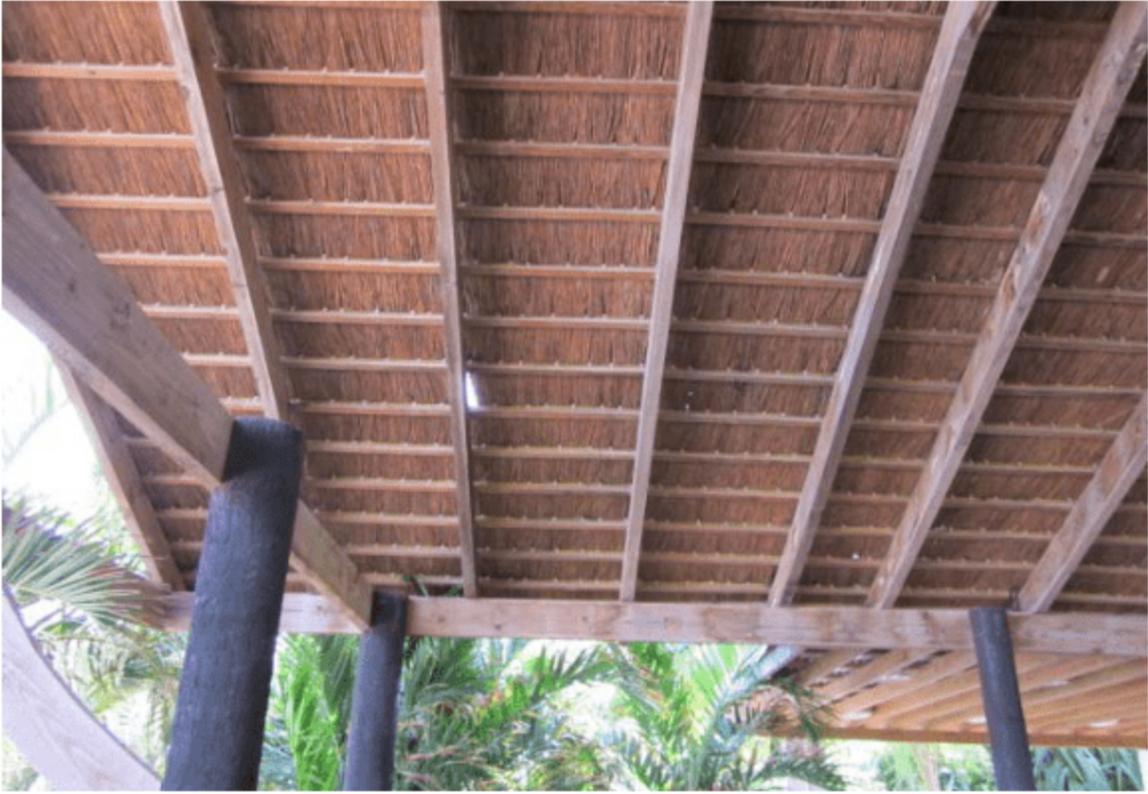
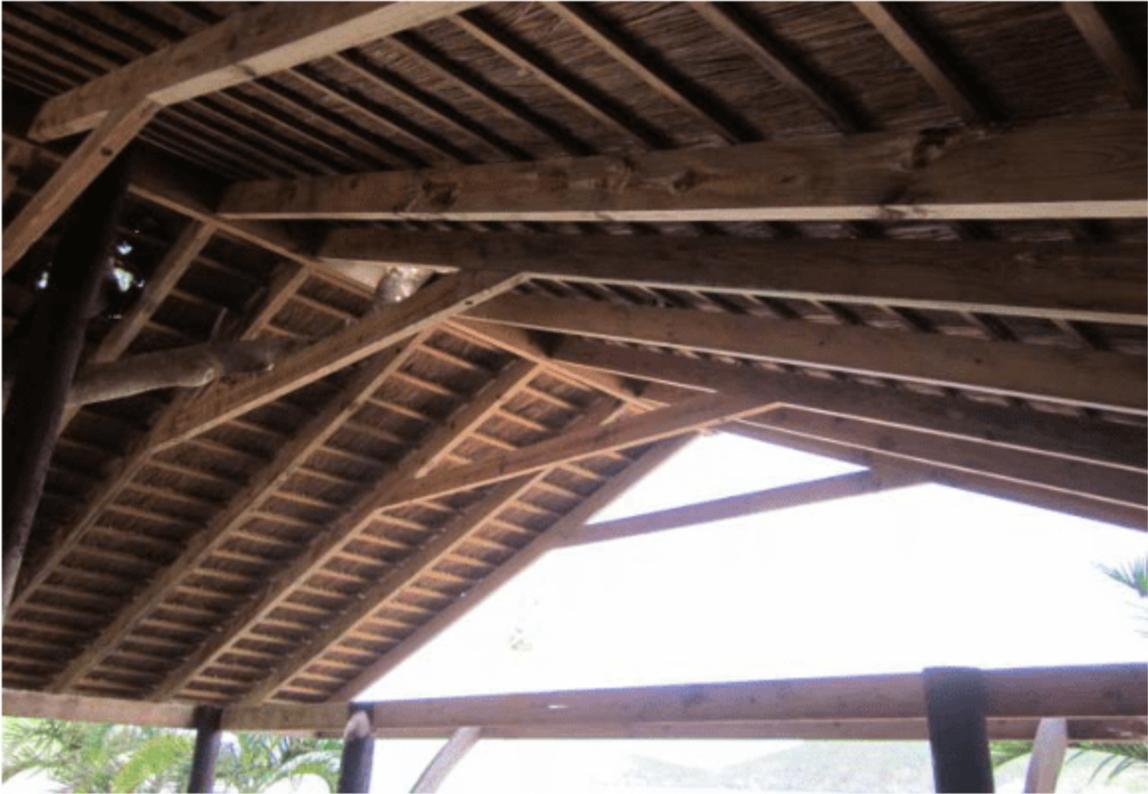
Tiki House – Wood frame structure with thatched roof, clay tile decking, and a kitchenette. Approximately 1,564 sq ft in size. Current replacement cost is \$61,000. Damage to thatched roof structure.

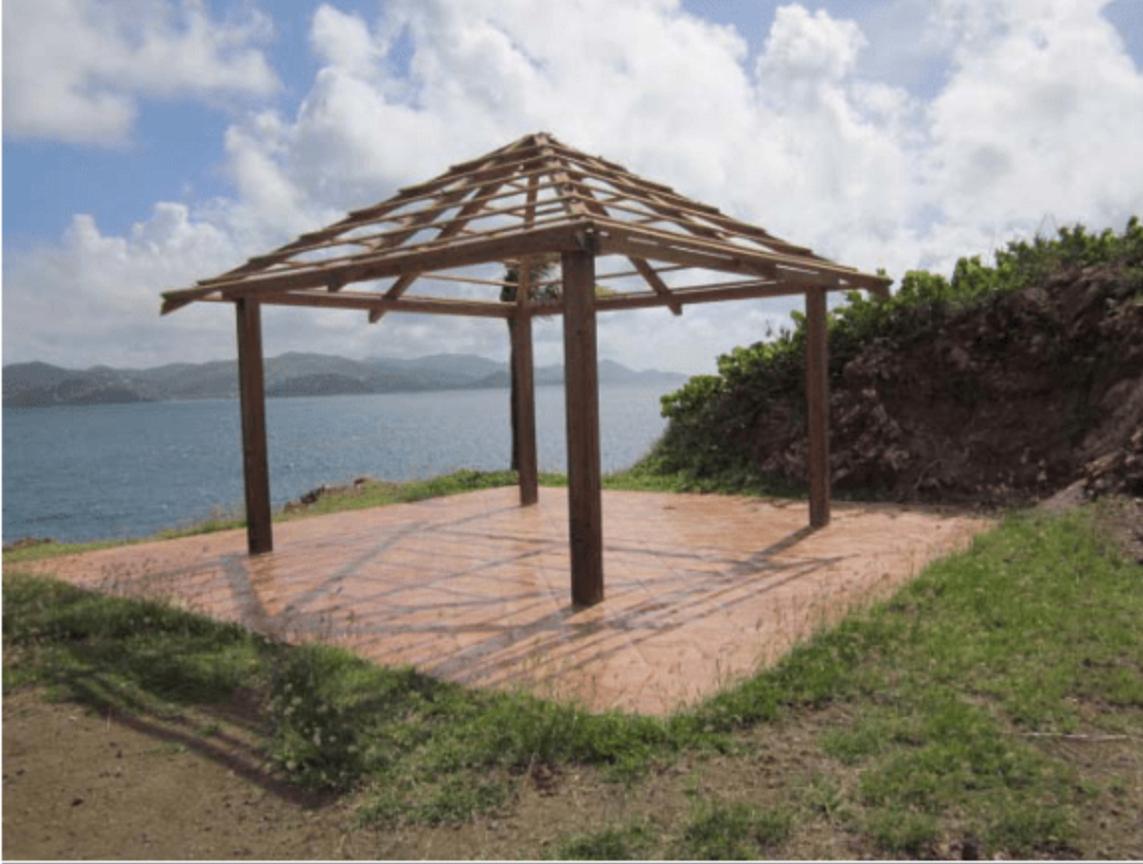
St. John's Massage Cabana – Frame structure with thatched roof.
Approximately 122 sf in size. Thatched roof completely missing from structure.
Current replacement cost is \$15,000. (Not listed on prior inspection)

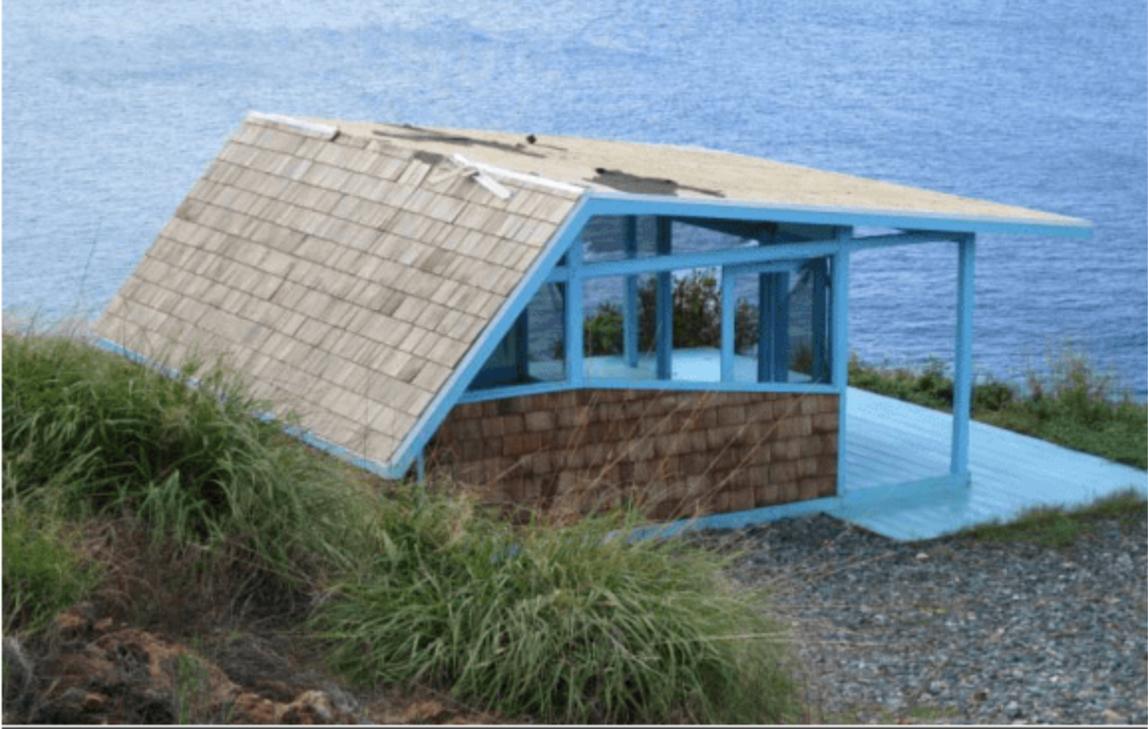
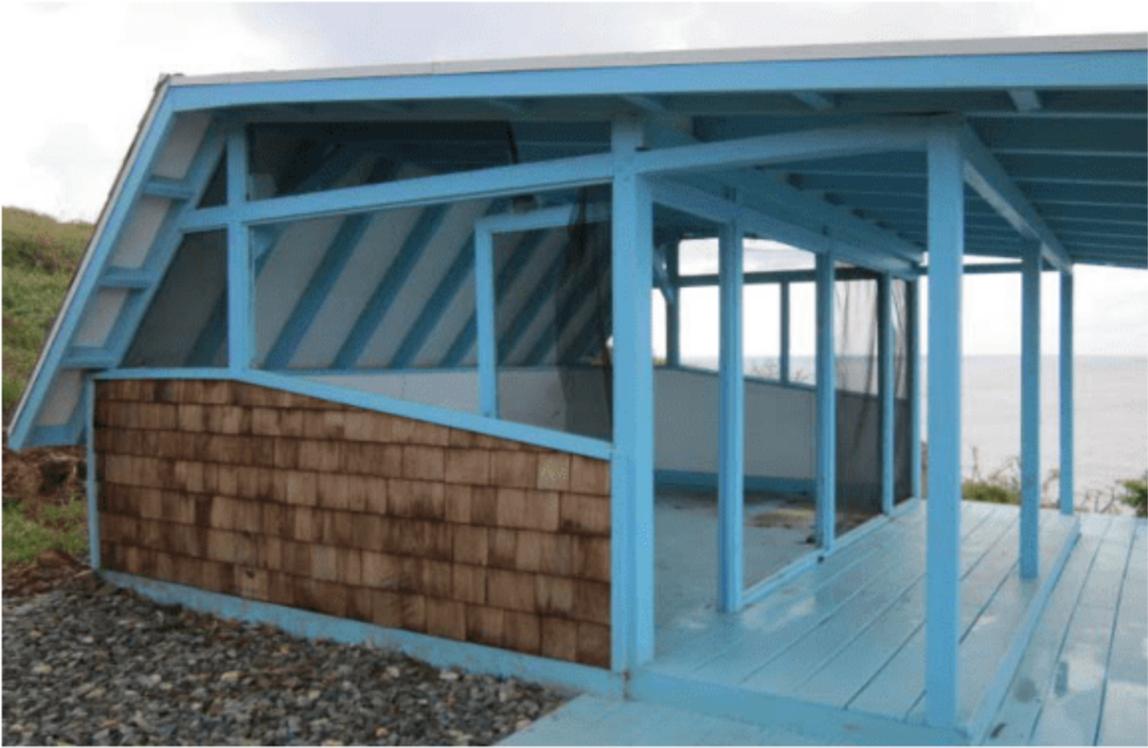
Small Beach Cabin – Frame structure with cedar shake siding. Includes a covered area of 75 sf and a screened area of 165 sf. Damage occurred to the roof with some tiles being ripped from the decking and the screen was damaged. Current replacement cost is \$30,000.

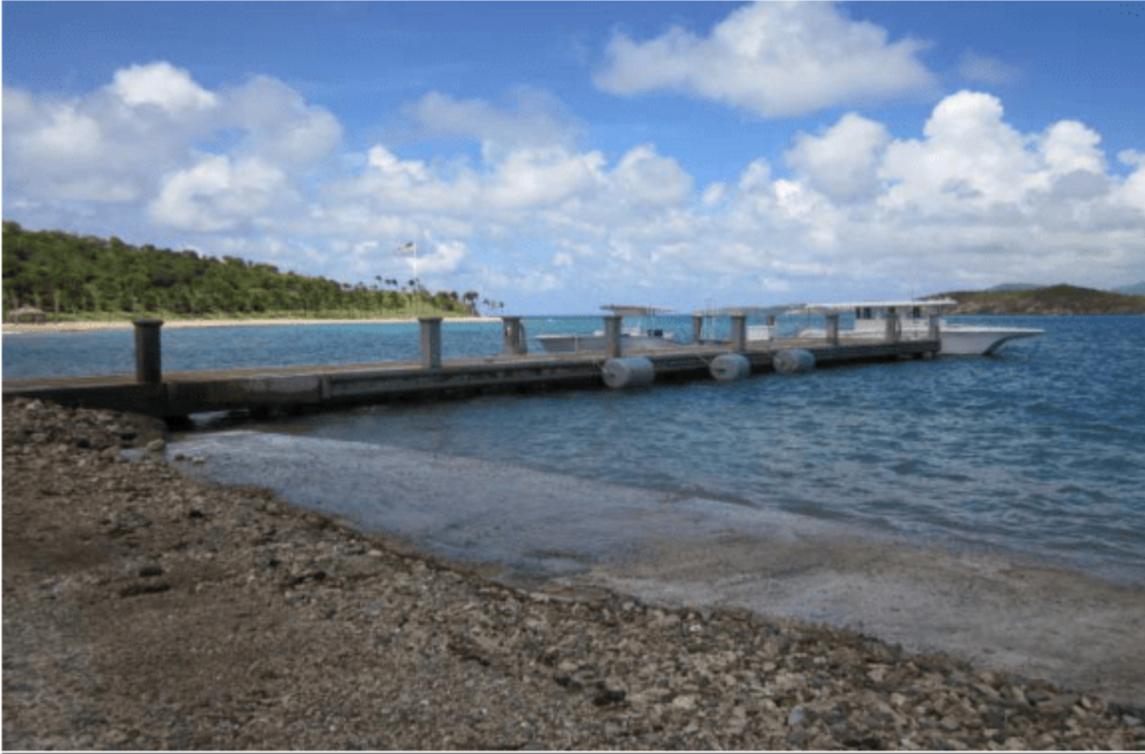
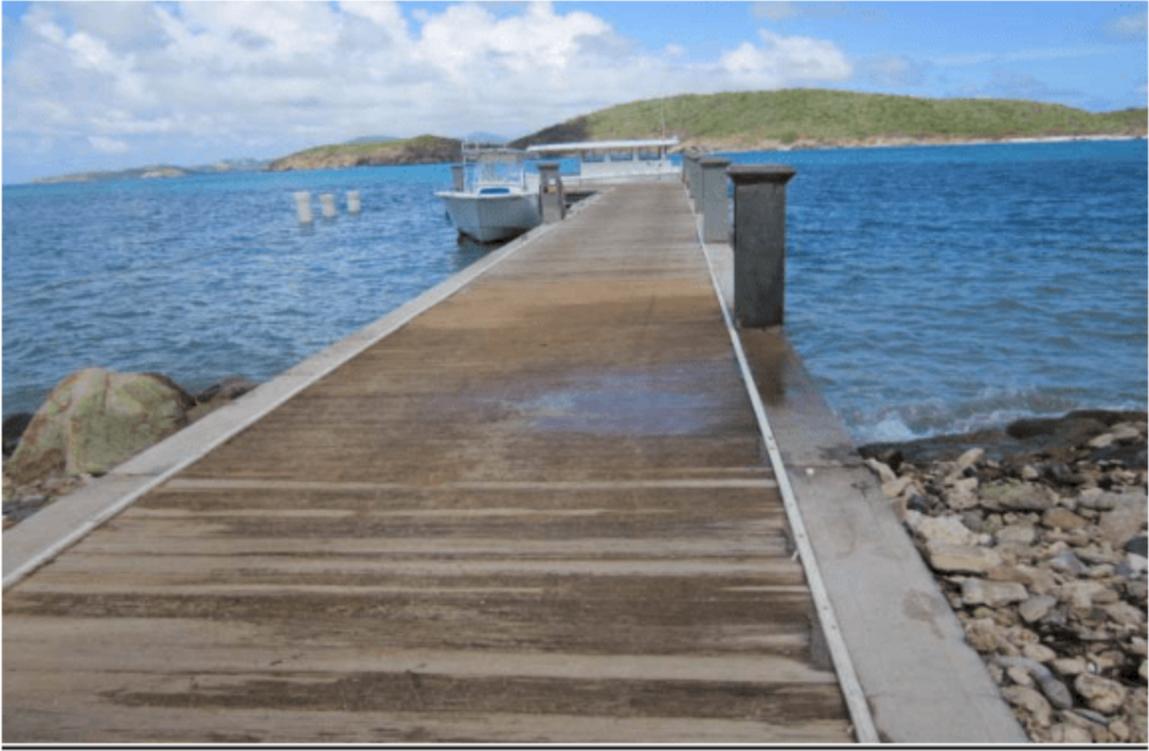
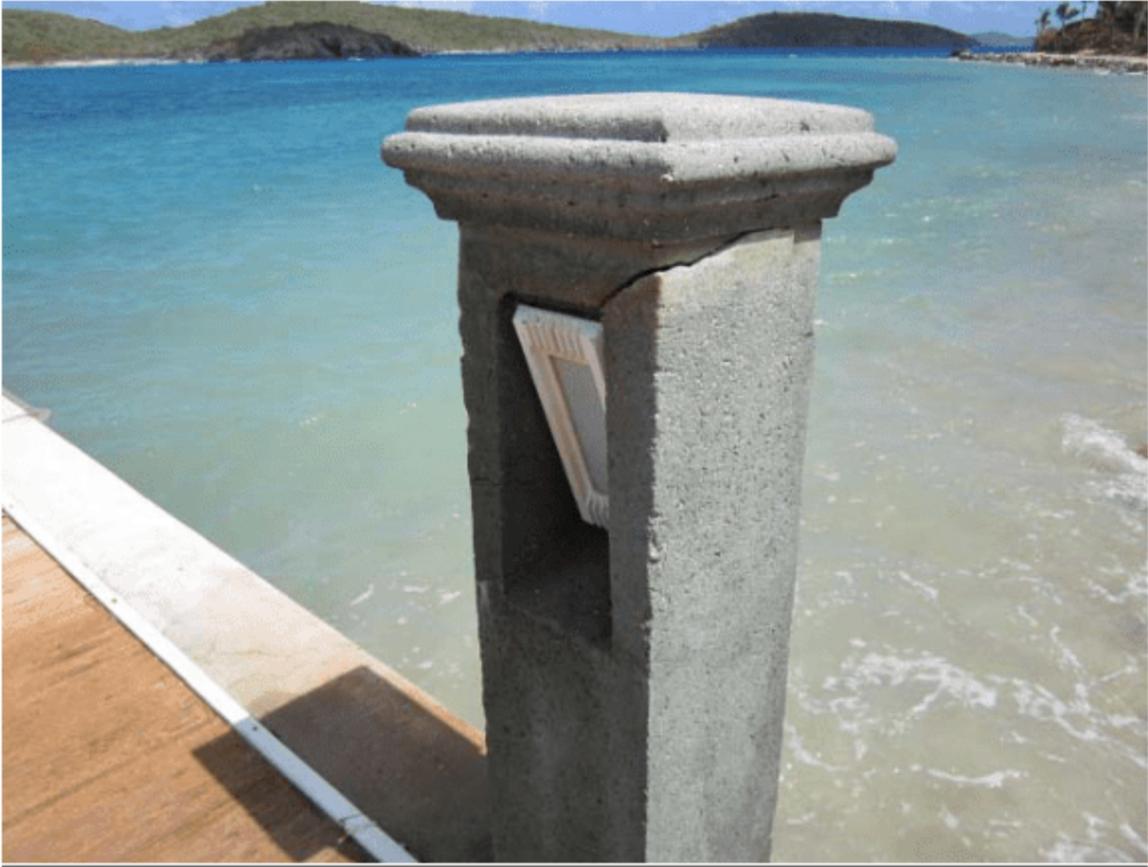
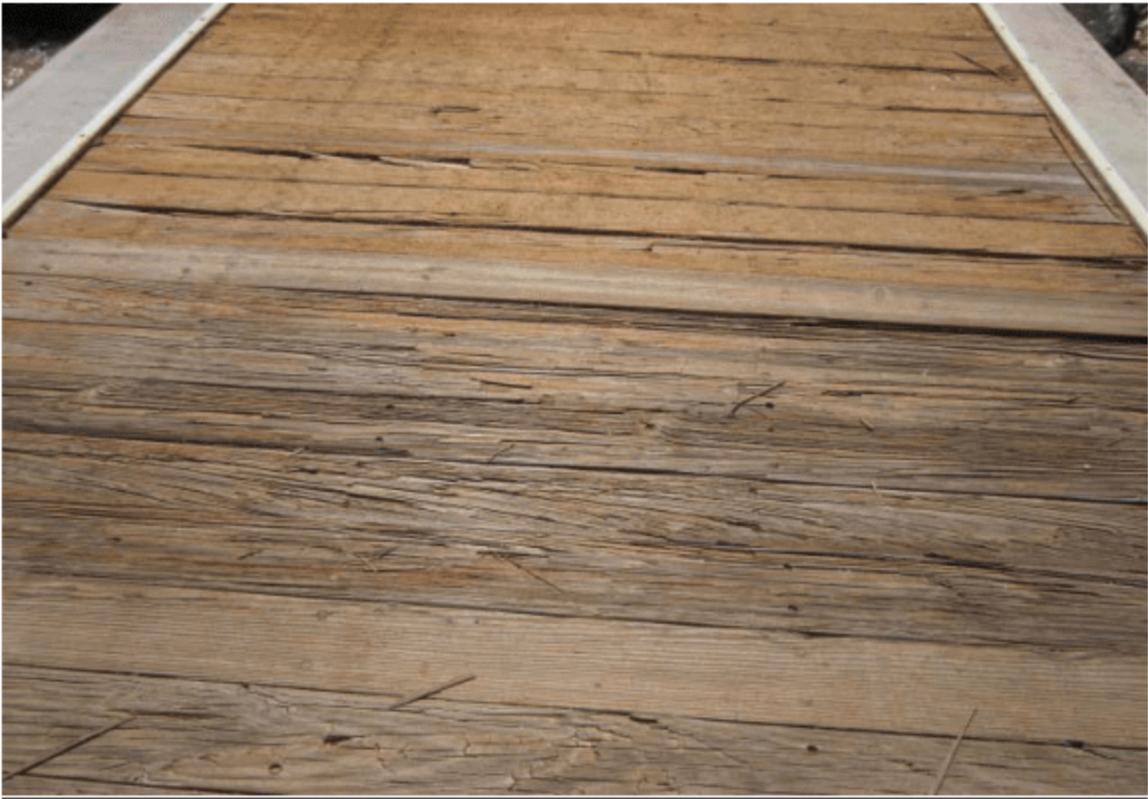
Boat Dock – Located at entrance to residential island. Constructed of concrete pilings, concrete dock, and wood decking. Carpet covering, wood decking and concrete pilings were damaged. (Damaged carpet has been removed). Current replacement cost is \$608,000.
