**APPLICATION FORMS AND ENVIRONMENTAL ASSESSMENT
FOR THE CONSTRUCTION OF TWO DOCKS AND A BARGE LANDING
ON GREAT ST. JAMES ISLAND
U.S. VIRGIN ISLANDS**

Re: Major Water Permit Application for the Construction of a Temporary Barge Landing, an Access Dock, and a Combination Dock and Barge Landing

**ENVIRONMENTAL ASSESSMENT
FOR THE CONSTRUCTION OF TWO DOCKS AND A BARGE
LANDING
ON GREAT ST. JAMES ISLAND
U.S. VIRGIN ISLANDS**

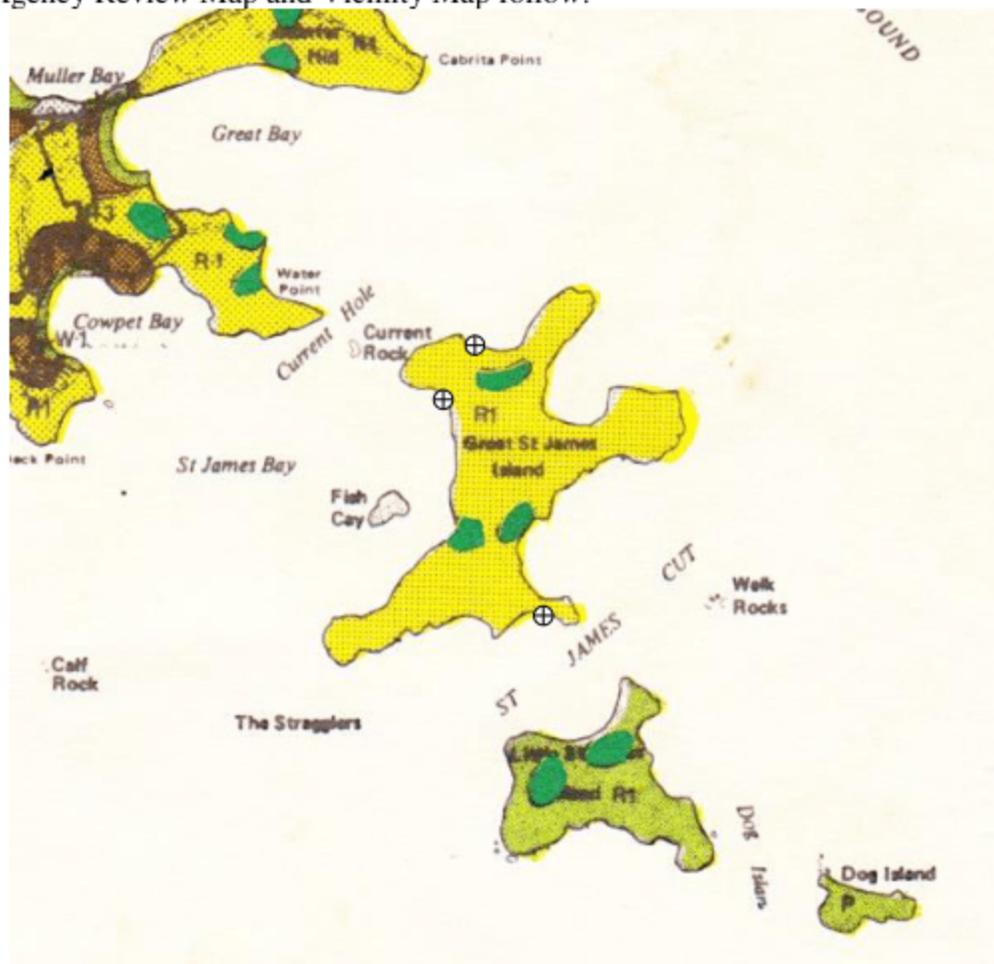
Figure 2.01 Agency Review Map, the entire island of Great St. James is within CZM first tier jurisdiction. The dock locations on the island are indicated.

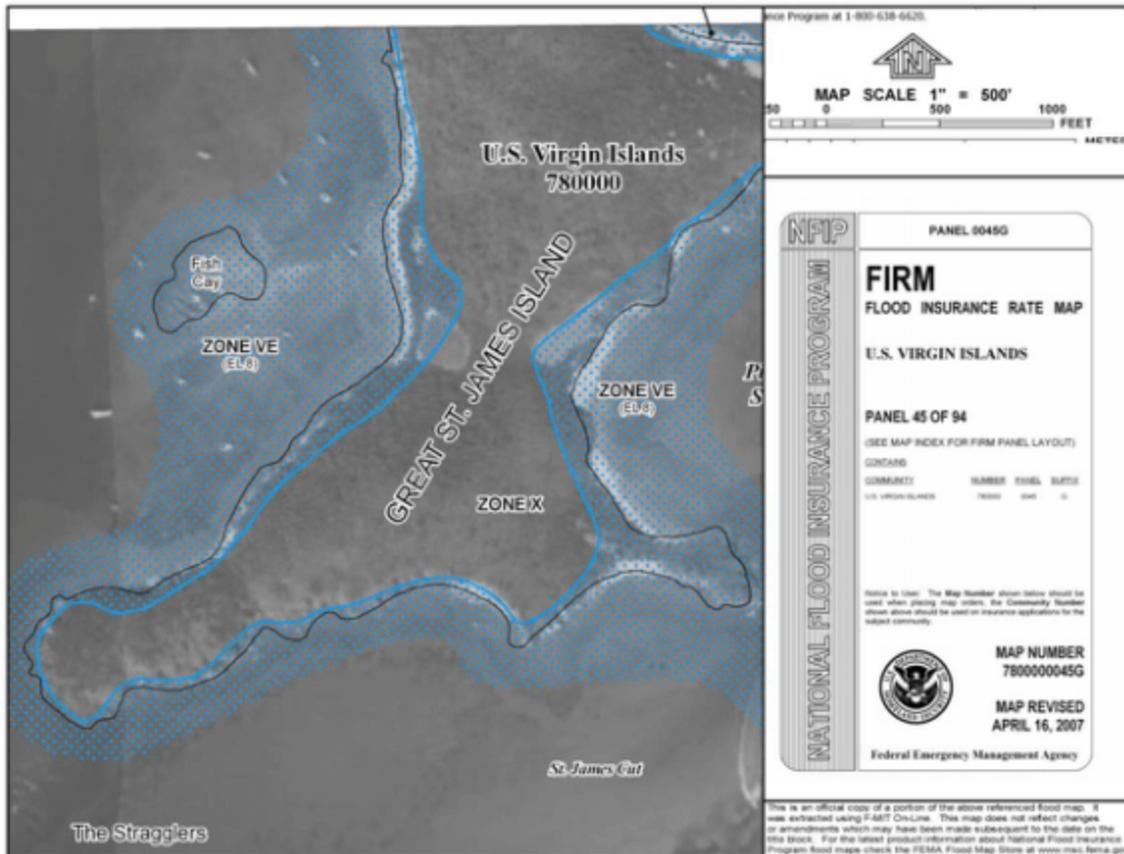
Figure 6.02.2. FEMA FIRM Map Panel 45 of 94.

All three sites lie with area VE elevation 8ft where FEMA has determined that the 100-year flood elevation with velocity will be 8ft as shown on FIRM maps 45 and 30 below.

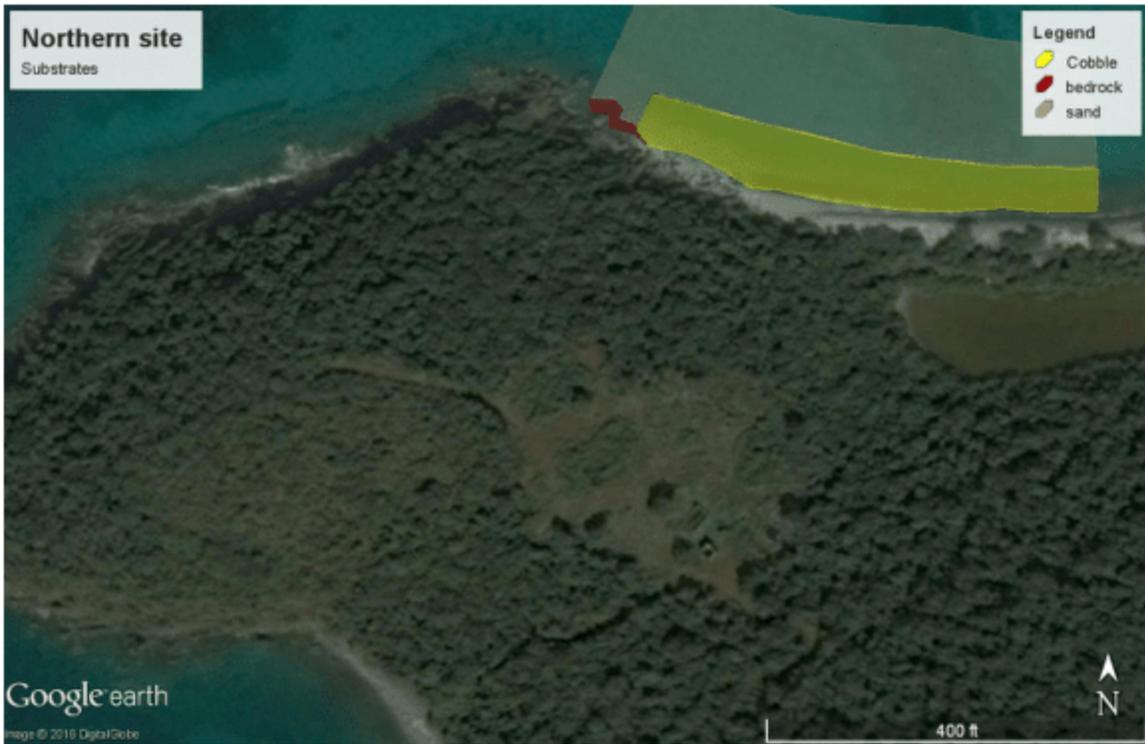
Figure 6.06.2. Benthic habitats at the barge landing.

The temporary barge landing is located at the western end of the north-west bay. The landing. The beach is cobble and the cobbles extend out to a depth of 7ft at the landing site. The landing site contains some scattered *Millepora complanata*, but no hard-coral species. There are scattered corals to the east in the cobble including a few *Orbicella annularis* and *Acropora palmata*. *Porites astreoides* is the most abundant coral in the cobble to the east. The location for the barge ramp was chosen due to the presence of corals and coral colonized boulders throughout the bay to the east. To the east in the bay there are numerous *Orbicella annularis*, *O. faveolata* and *Dendrogyra cylindrus* as well as other coral species. Offshore there are dense seagrass beds consisting of *Thalassia testudinum* and *Syringodium filiforme*, however these are greater than the 75ft off shore which the barge will extend while moored. There very sparse *Syringodium* colonization within the barge approach, representing less than 5% bottom coverage.

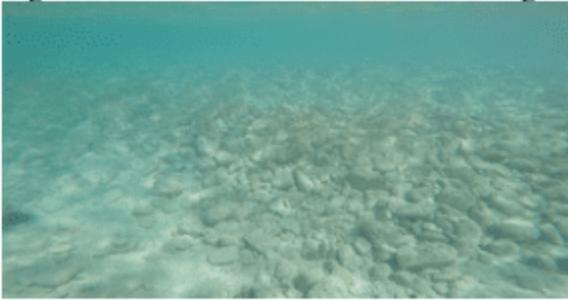
Cobble in footprint of barge mooring site

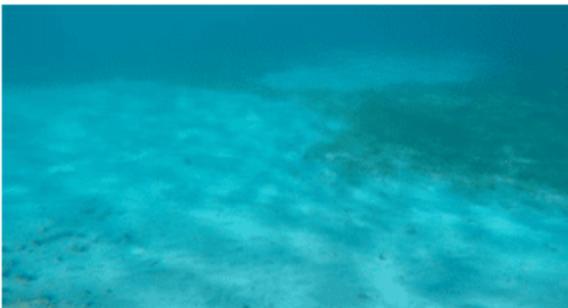
Seagrass offshore well beyond the cobble

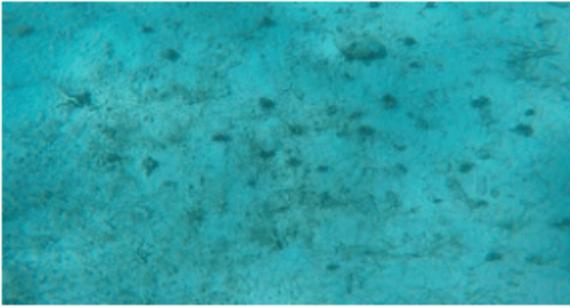
Sparse seagrass in the immediate barge

approach

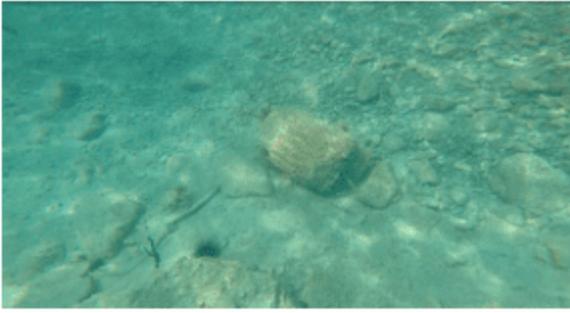
Old piling

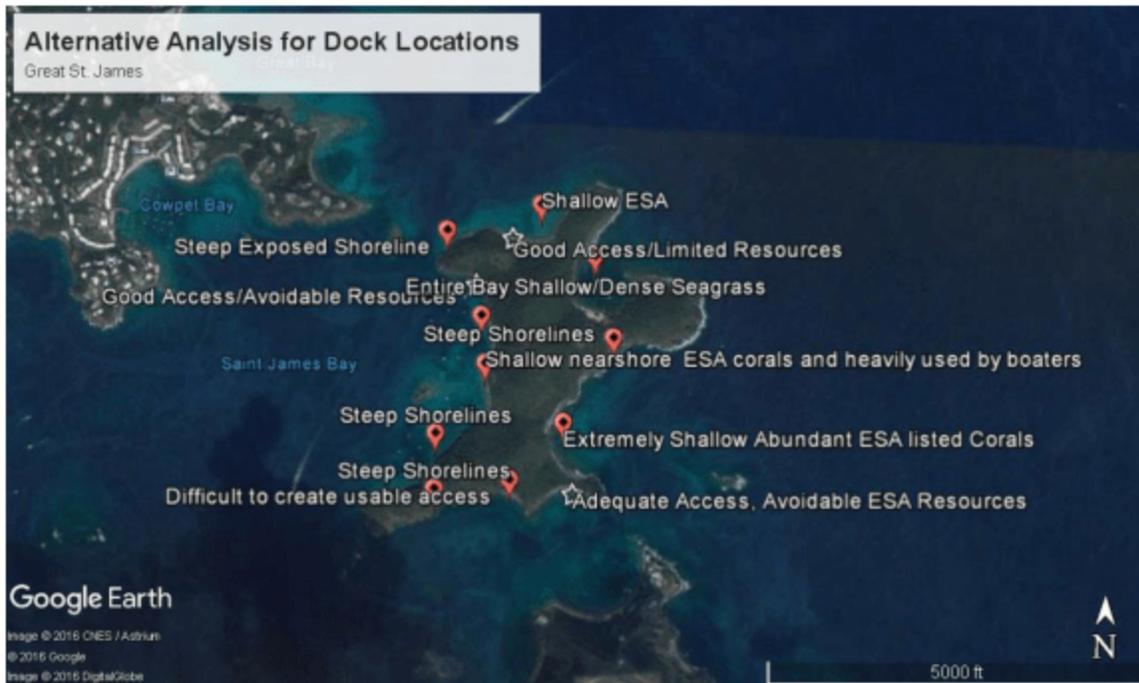
Figure 9.01 Options considered

On Christmas Cove there are several areas where a dock could be extended from the shoreline with similar potential impacts as the proposed dock, however, the areas further to the south would have greater seagrass impact, could impact the salt pond and would have a significant impact on the public use of Christmas Cove since the dock would extend into the highly used mooring area. The area selected in Christmas Cove is at the far end of the cove and therefore will not result in boat traffic through the mooring field.

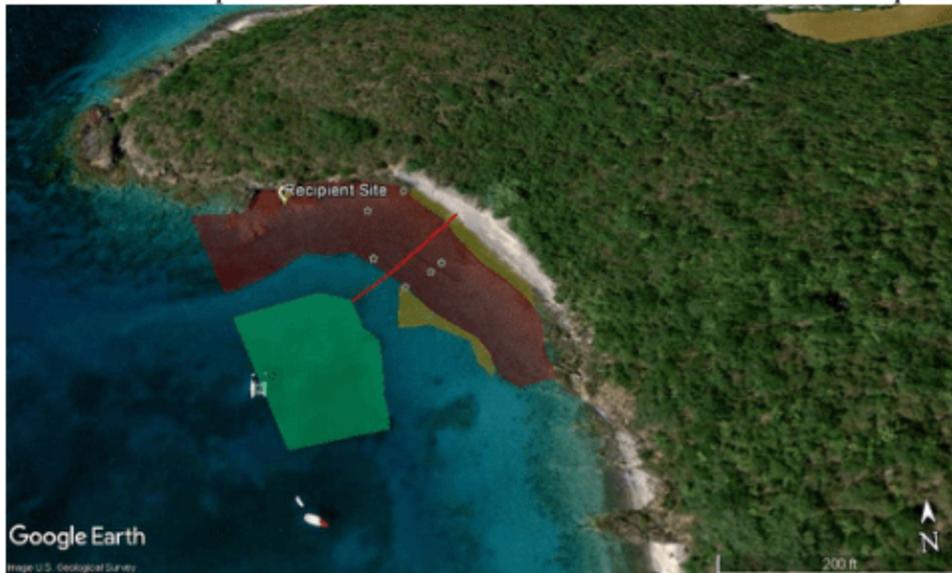
Figure 1. Recipient site Christmas Cove

The corals from the Christmas Cove site will be located to the north onto the adjacent hardbottom areas which are at equivalent depths. The corals from the southeastern dock site will be transplanted to the hardbottom to the south which are at equivalent depths.

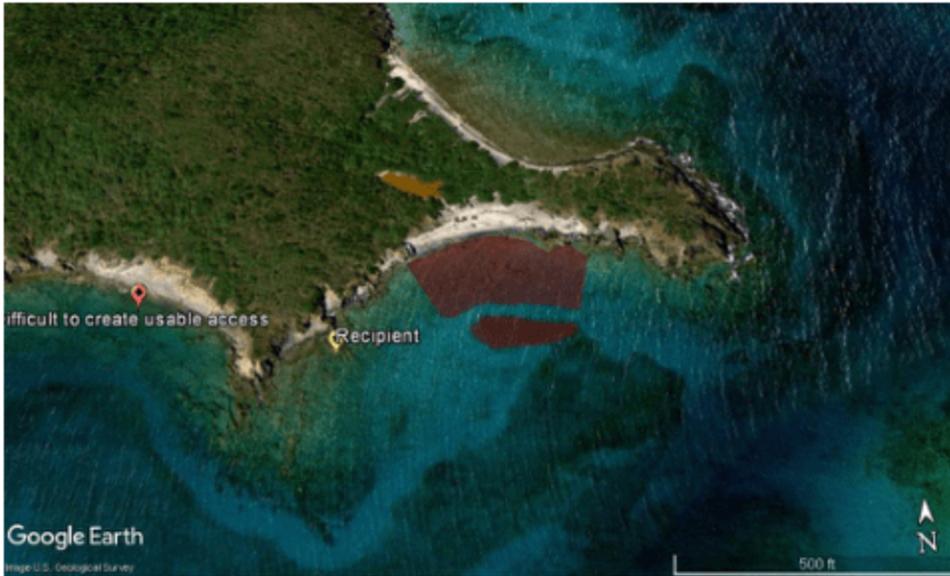
Figure 2. Recipient site southeastern dock

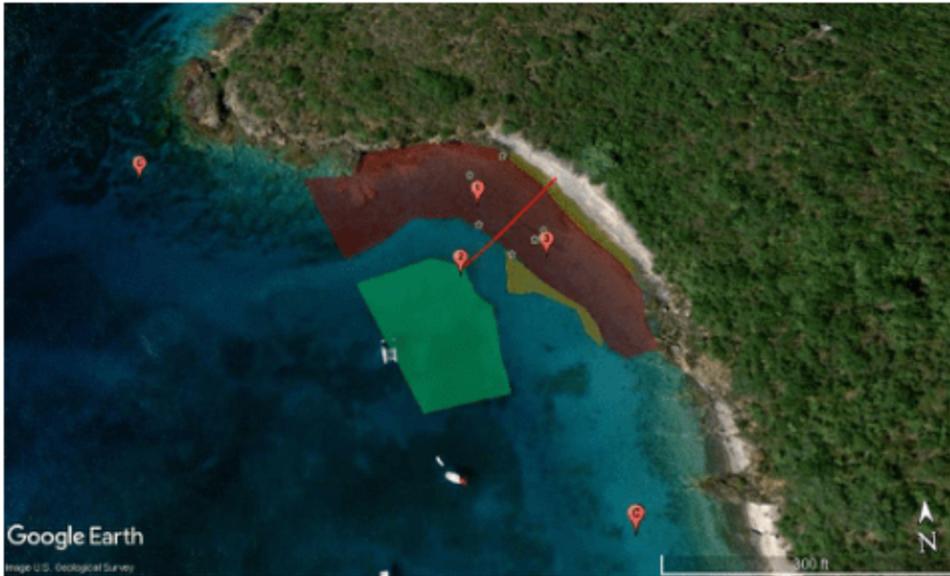
Figure 1. Christmas Cove Monitoring Stations and Controls

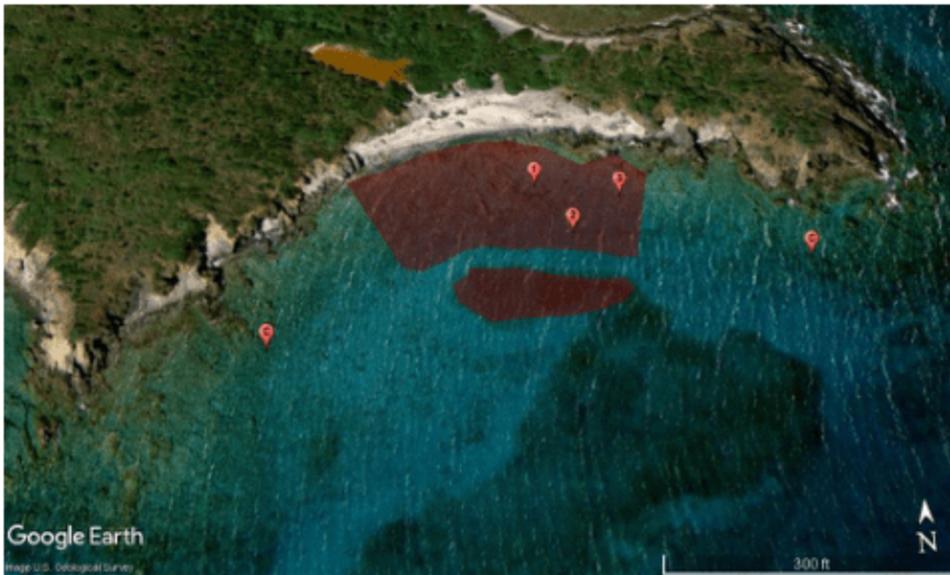
Figure 2. Southeastern monitoring stations and controls
