**ENVIRONMENTAL ASSESSMENT
FOR THE CONSTRUCTION OF TWO DOCKS AND A BARGE
LANDING
ON GREAT ST. JAMES ISLAND
U.S. VIRGIN ISLANDS**

GREAT ST. JIM, LLC.

BIOIMPACT, INC.
P.O. BOX 132
KINGSHILL, ST. CROIX
U.S. VIRGIN ISLANDS 00851
bioimpact@islands.vi

REVISED JANUARY 2018

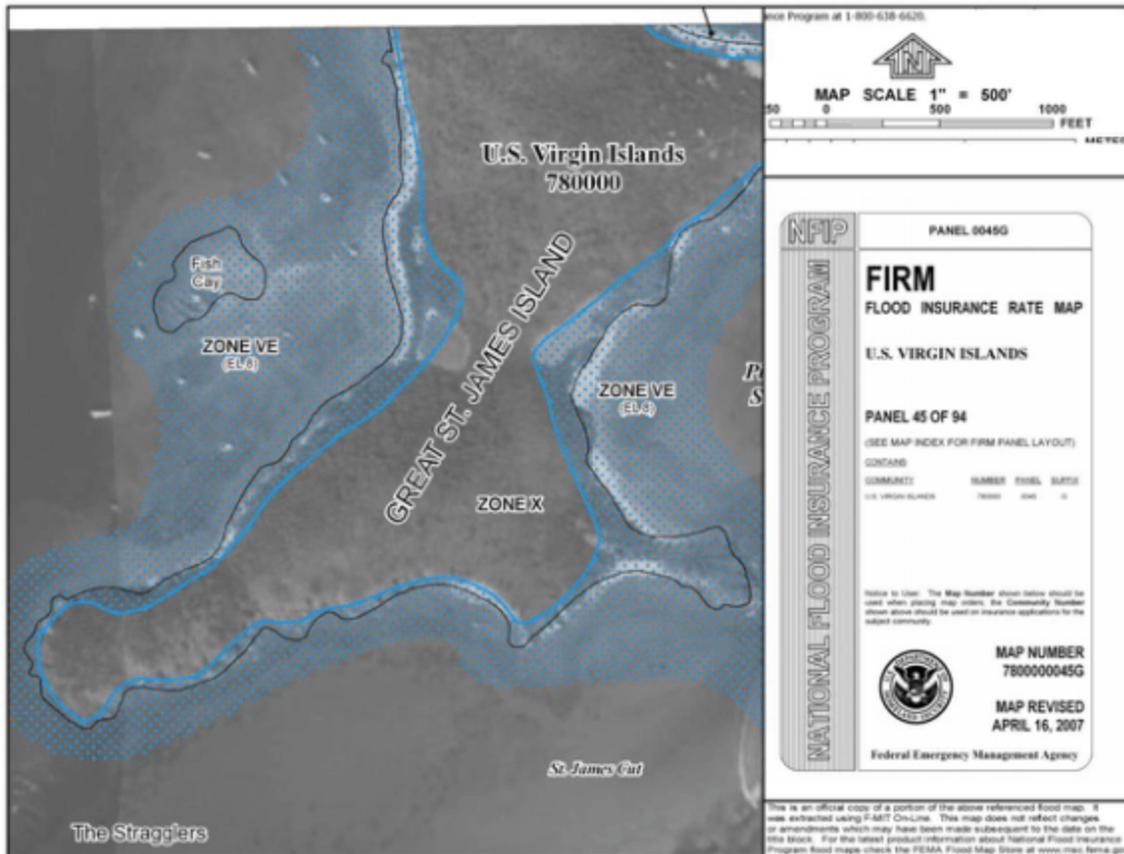
All three sites lie with area VE elevation 8ft where FEMA has determined that the 100-year flood elevation with velocity will be 8ft as shown on FIRM maps 45 and 30 below.

Figure 6.02.2. FEMA FIRM Map Panel 45 of 94.

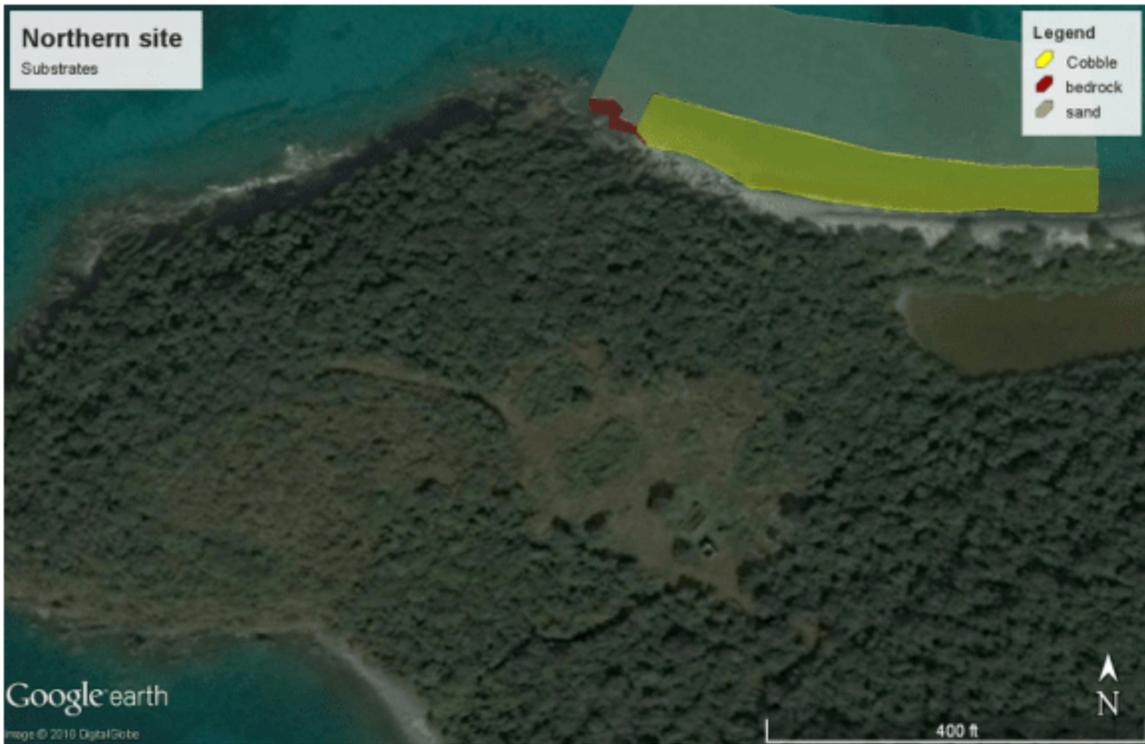
The temporary barge landing is located at the western end of the north-west bay. The landing. The beach is cobble and the cobbles extend out to a depth of 7ft at the landing site. The landing site contains some scattered *Millepora complanata*, but no hard-coral species. There are scattered corals to the east in the cobble including a few *Orbicella annularis* and *Acropora palmata*. *Porites astreoides* is the most abundant coral in the cobble to the east. The location for the barge ramp was chosen due to the presence of corals and coral colonized boulders throughout the bay to the east. To the east in the bay there are numerous *Orbicella annularis*, *O. faveolata* and *Dendrogyra cylindrus* as well as other coral species. Offshore there are dense seagrass beds consisting of *Thalassia testudinum* and *Syringodium filiforme*, however these are greater than the 75ft off shore which the barge will extend while moored. There very sparse *Syringodium* colonization within the barge approach, representing less than 5% bottom coverage.

Figure 6.06.2. Benthic habitats at the barge landing.

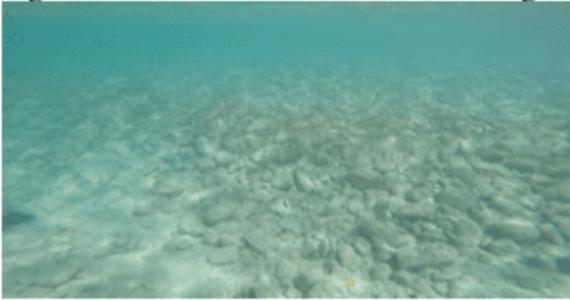
Cobble in footprint of barge mooring site

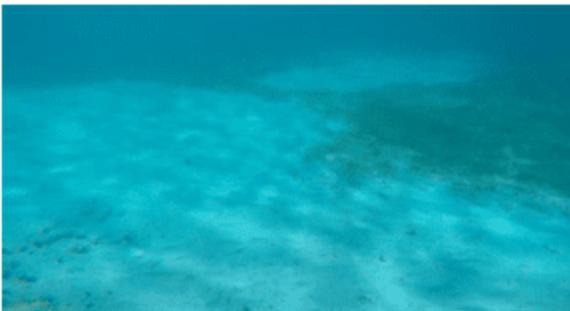
Seagrass offshore well beyond the cobble

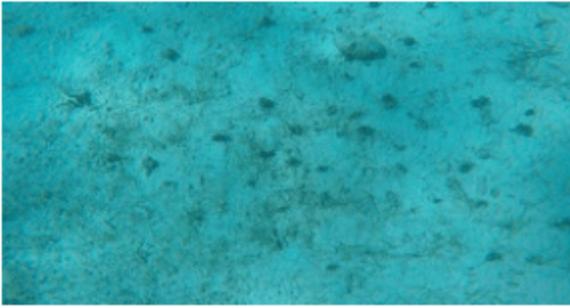
Sparse seagrass in the immediate barge

approach
