Minor Land Development Permit Application

Little St. James Island
Parcel B

For Additions to Little St. James Island, VI – Parcel B

CZM Minor Land Permit Application

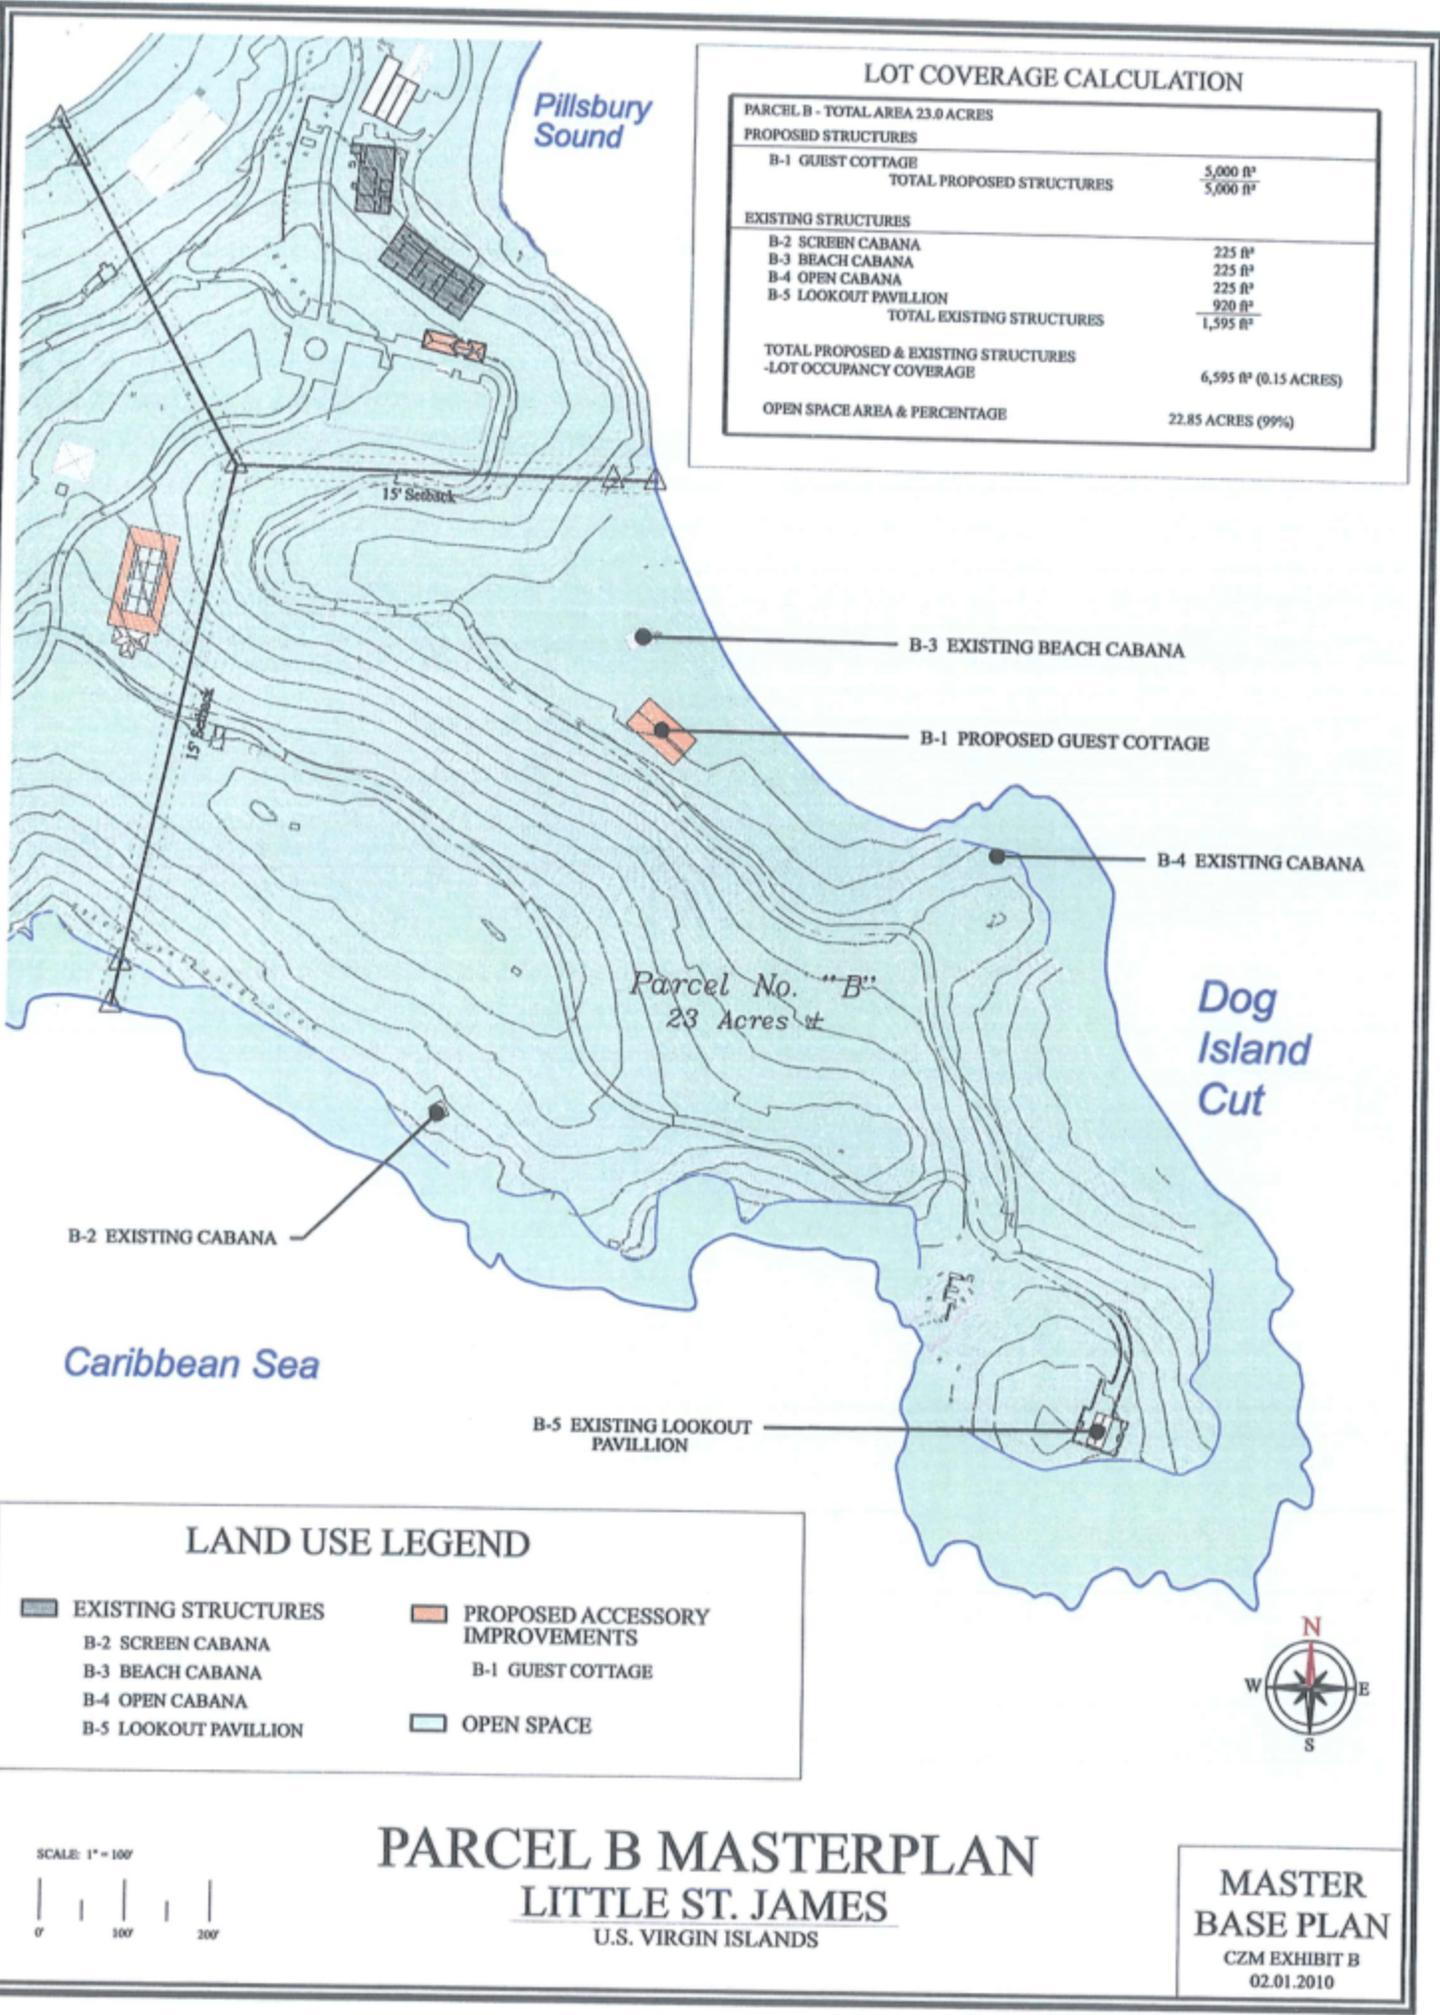
MASTER
BASE PLAN
 CZM EXHIBIT B
 02.01.2010

PARCEL B - TOTAL AREA 23.0 ACRES	
PROPOSED STRUCTURES	
B-1 GUEST COTTAGE	5,000 ft ²
TOTAL PROPOSED STRUCTURES	5,000 ft²
EXISTING STRUCTURES	
B-2 SCREEN CABANA	225 ft ²
B-3 BEACH CABANA	225 ft ²
B-4 OPEN CABANA	225 ft ²
B-5 LOOKOUT PAVILLION	920 ft ²
TOTAL EXISTING STRUCTURES	1,595 ft²
TOTAL PROPOSED & EXISTING STRUCTURES	6,595 ft² (0.15 ACRES)
-LOT OCCUPANCY COVERAGE	
OPEN SPACE AREA & PERCENTAGE	22.85 ACRES (99%)

PARCEL B MASTERPLAN
LITTLE ST. JAMES
 U.S. VIRGIN ISLANDS

LSJ is divided into three lots or parcels and is shown on Exhibit A. Parcel A is comprised of 36.7 acres, Parcel B is 23.0 acres and Parcel C is 11.8 acres for a total of 71.5 acres. Parcels A & B are very sparsely developed with most of the main house compound within Parcel C, including a main house with an accessory staff house and associated mechanical workshops for standby generators and an R/O complex which generates water.

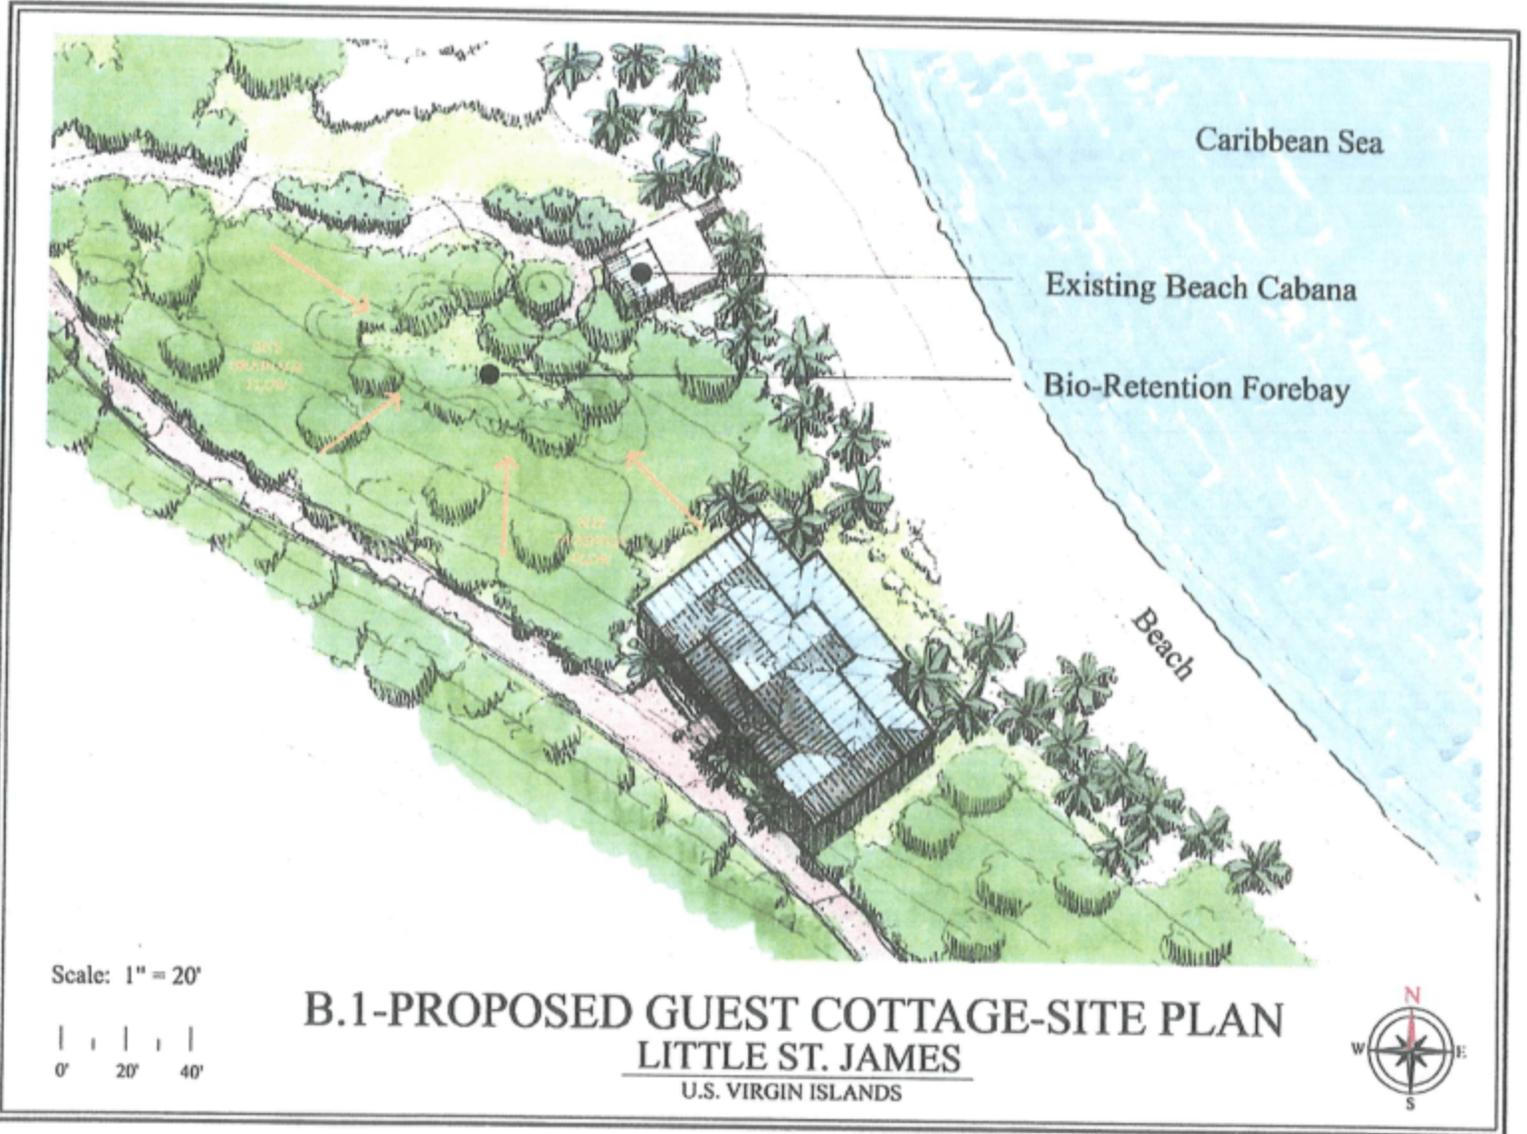
GUEST COTTAGE FLOOR PLAN
LITTLE ST. JAMES
 U.S. VIRGIN ISLANDS

Living Area.....2,260ft²
 Covered Porch.....1,800ft²
 Total.....4,060ft²

The proposed 5,000 square foot guest cottage will be constructed on the eastern side of LSJ near the beach known as Second Beach. The raised four bedroom cottage will be designed in a colonial Caribbean design and will have all of the living areas on a single floor. The cottage will be placed on the site so as to be setback from the required CZM coastal setback line. There will be minimal sitework associated with this cottage as it will be a raised pier structure and most of the surrounding site will remain in a natural state.

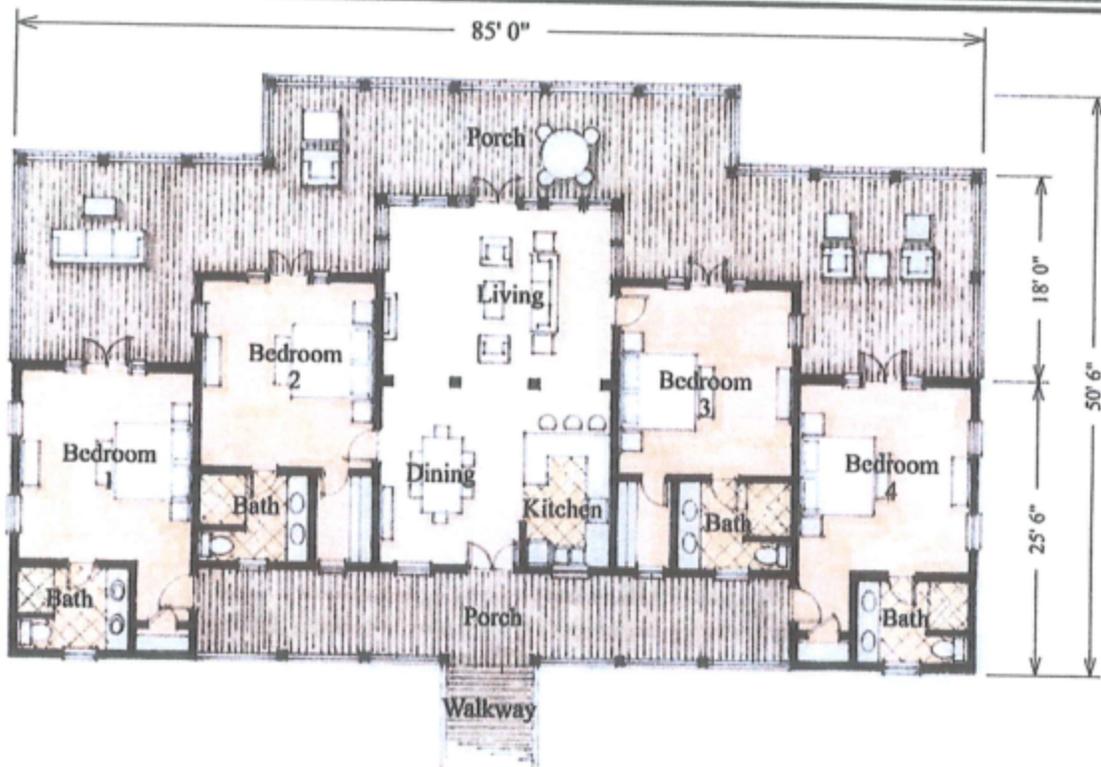
B.2-GUEST COTTAGE FLOOR PLAN
LITTLE ST. JAMES
 U.S. VIRGIN ISLANDS

Living Area.....	2,260ft ²
Covered Porch.....	1,800ft ²
Total.....	4,060ft²

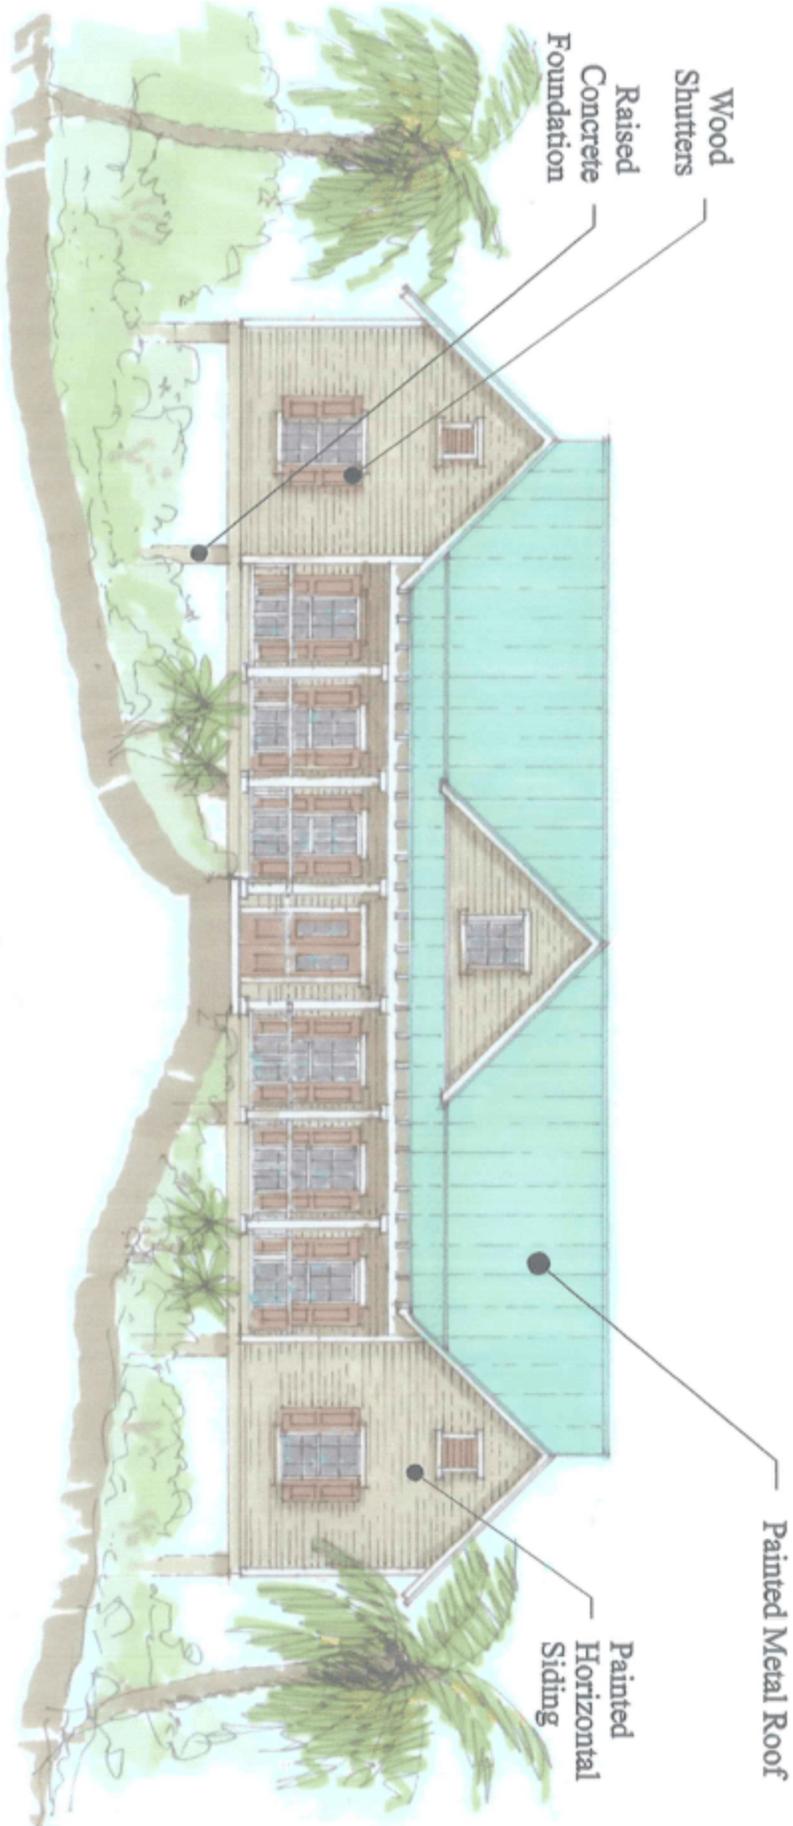
GUEST COTTAGE FRONT ELEVATION
LITTLE ST. JAMES
 U.S. VIRGIN ISLANDS

Living Area.....2,260ft²
 Covered Porch.....1,800ft²
 Total.....4,060ft²

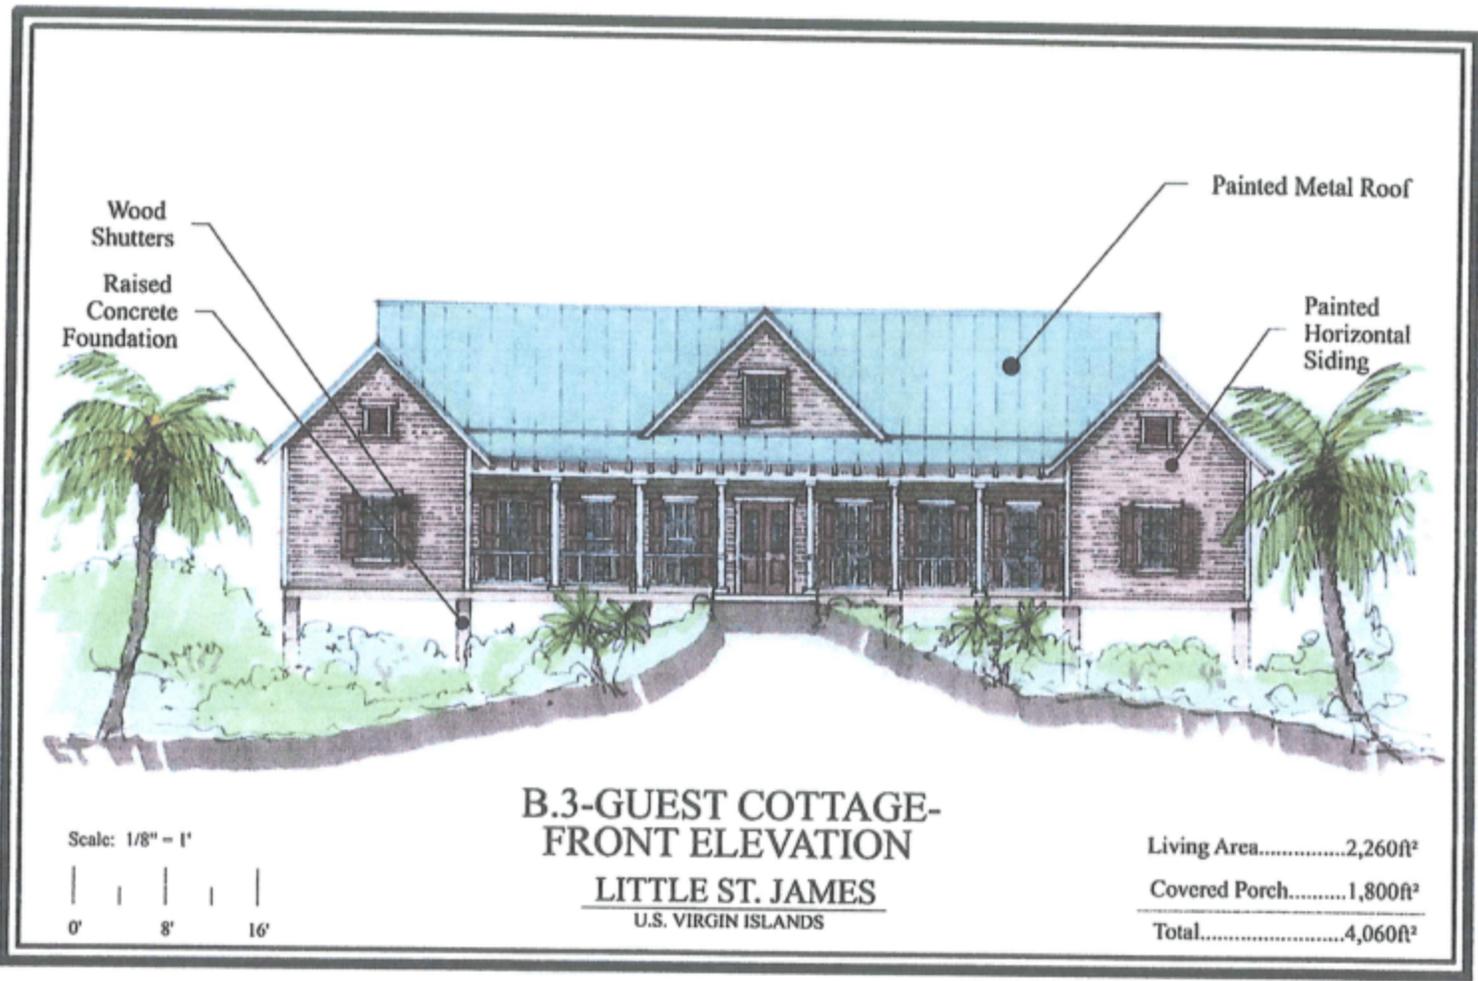
**B.3-GUEST COTTAGE-
FRONT ELEVATION**

Living Area.....	2,260ft ²
Covered Porch.....	1,800ft ²
Total.....	4,060ft ²

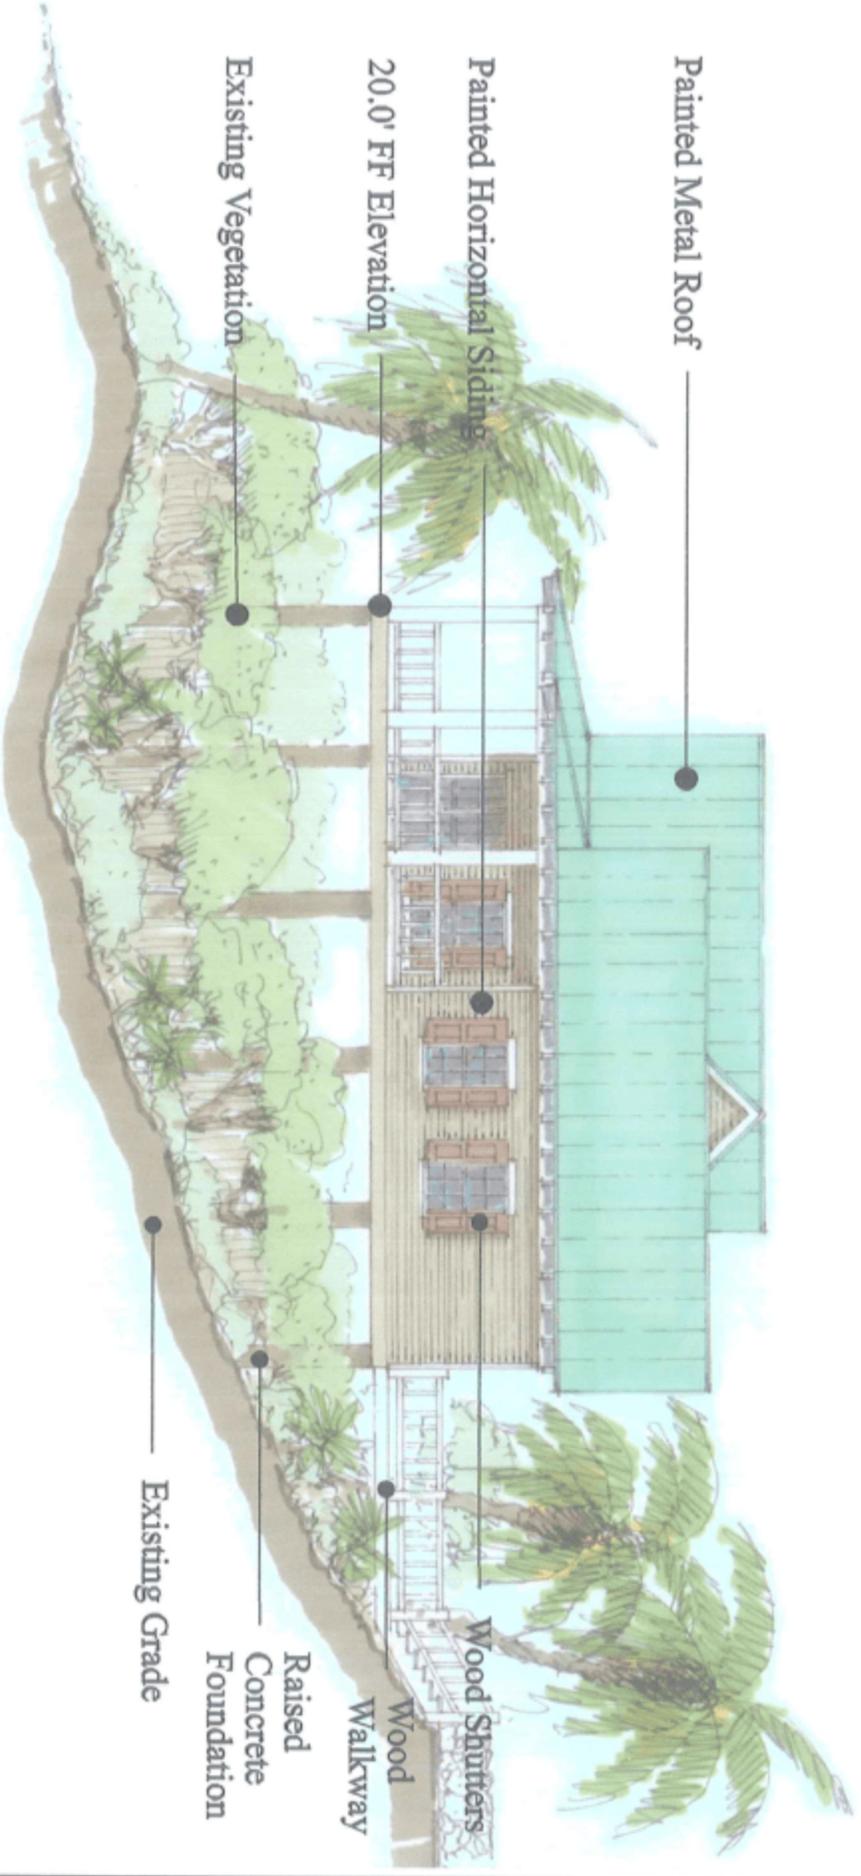
GUEST COTTAGE SIDE ELEVATION
 LITTLE ST. JAMES
 U.S. VIRGIN ISLANDS

Painted Metal Roof

Painted Horizontal Siding

20.0' FF Elevation

Wood Shutters
Wood Walkway

Raised Concrete Foundation
