Façade Inspection & Safety Program
Cycle 7A Report

9 East 71st Street
New York, NY 10021

February 2012

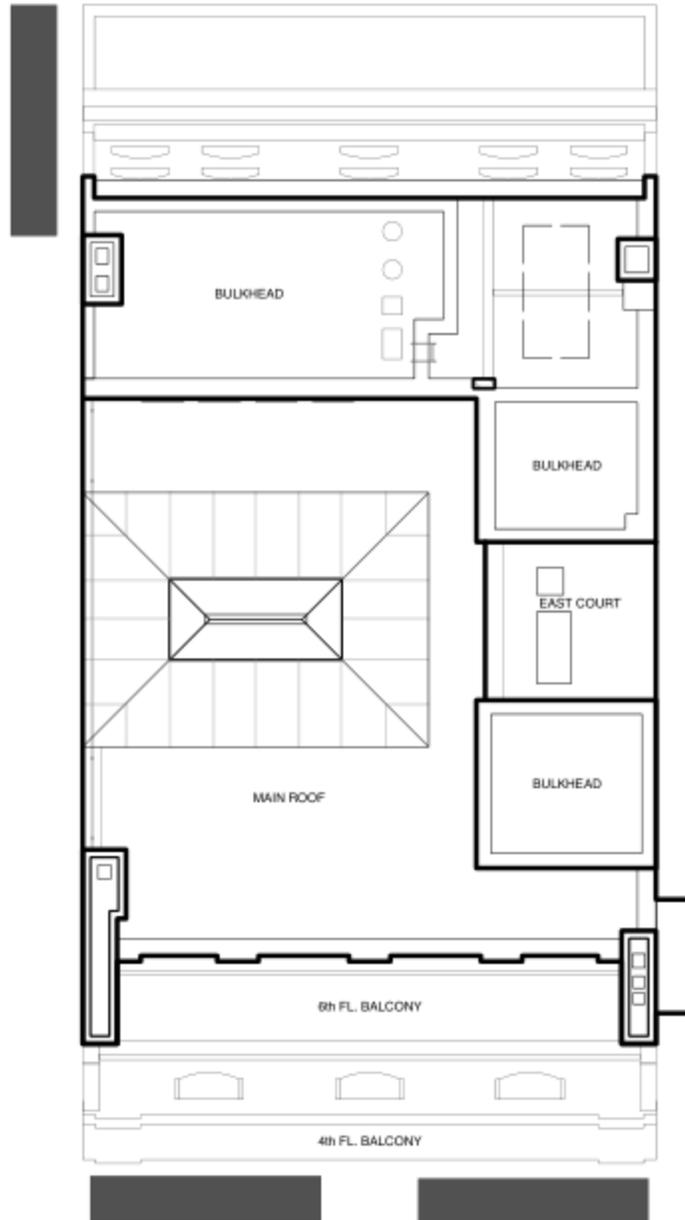
A-001

Scaffold
Inspection
Location
On 1/5/12

Scaffold
Inspection
Location
On 11/22/11

Scaffold
Inspection
Location
On 11/9/11
