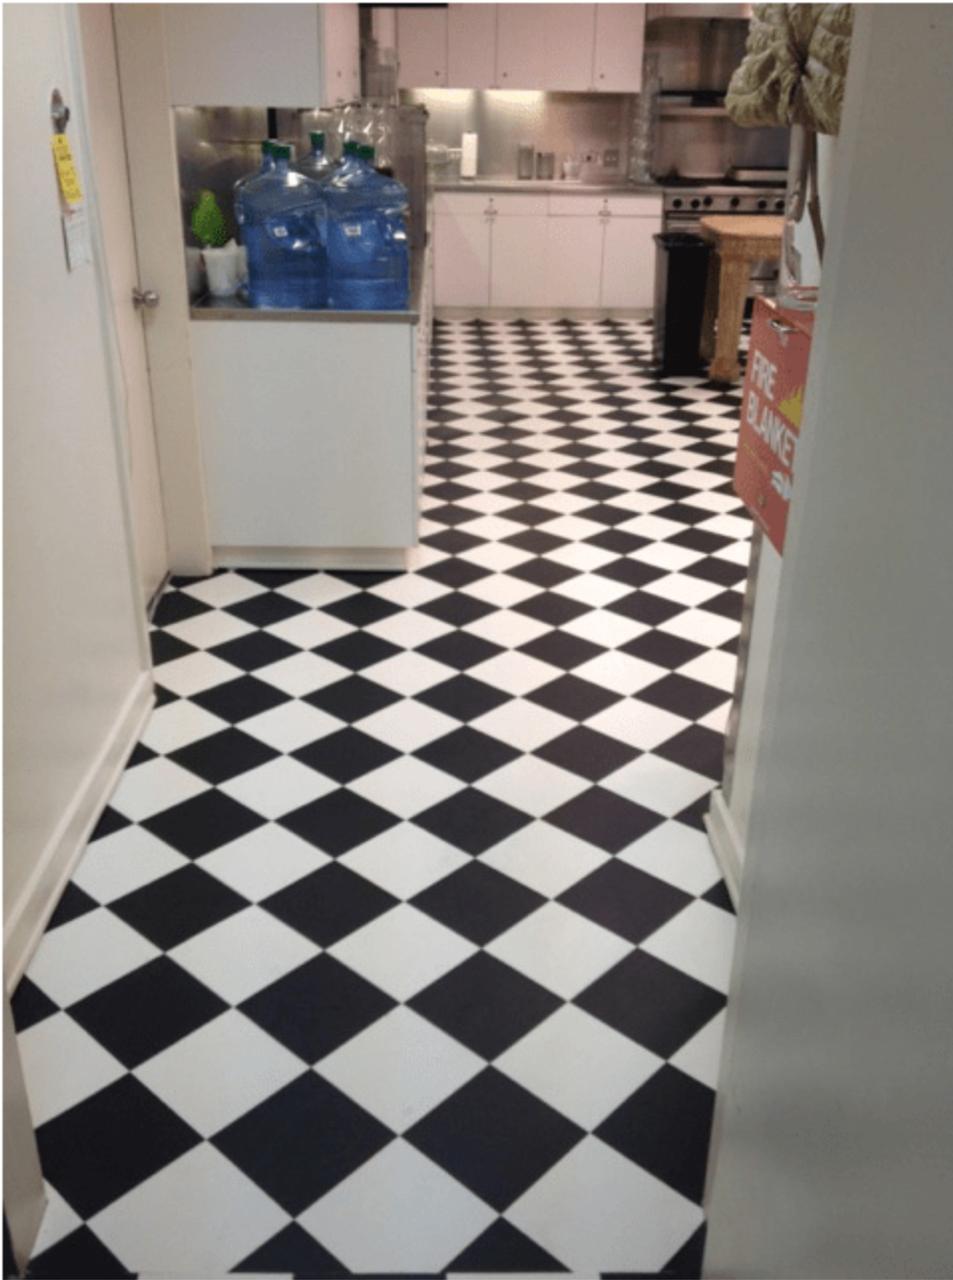
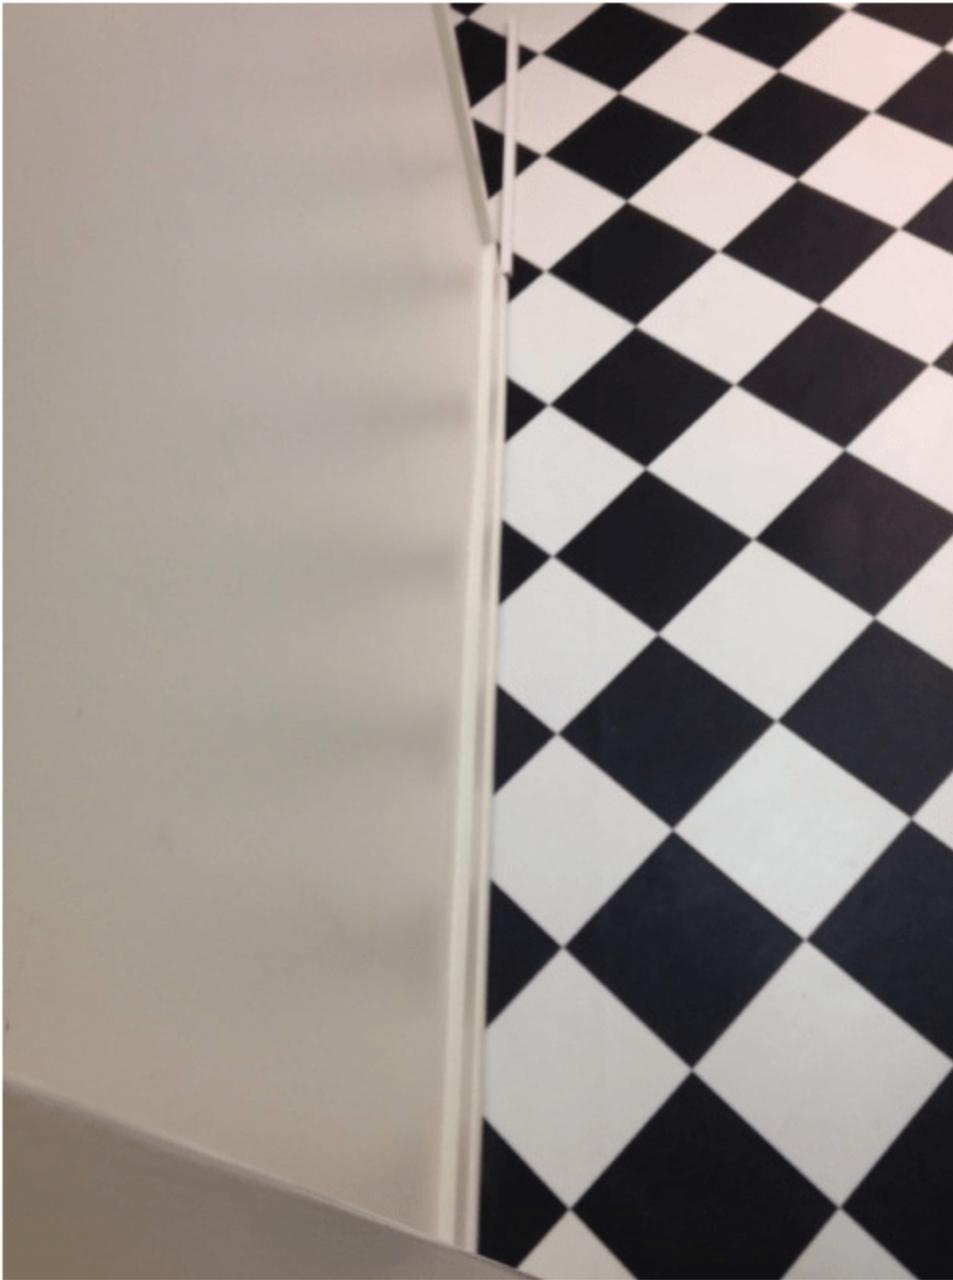
These 2 show how the design is crooked; it veers to the left. If you notice in the second photo, this is of the adjacent wall to the cabinets, it is also skewed; the black diamonds are gradually getting smaller against the wall. So, if it's crooked against both the wall and the cabinets, it would be safe to conclude that the flooring is indeed skewed itself, not that the cabinets or wall is skewed.

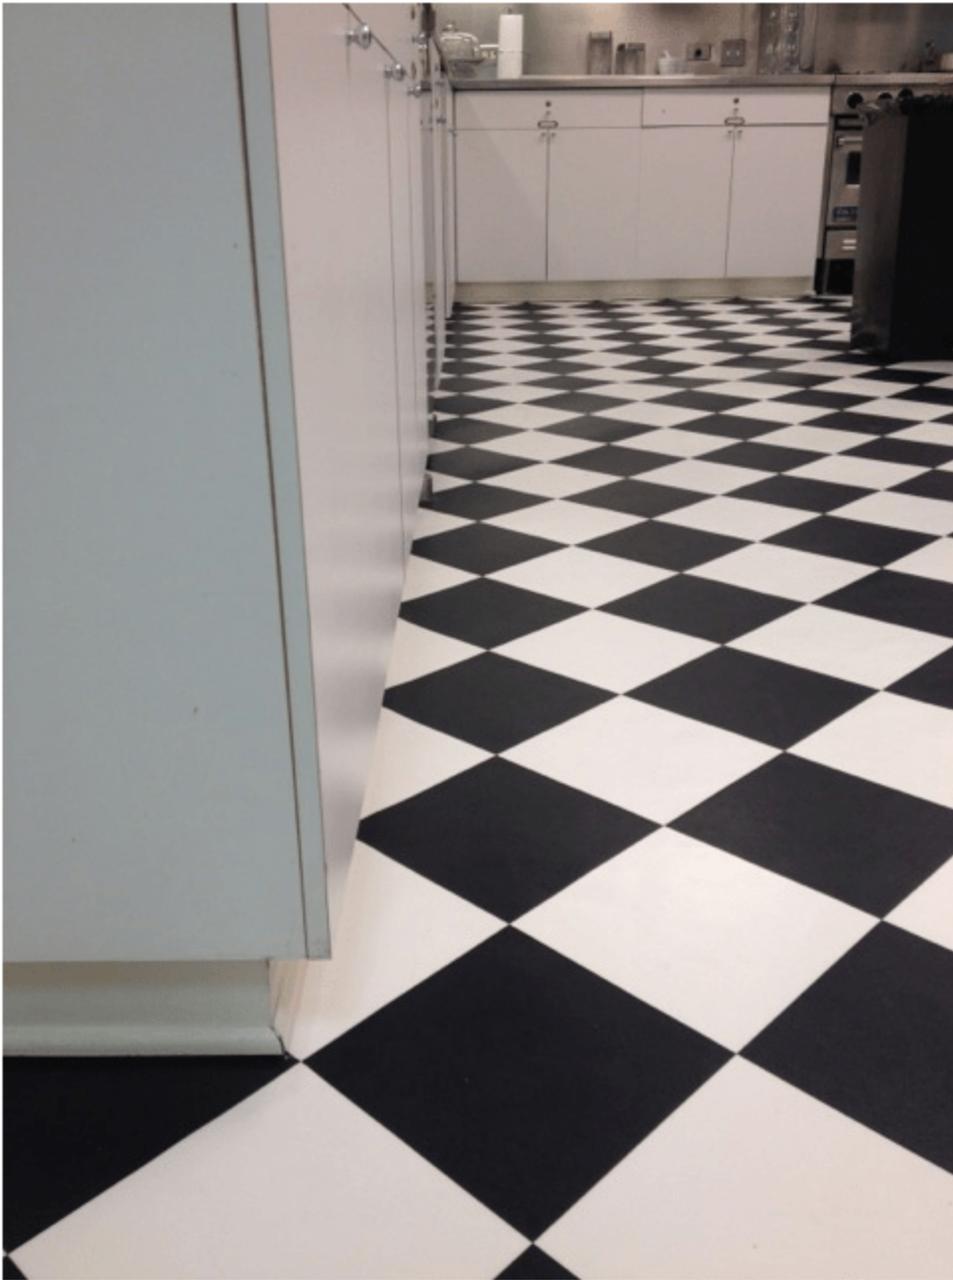
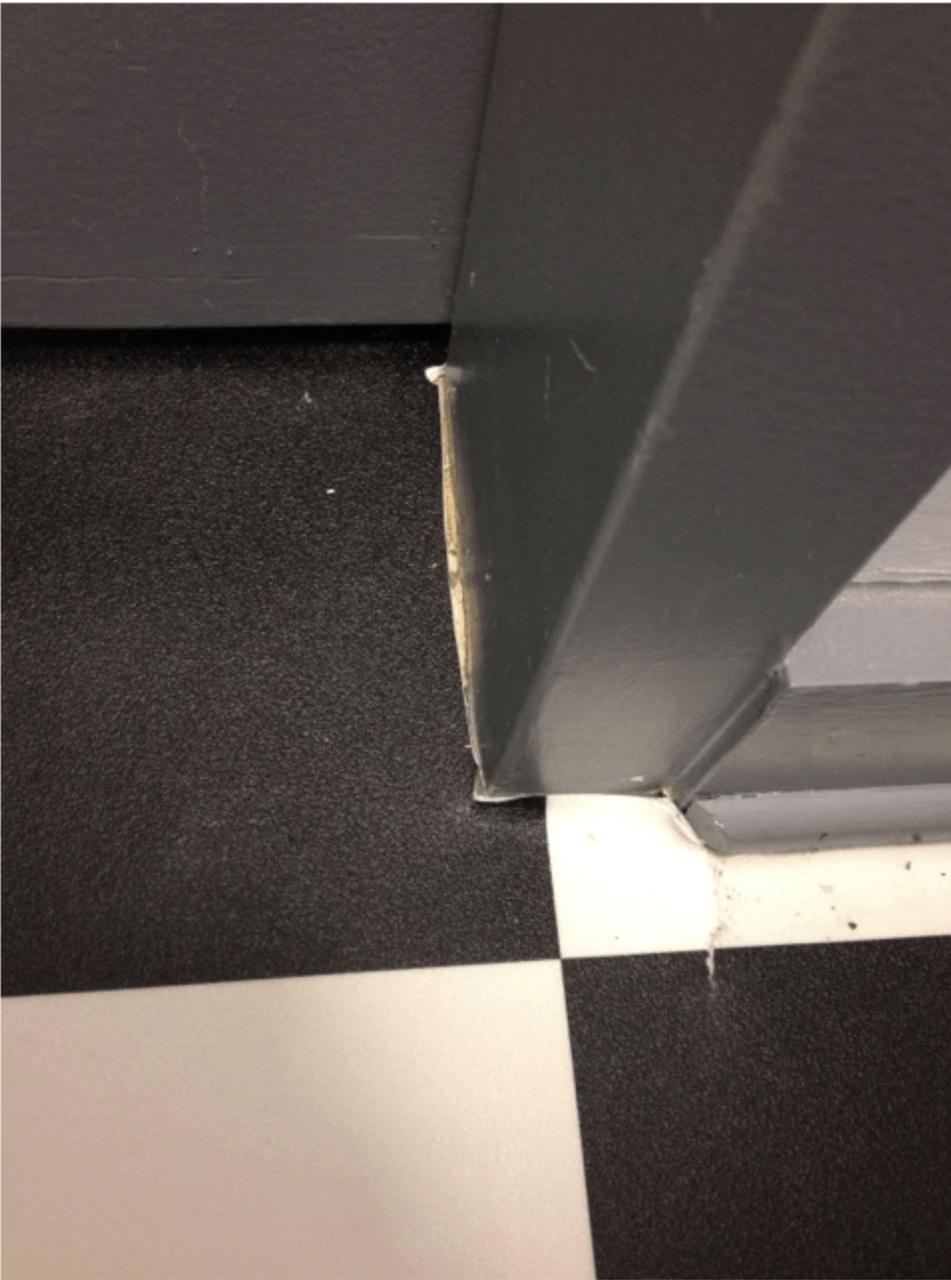
There are tears in the material in several of the corners. Not sure how this will be fixed? I understand caulking will help the edges look finished, but it won't hide the tears.

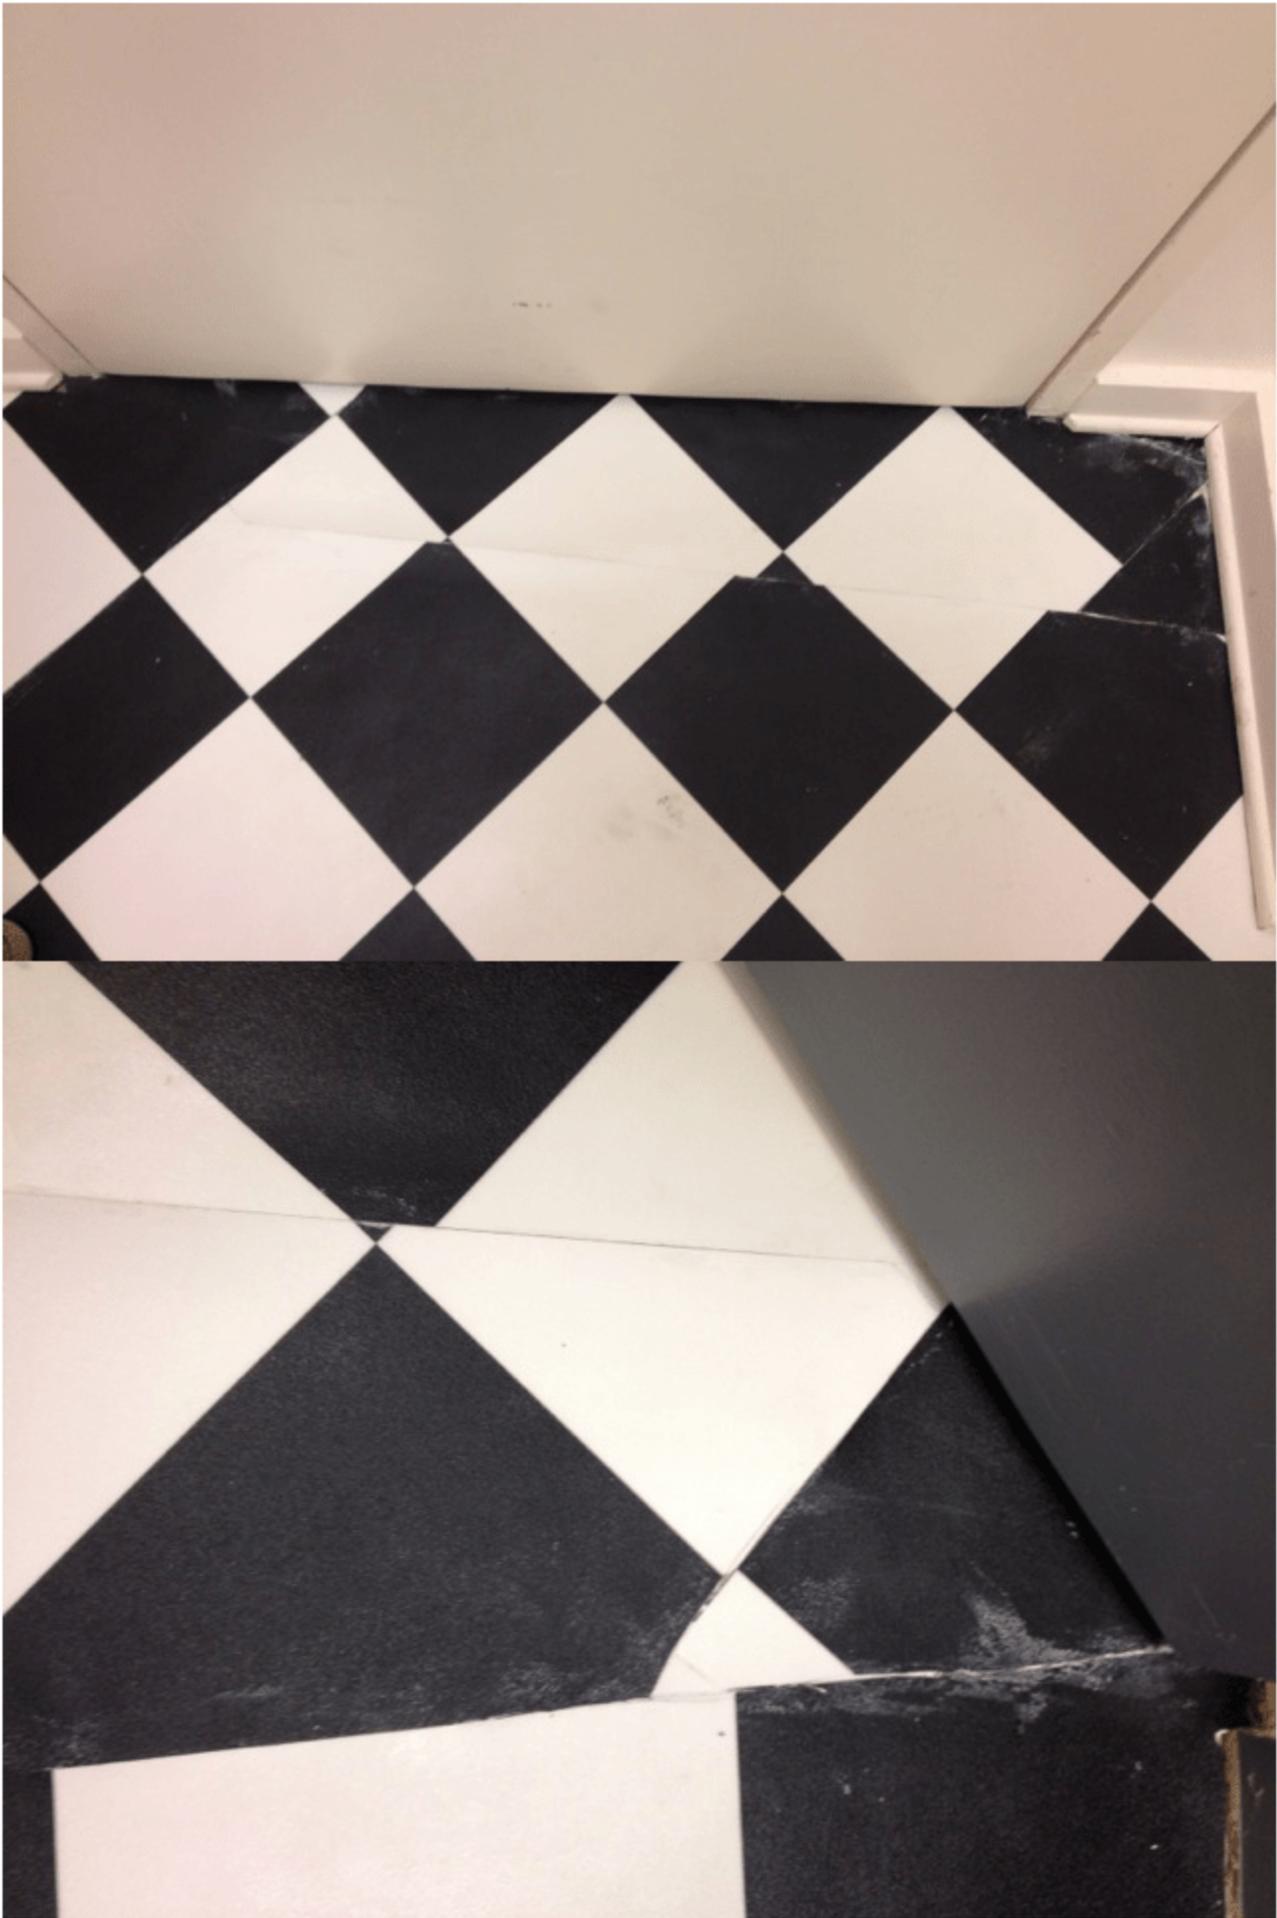
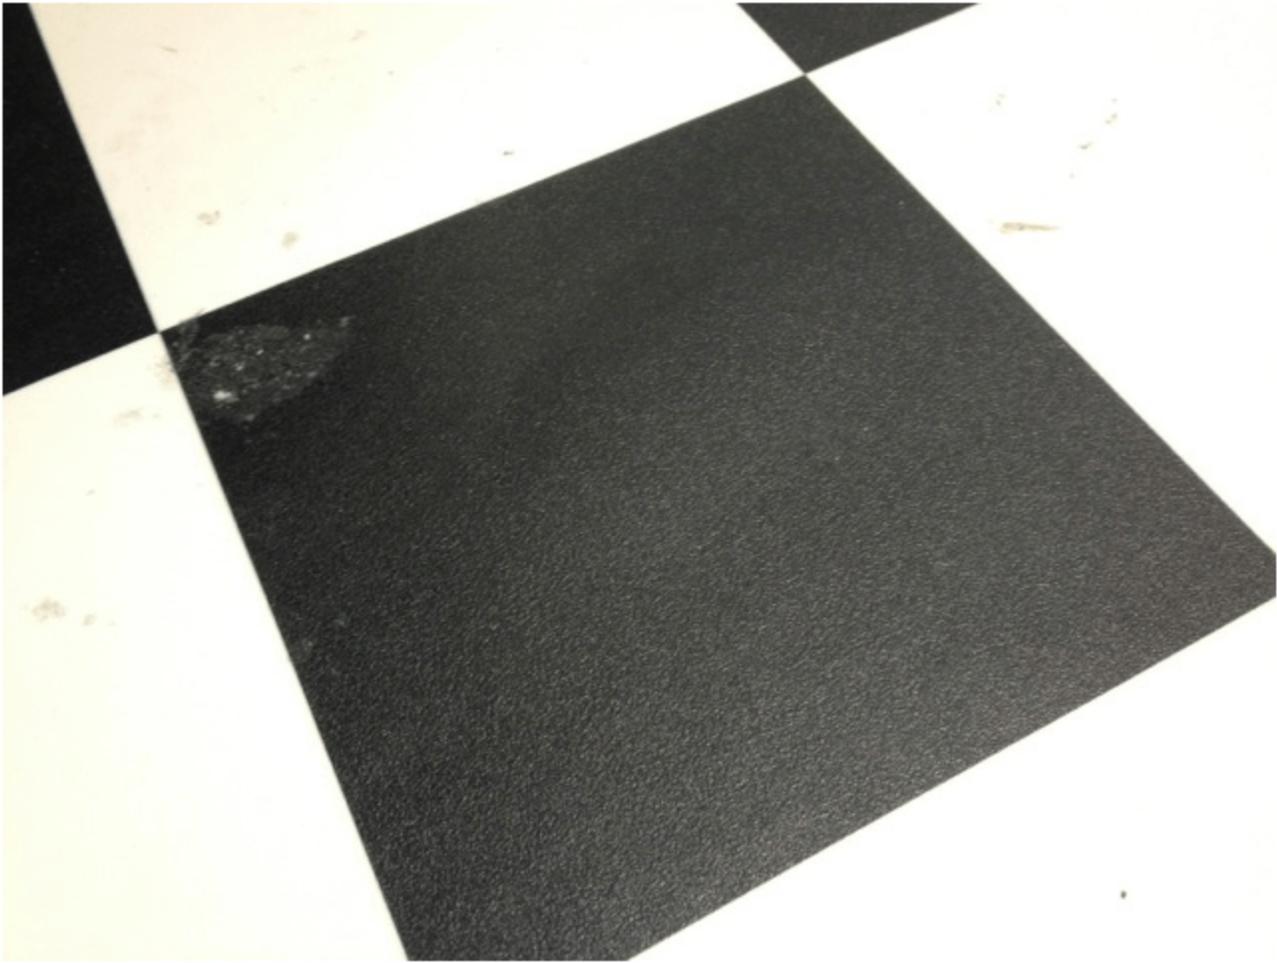
Where to begin on these. If it was temporarily put down to avoid someone tripping, why was it glued down? and very meticulously small triangular pieces were cut to fill in the small spaces. Why bother cutting so many small little pieces to fit in the holes if it was meant to be temporary? I don't buy it. Your explanation doesn't make any sense. There is no excuse for this.

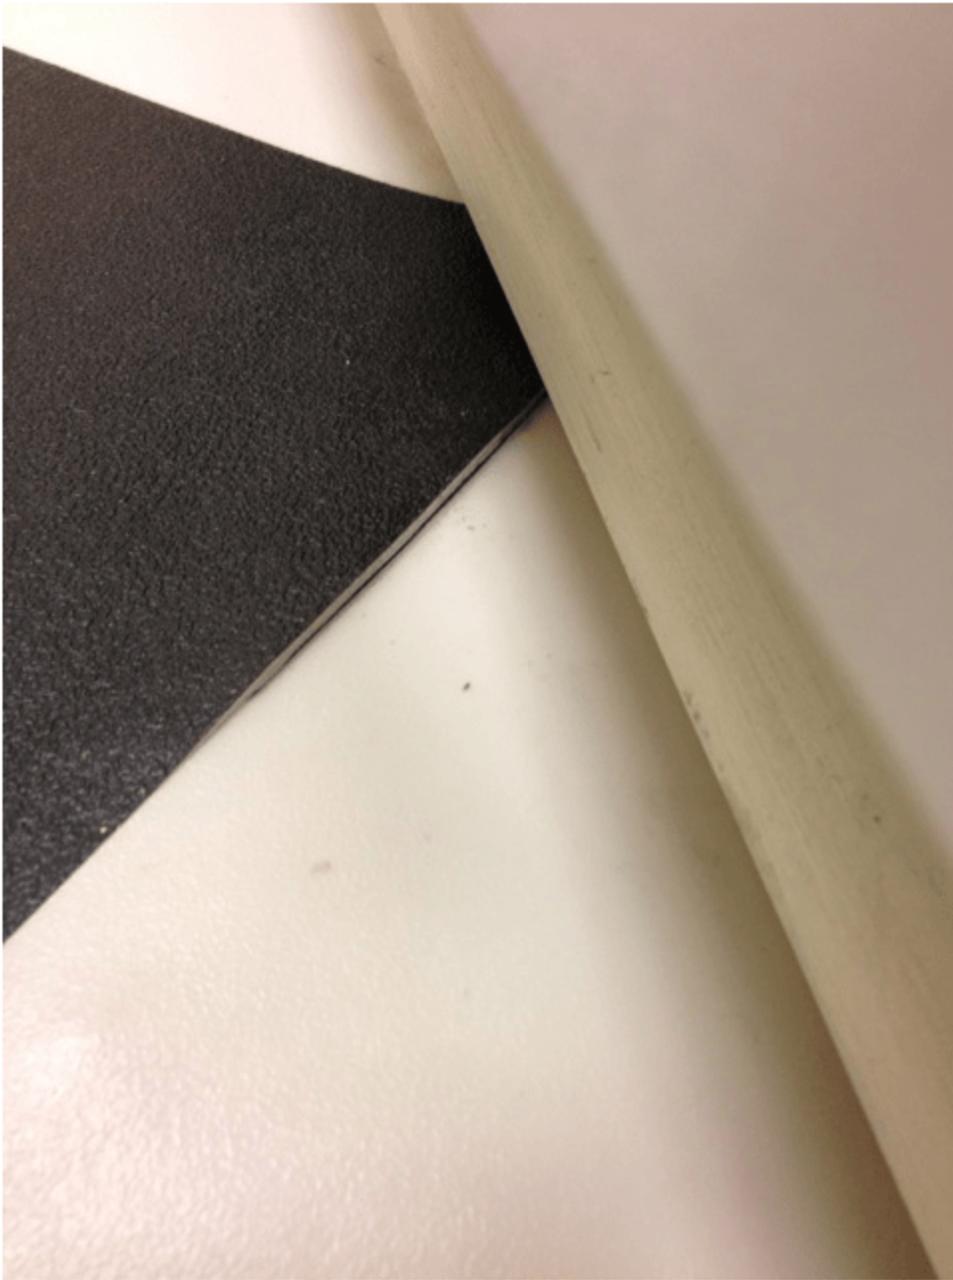
There are bubbles popping up in several areas of the flooring. How does that get fixed? The floor is covered with blobs of glue everywhere as well because the installer didn't have any clean up solution for the glue. How is that possible??

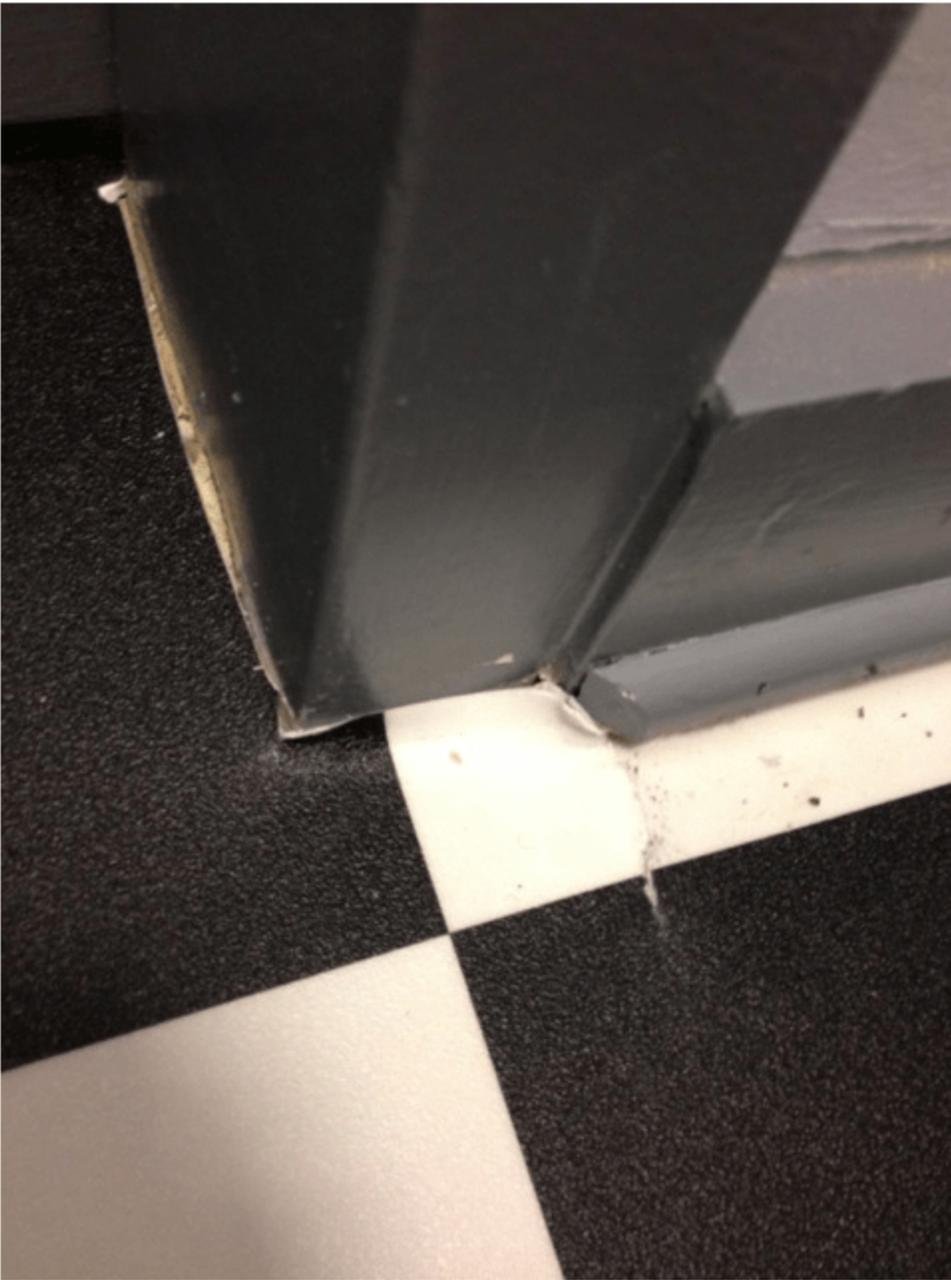
Seams coming up, and more tears in the material at the corners

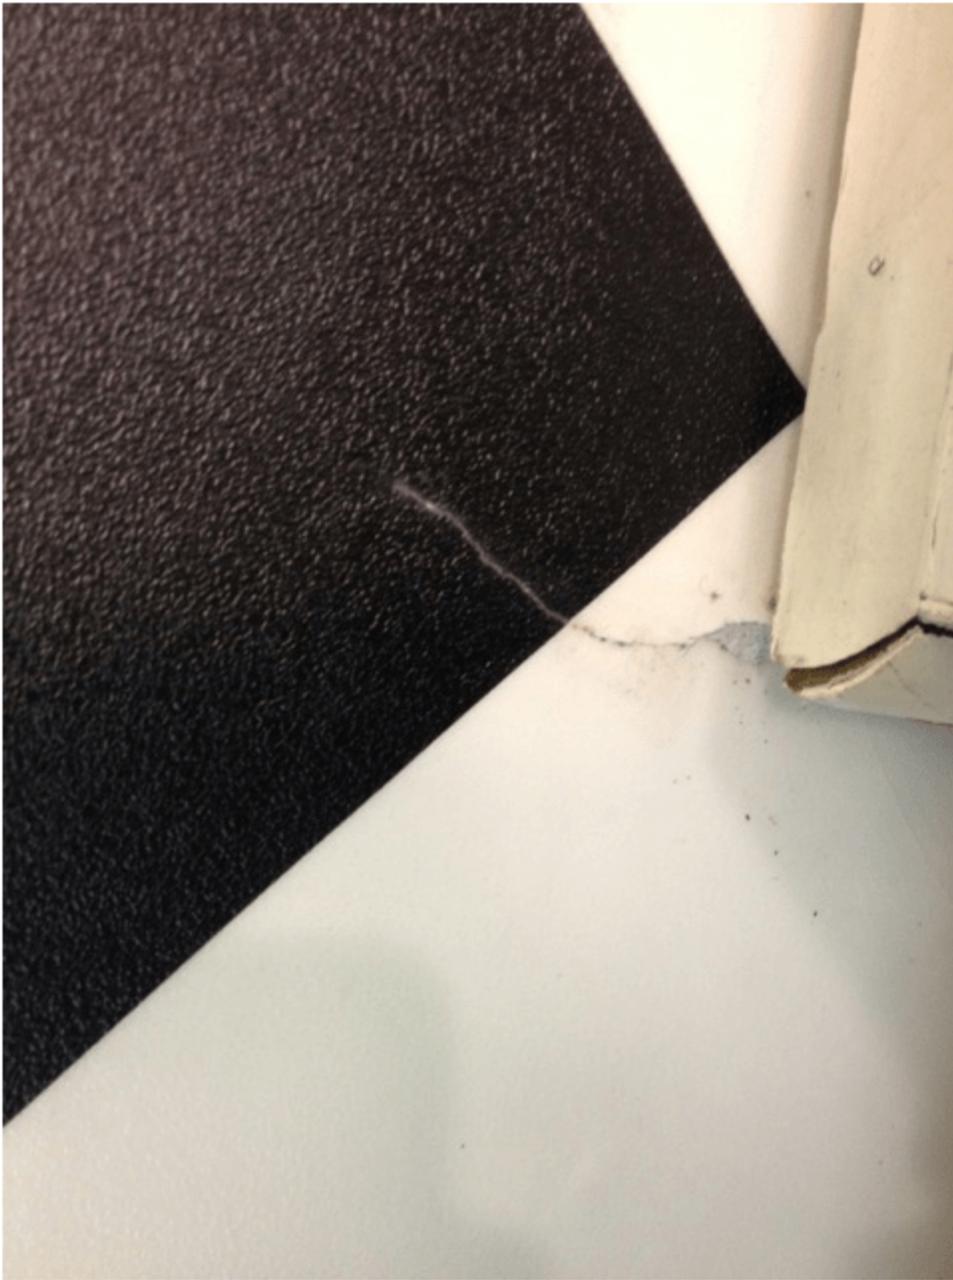
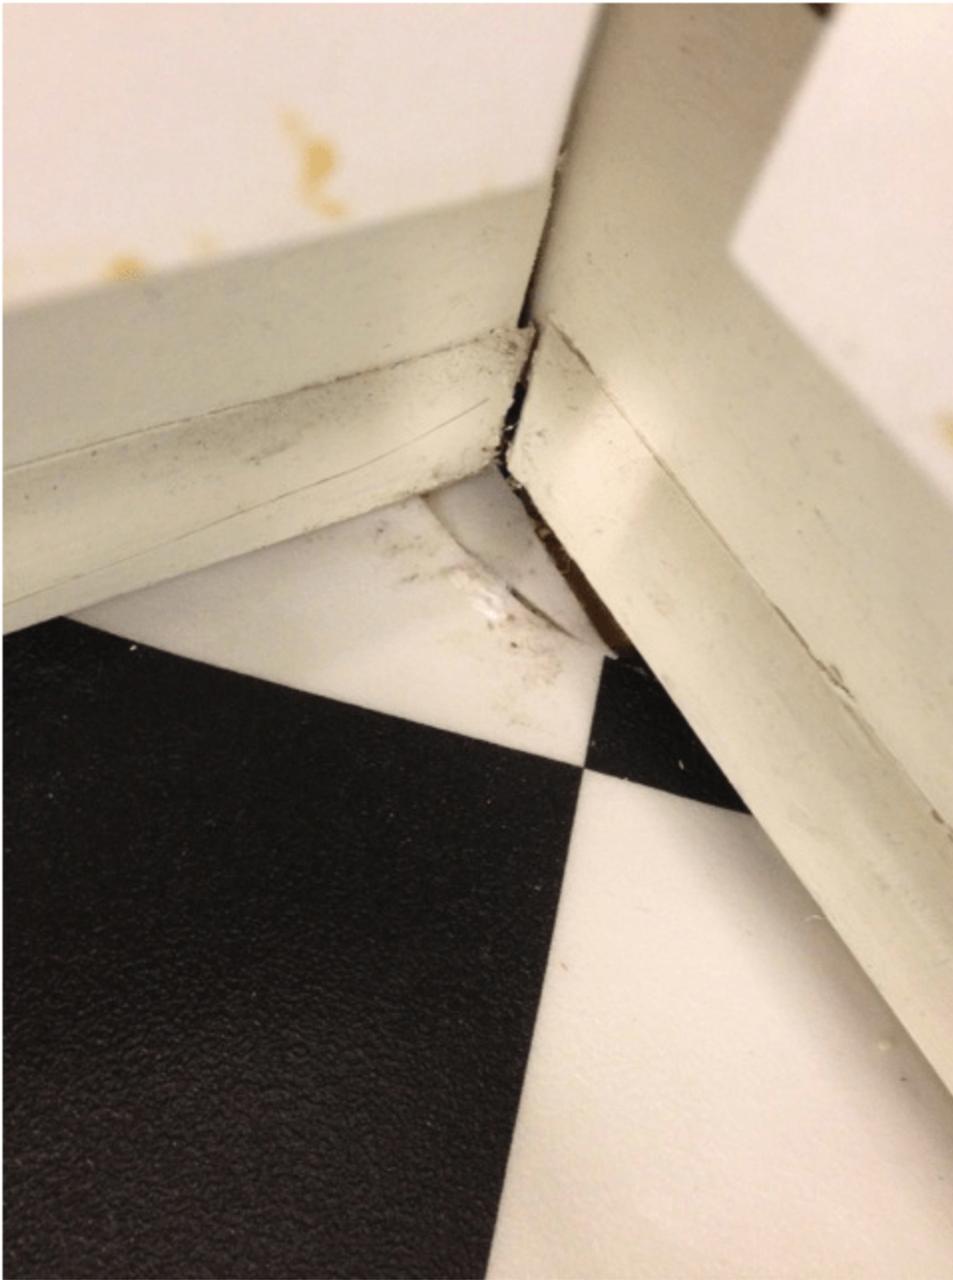
Tear in the material, and in second photo, another "cut and paste" job in the corner.

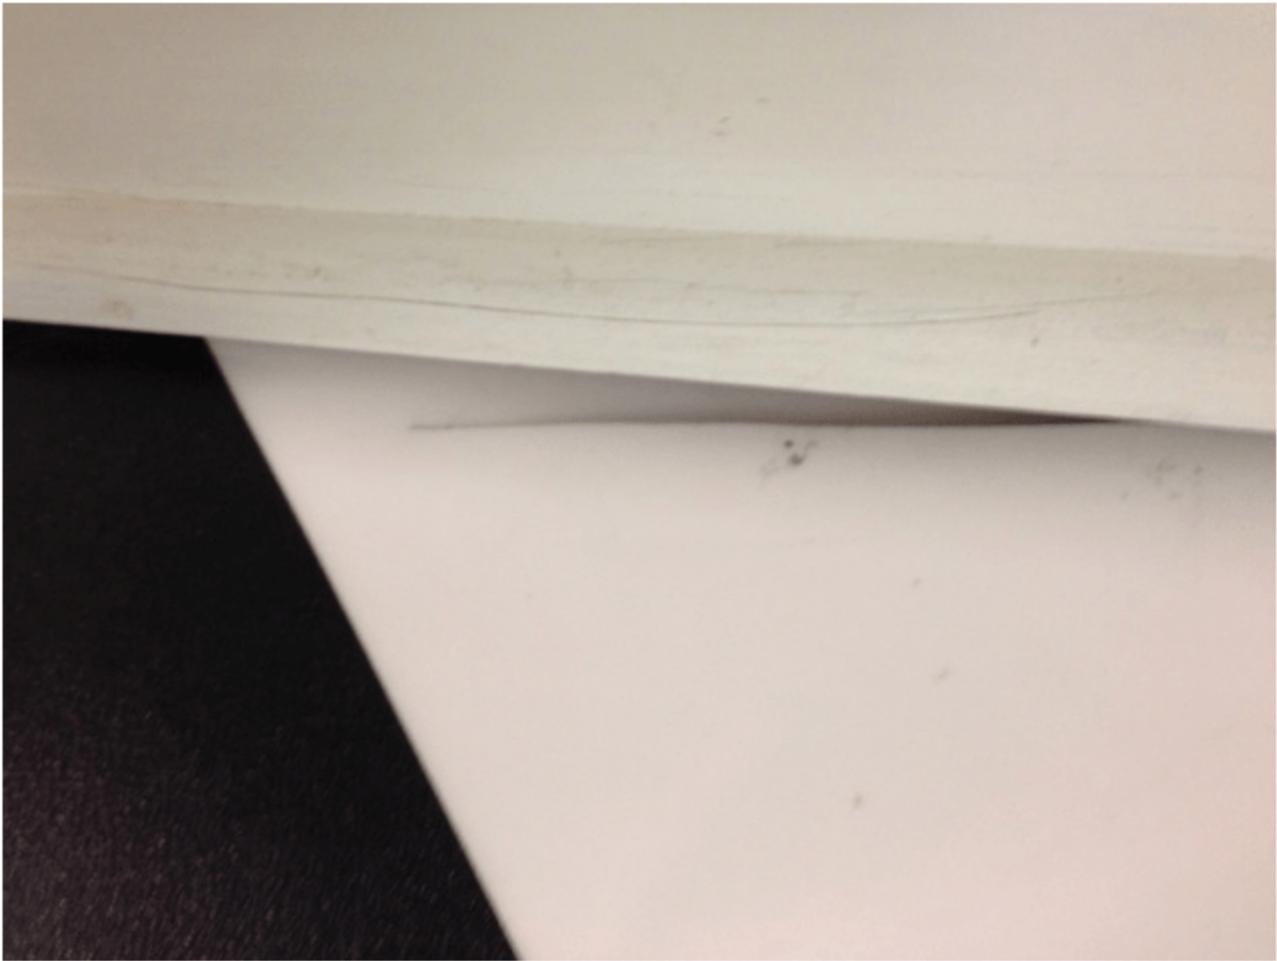
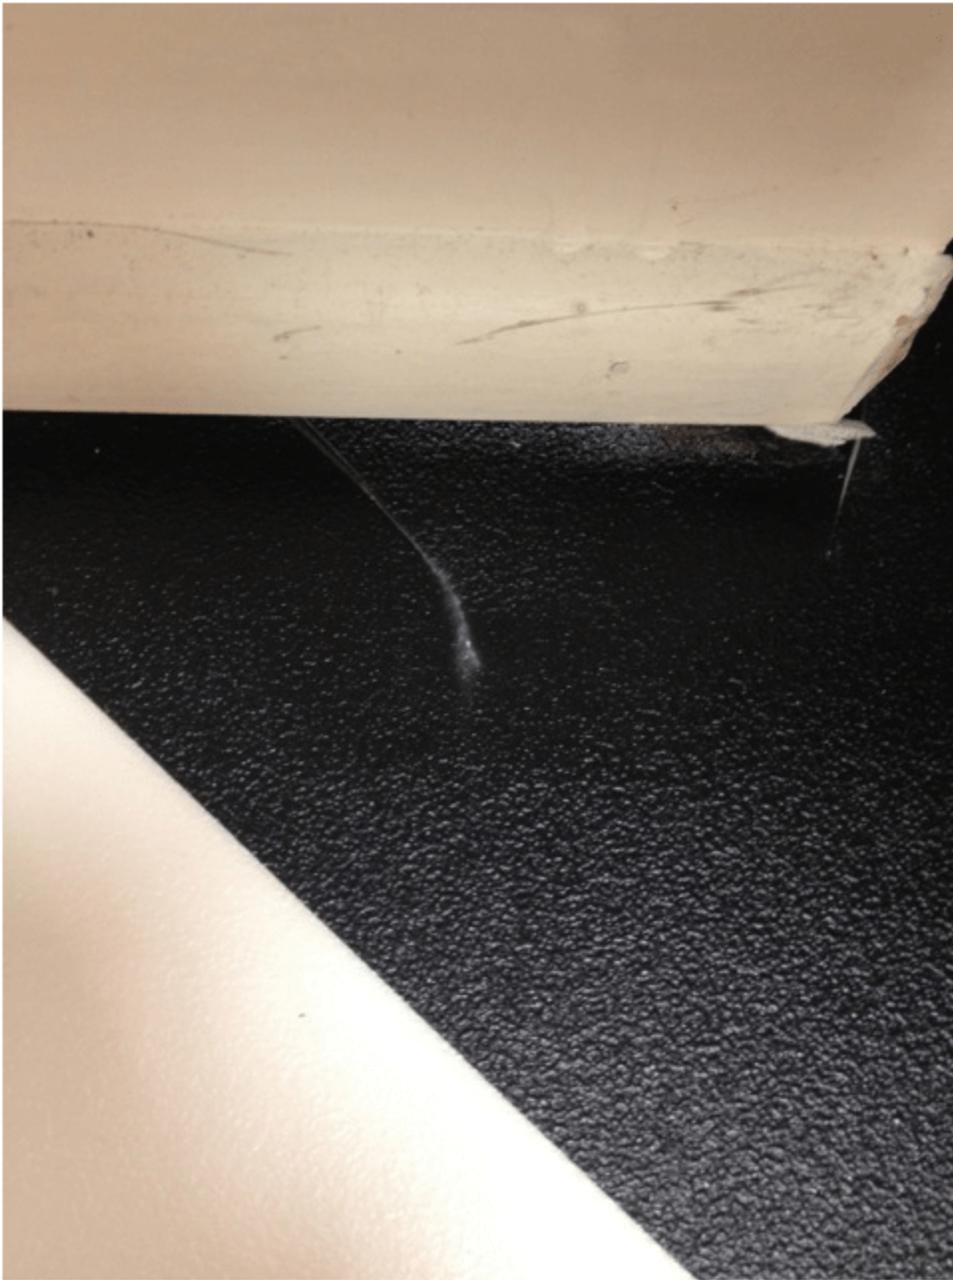
More cuts and tears where there shouldn't be.
