**Subject:** Big N

I wanted to give you and update on the progress of the Big N. This morning we were ready to lift and install the port engine. Bosco has informed us that the port engine is not ready, he has a few more things he needs to address. I know you were looking into replacing the gear boxes but have had no success in finding new ones that are similar. I am writing this email so we are all on the same page as far as a completion date. The majority of our work hinges on having those engines installed. The exhaust system on each engine has to be finished, but in order for us to complete this we have to have the engines in. The same goes for the new fuel lines and all the electrical components that run to the engines. I know we discussed the end of this month/beginning of next month but each day that we wait for the engines to be completed it delays us from our target date. A few issues have been discovered while working on Big N. 1) The shaft logs on both sides are corroded beyond repair. We anticipated that we might have this problem so it was factored into the quotation. 2) The port stern quarter looks like it might have hit a dock which has separated some of the stringer

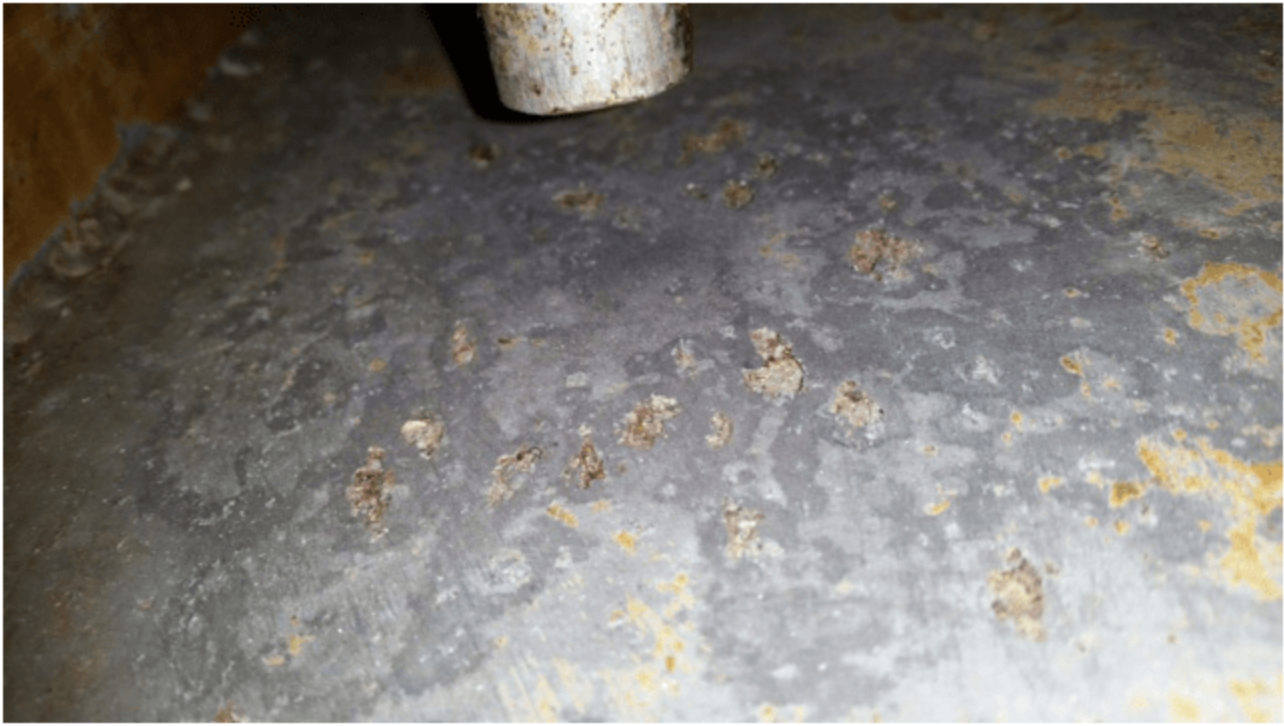
replace both tanks. The original tanks got you 40 years so I don't see why the new ones we fabricate cant get the same amount of usage out of them. Attached our a couple of pictures of the corrosion and an estimate to remove and replace both tanks. Please call or email with any questions...
