**Subject:** Big N

I wanted to give you and update on the progress of the Big N. This morning we were ready to lift and install the port engine. Bosco has informed us that the port engine is not ready, he has a few more things he needs to address. I know you were looking into replacing the gear boxes but have had no success in finding new ones that are similar. I am writing this email so we are all on the same page as far as a completion date. The majority of our work hinges on having those engines installed. The exhaust system on each engine has to be finished, but in order for us to complete this we have to have the engines in. The same goes for the new fuel lines and all the electrical components that run to the engines. I know we discussed the end of this month/beginning of next month but each day that we wait for the engines to be completed it delays us from our target date. A few issues have been discovered while working on Big N. 1) The shaft logs on both sides are corroded beyond repair. We

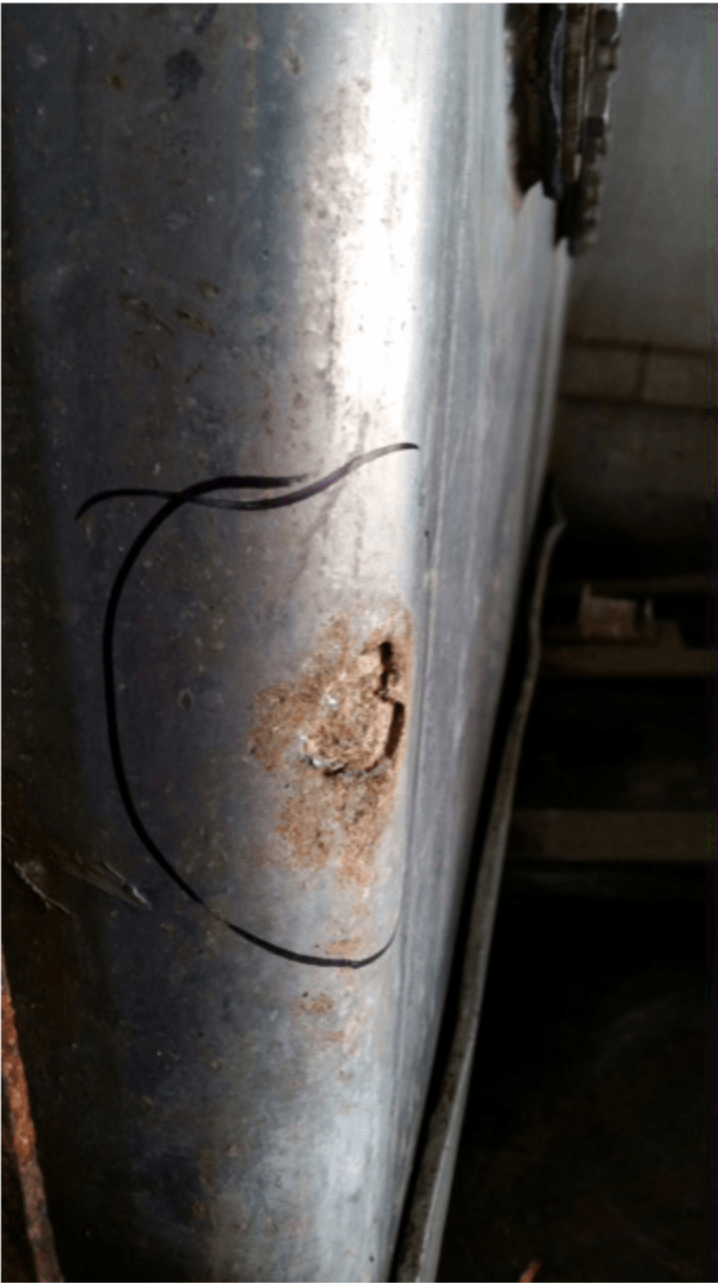
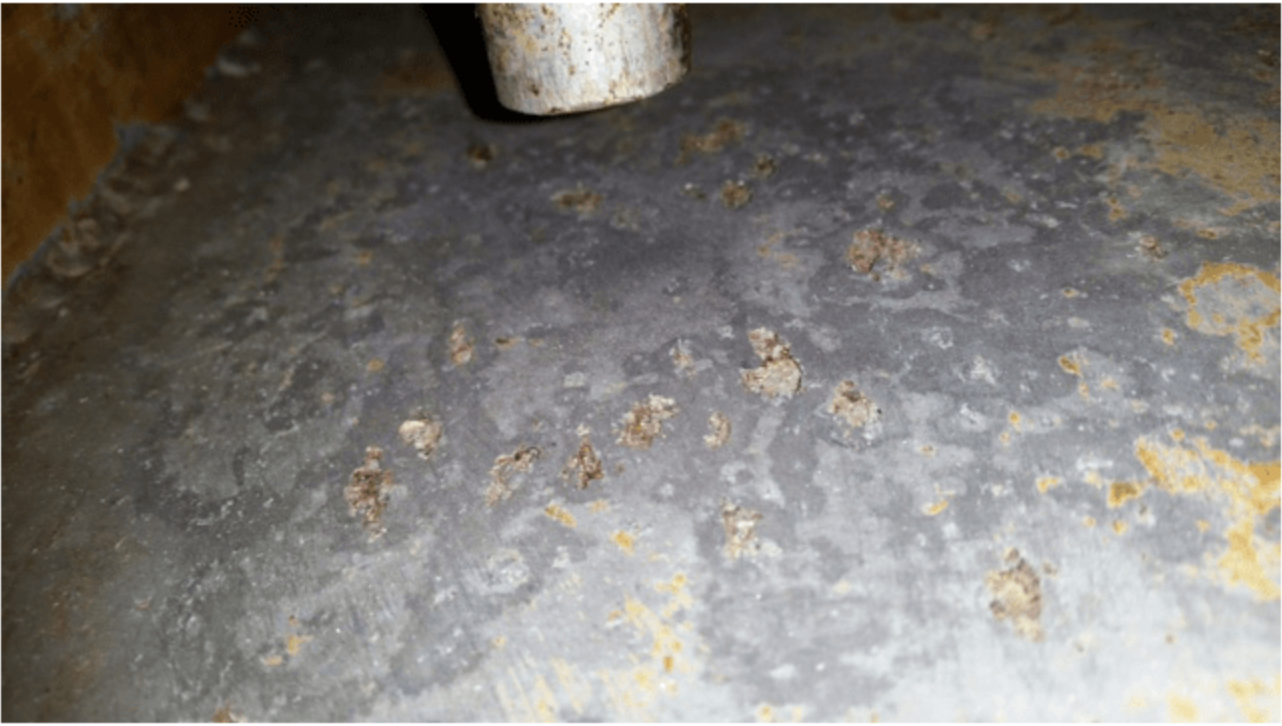
anticipated that we might have this problem so it was factored into the quotation. 2) The port stern quarter looks like it might have hit a dock which has separated some of the stringers on the inside. It is repairable and I told you we would repair it under the quotation. 3) The fuel fill cover on both sides are compromised and need to be replaced. They are not sealing properly and over the course of time have allowed salt water to seep in and contaminate the fuel tanks. Which leads me to your biggest issue we have discovered while working in the rudder room where the fuel tanks are located. The bottoms of the fuel tanks and several other areas are severely corroded. It is my recommendation that these tanks be replaced. The only way for a proper repair are to replace both tanks. The original tanks got you 40 years so I don't see why the new ones we fabricate cant get the same amount of usage out of them. Attached our a couple of pictures of the corrosion and an estimate to remove and replace both tanks. Please call or email with any questions...
